Ammonoosuc River Geomorphic Assessment, Floodplain Conservation, and River Corridor Planning

Connecticut River Joint Commissions
Lebanon, NH

Dr. John Field
Field Geology Services
Farmington, ME

October 2011

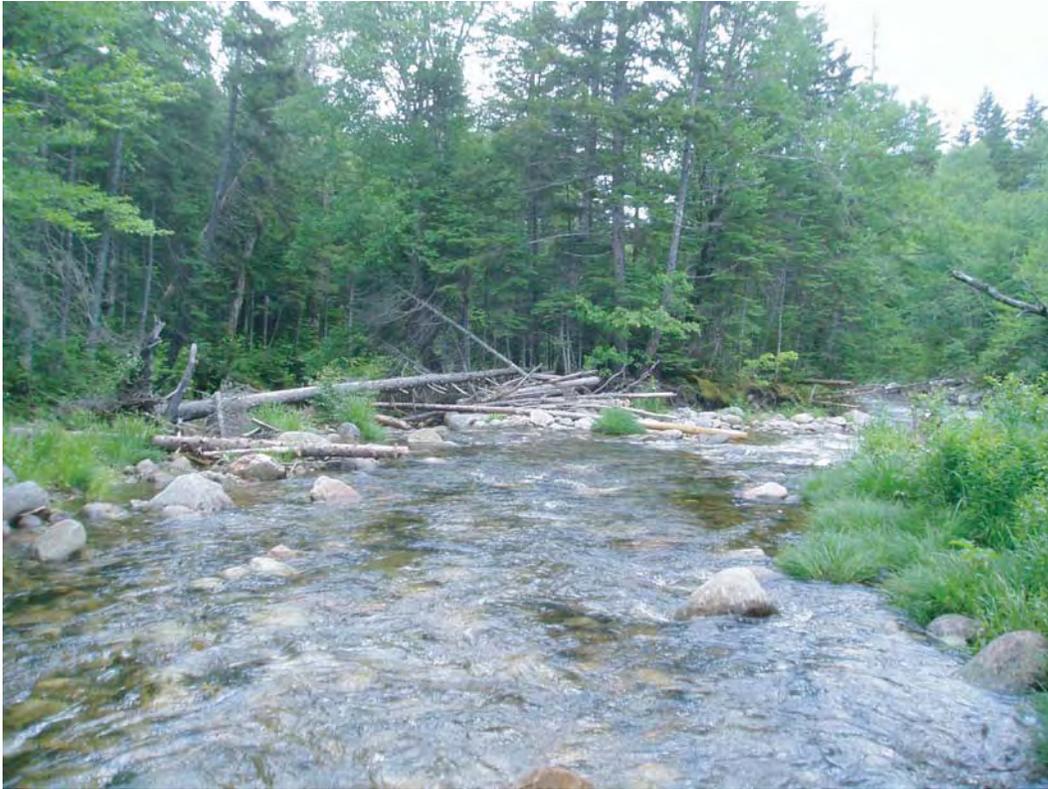
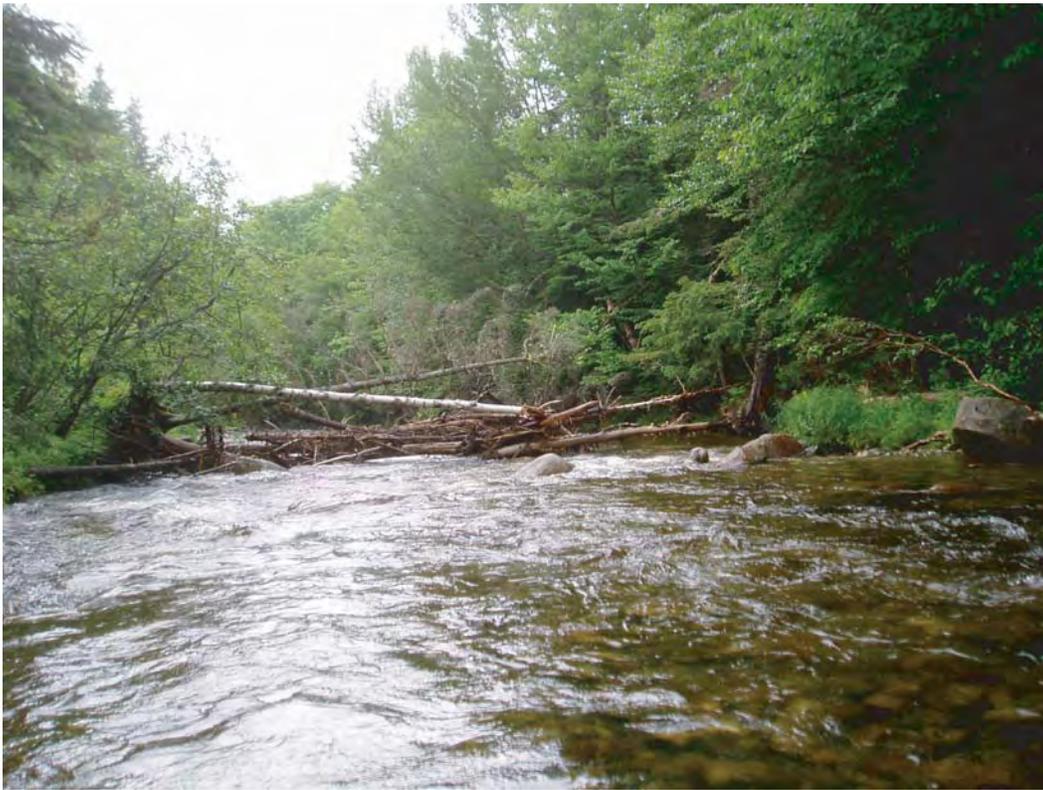
Figure 5. Log jams in the headwaters of the Ammonoosuc River are responsible for frequent channel avulsions between different threads of the anastomosed channels.

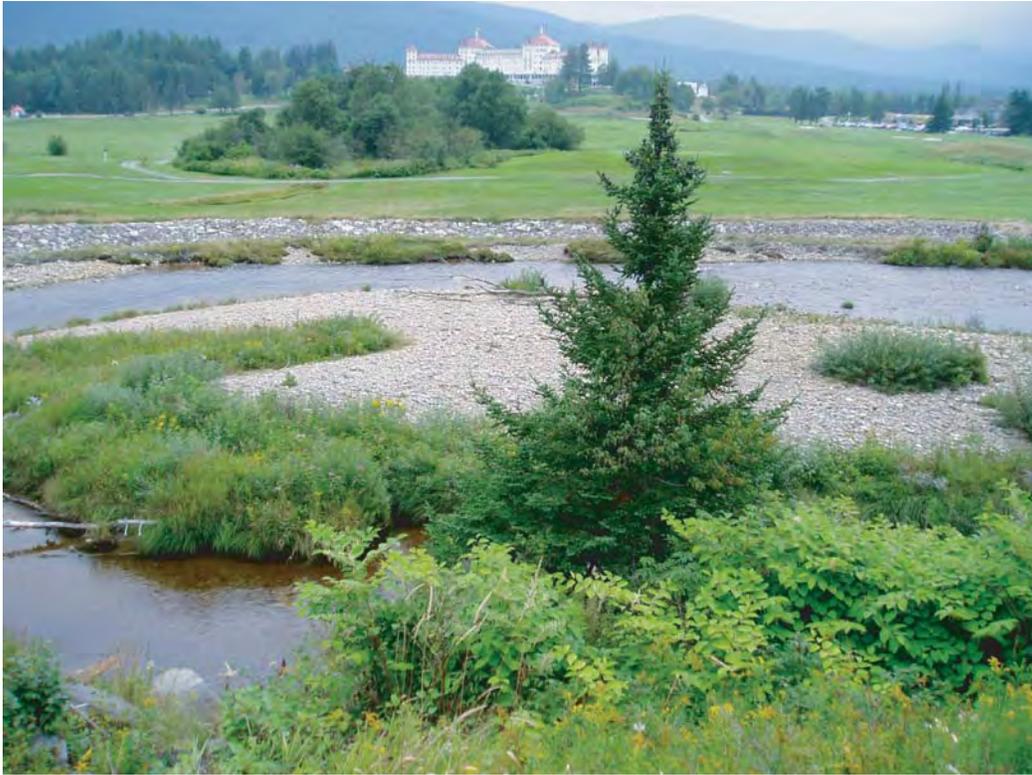
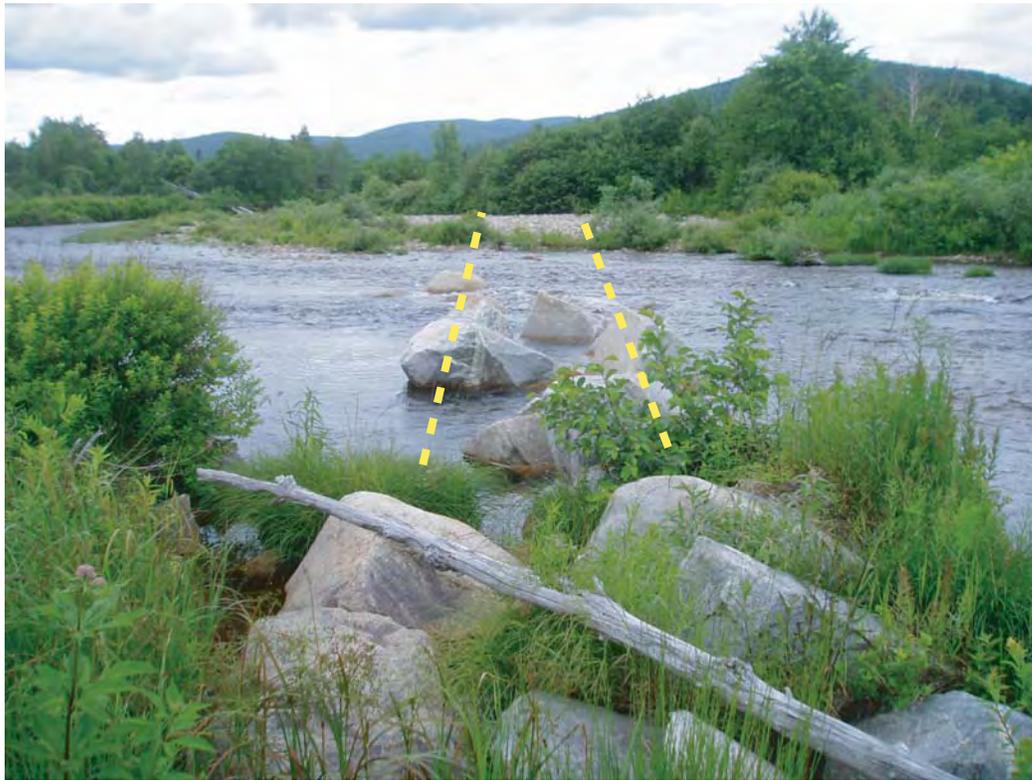
The dynamic nature of the river in the Bretton Woods section is partially a natural phenomenon resulting from the river's declining slope between the uplands and the valley bottom, but is still worrisome given human development of the corridor. Reaches 41-43 have higher than 64 percent corridor development and little to no riparian buffer over more than 17 percent of their length (Table 4). The poor buffer conditions (Table 5) may further contribute to the high bank instability and active growth of gravel bars (Table 6). Previous efforts at bank stabilization have not stood the test of time against the actively migrating river in this area. While more recent stabilization efforts apply some concepts of natural channel design aimed at reducing erosive forces along eroding banks (Figure 8), they do not address the larger issue of high sediment supply driving the erosion. Sediment storage opportunities are key to crafting sustainable management solutions addressing active channel migration and the resulting conflicts that arise with infrastructure in the river corridor. Creation of a meander migration zone buffering the channel, at least in places, can allow channel migration to occur unencumbered, store sediment on gravel bars, and reduce the likelihood similar dynamic processes will continue downstream where infrastructure pressures may be higher. Upstream sediment storage, enhanced through wood additions, would reduce sediment supply downstream and, thereby, reduce rates of bar growth and bank erosion.

Figure 7. a) Large unvegetated gravel bars and b) the resulting channel migration characterize the Bretton Woods area. Channel migration in “b” is evidenced by river now flowing over previous bank stabilization efforts.

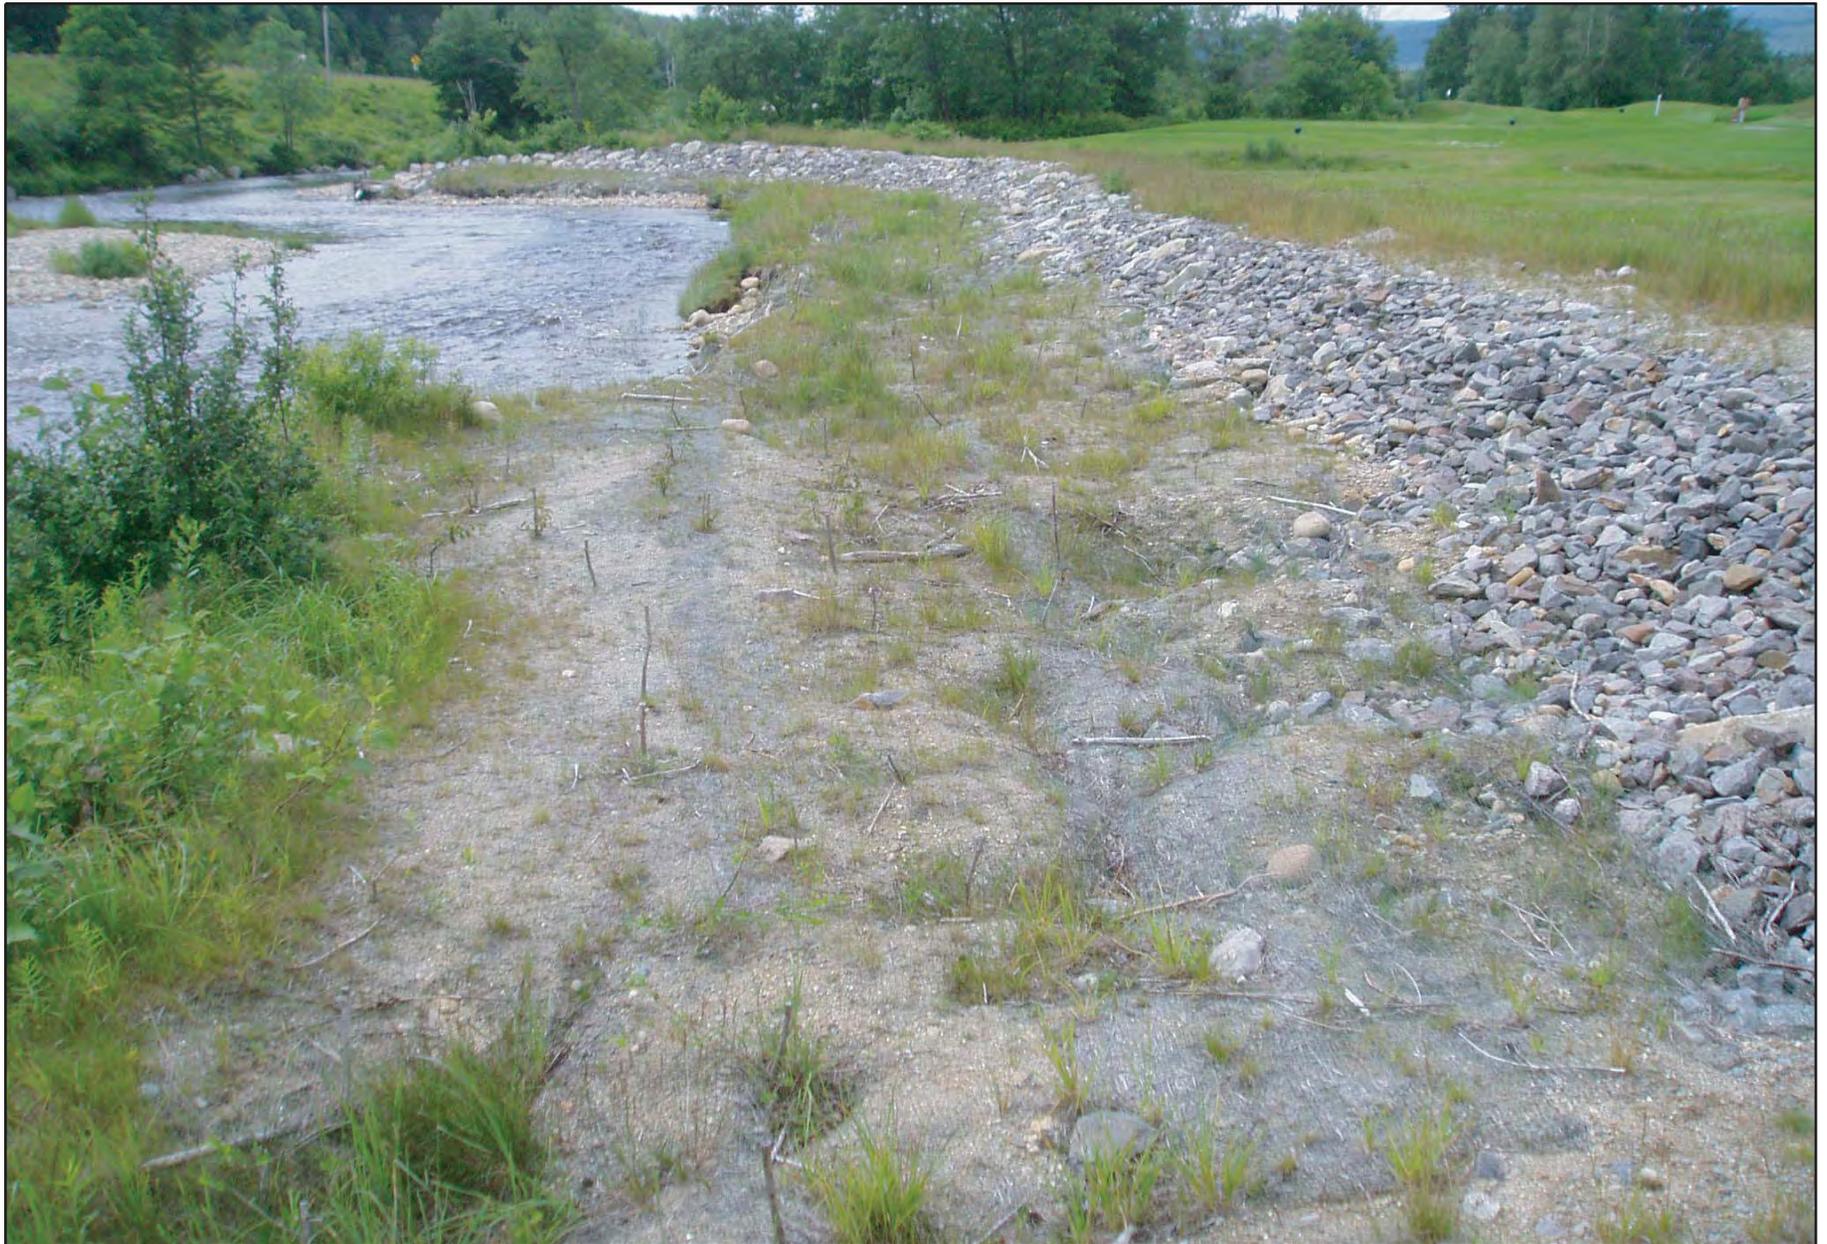
Figure 8. Recent bank stabilization project incorporating a floodplain bench in front of the eroding bank to reduce erosive forces through flow attenuation.

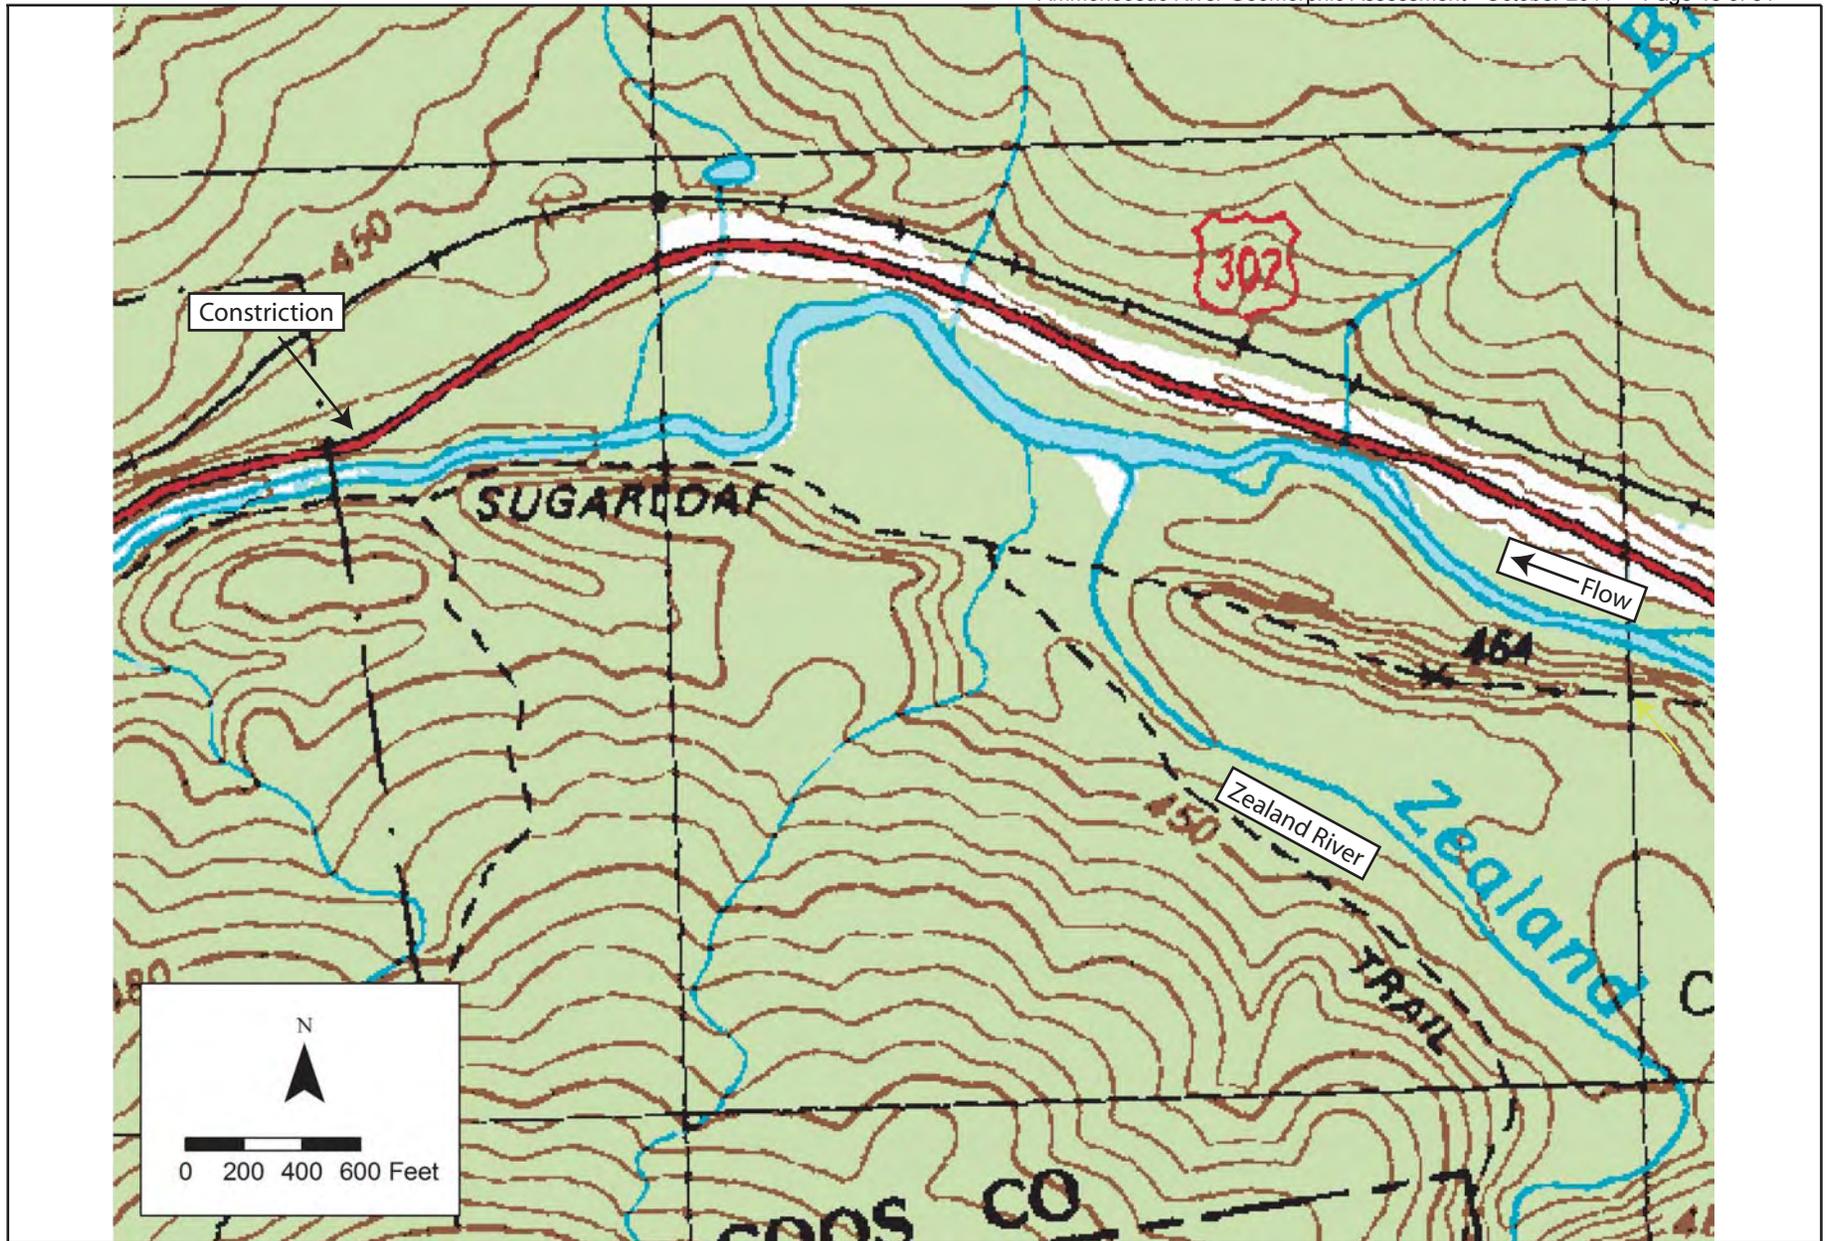
Figure 10. Sediment inputs from the Zealand River cause extensive bar formation and channel migration on the Ammonoosuc River, a situation enhanced by a downstream valley constriction

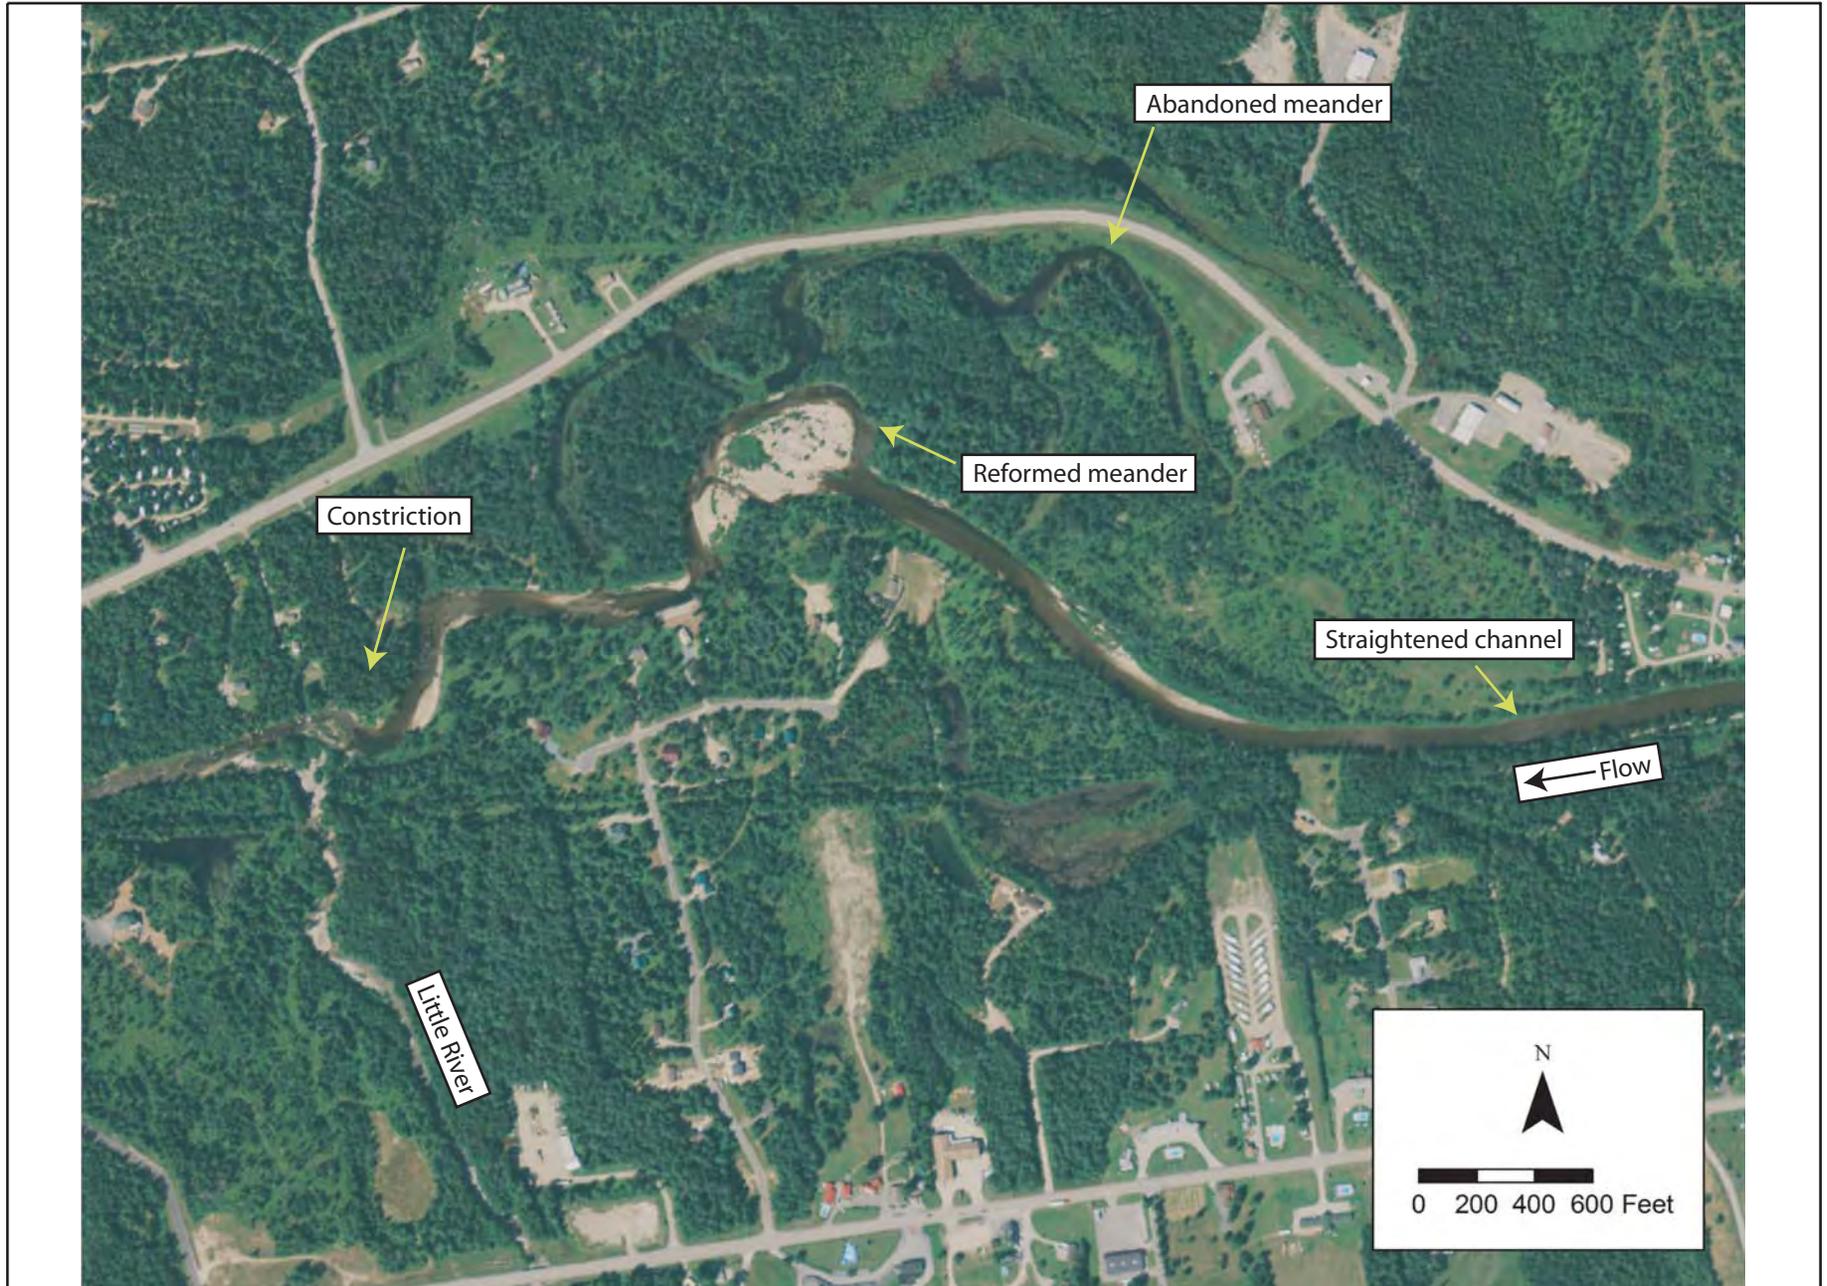
Figure 11. Sediment inputs from the Little River confluence occur at a natural valley constriction and enhance the upstream deposition responsible for channel migration and the reforming of meanders along the formerly straightened channel.

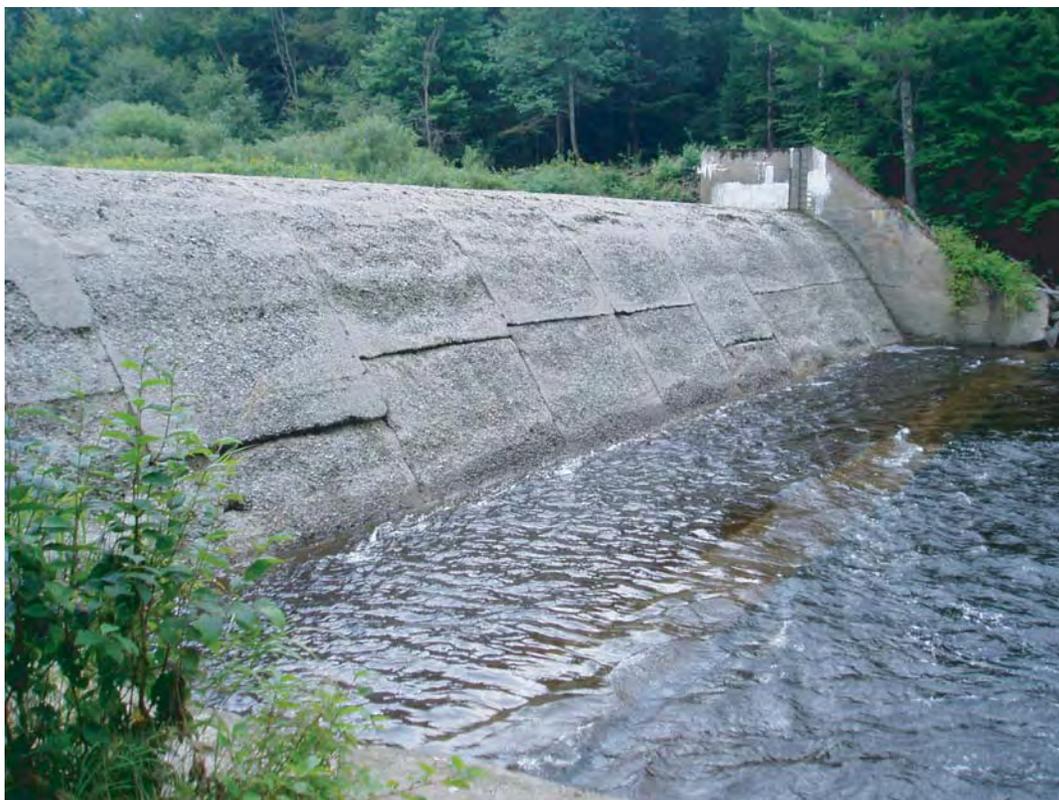
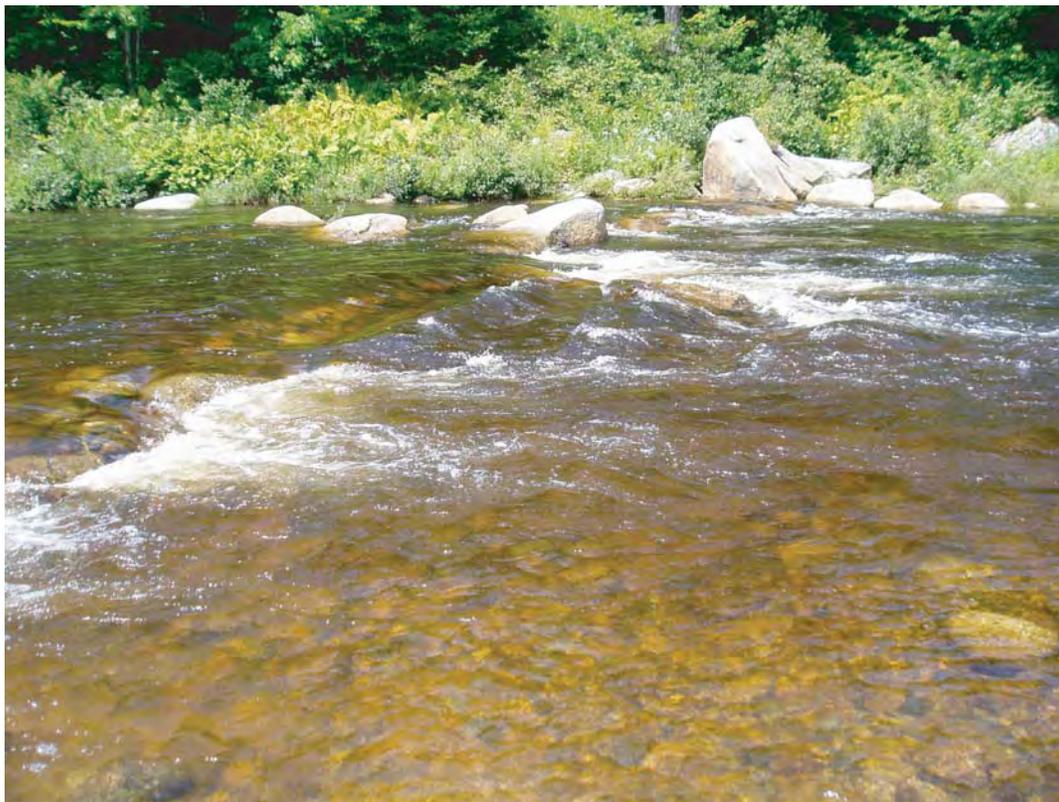
Figure 12. Decommissioning and lowering of the impoundment level upstream of a) the Bethlehem Dam has b) led to upstream migration of a headcut that has incised through a portion of the impoundment sediments.

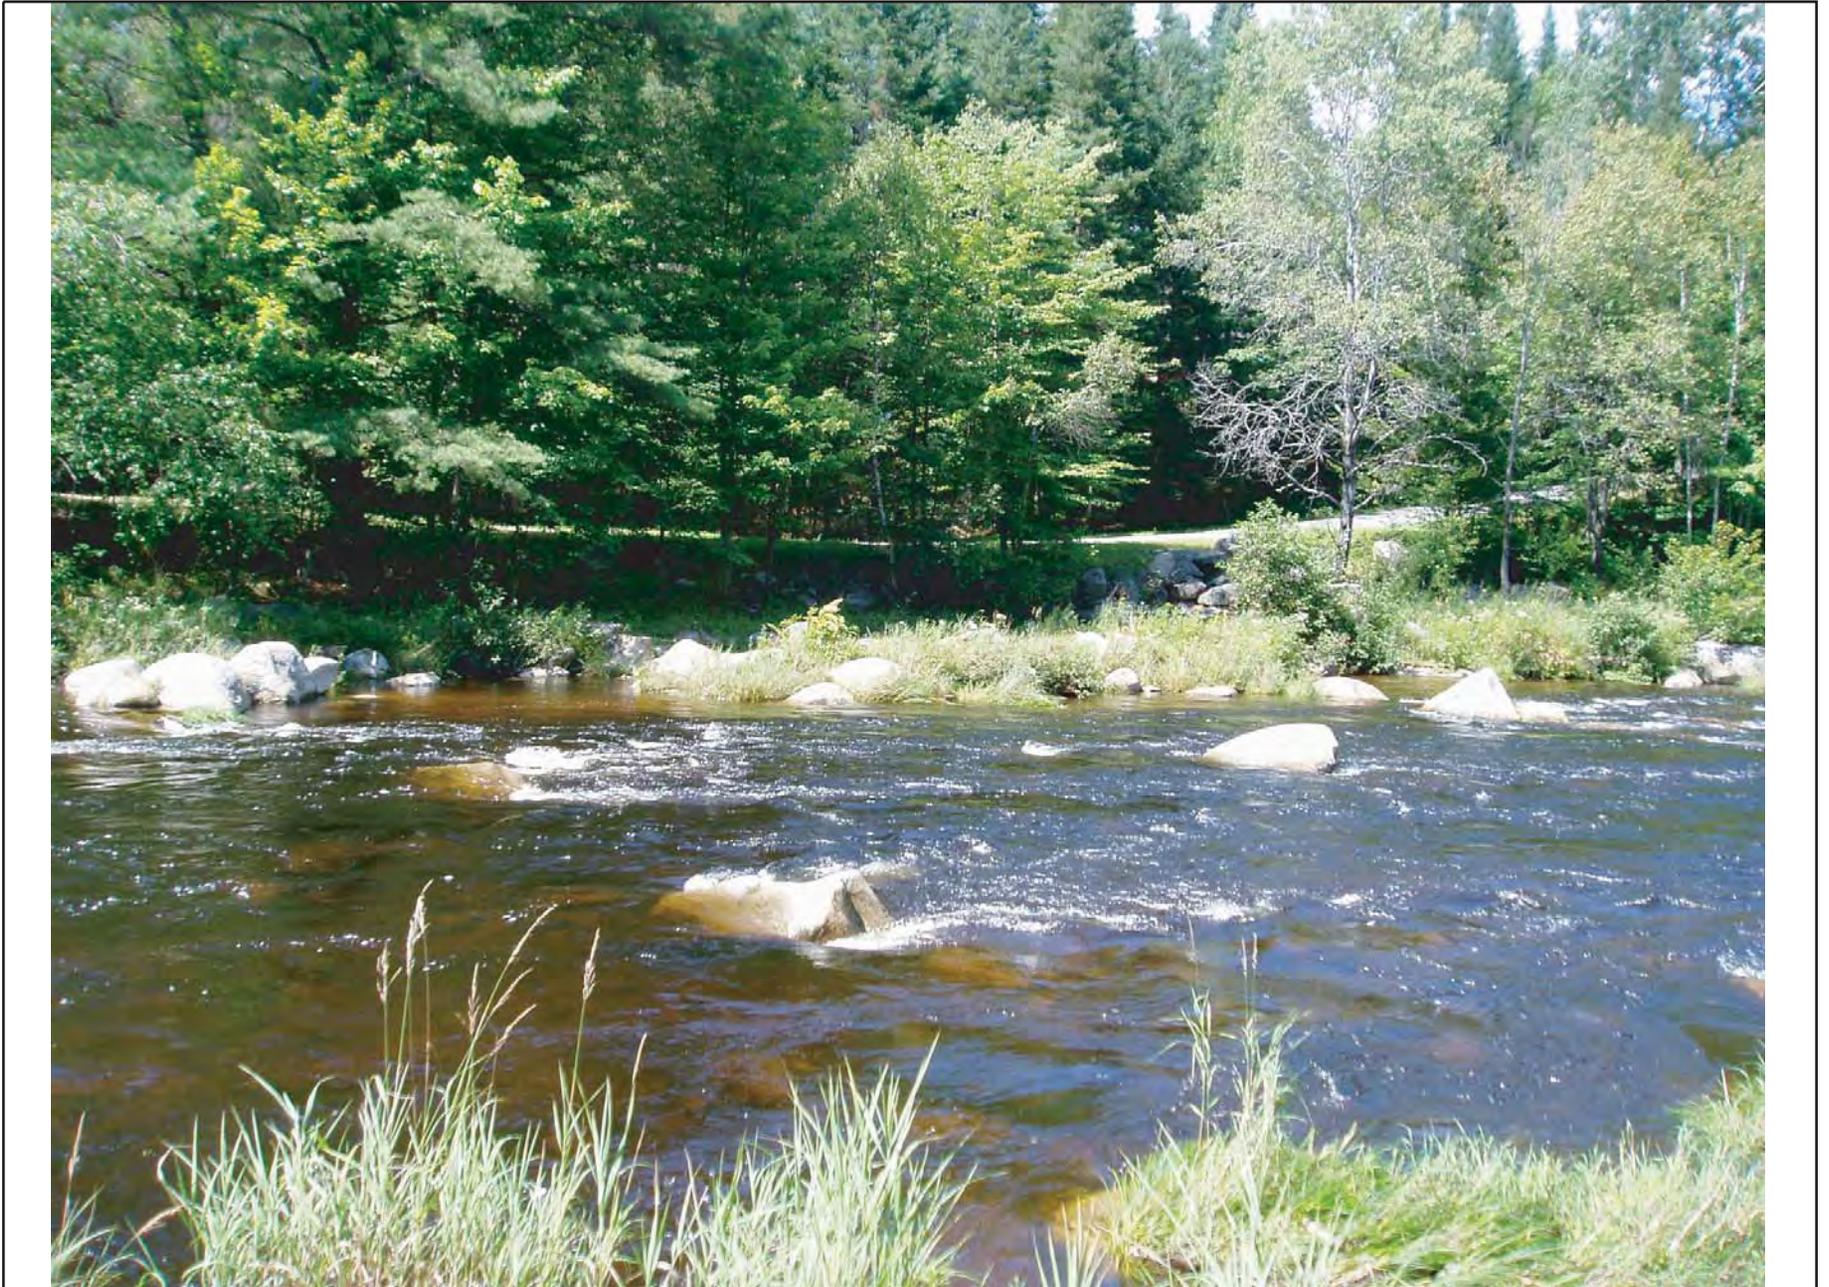
Figure 13. A considerable length of the channel in Bethlehem Hollow is armored against erosion due to the steep gradient and valley confinement.

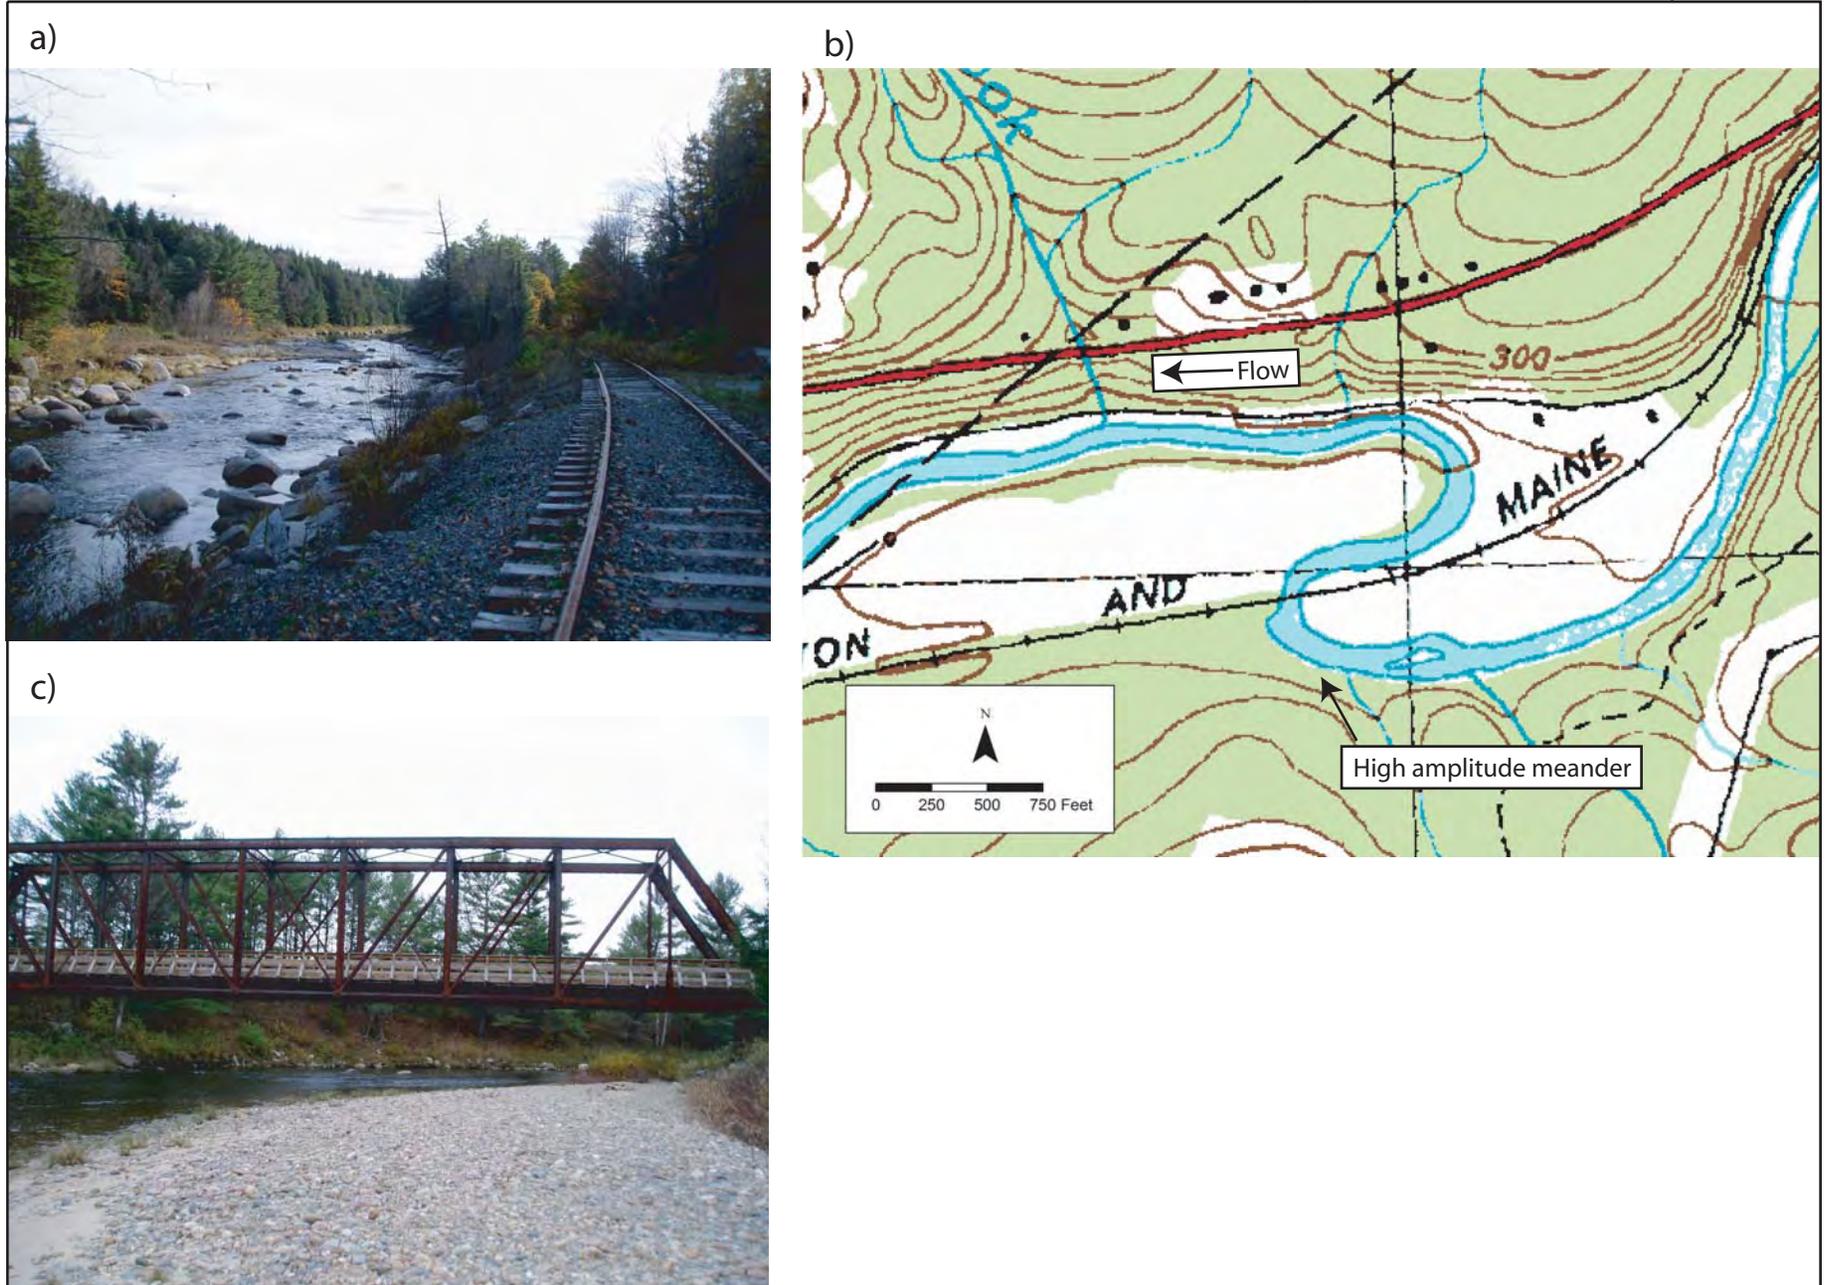
Figure 14. The railroad grade in the lower Bethlehem section a) blocks floodplain access, causing b) the growth of high amplitude meanders and c) considerable upstream sediment deposition.

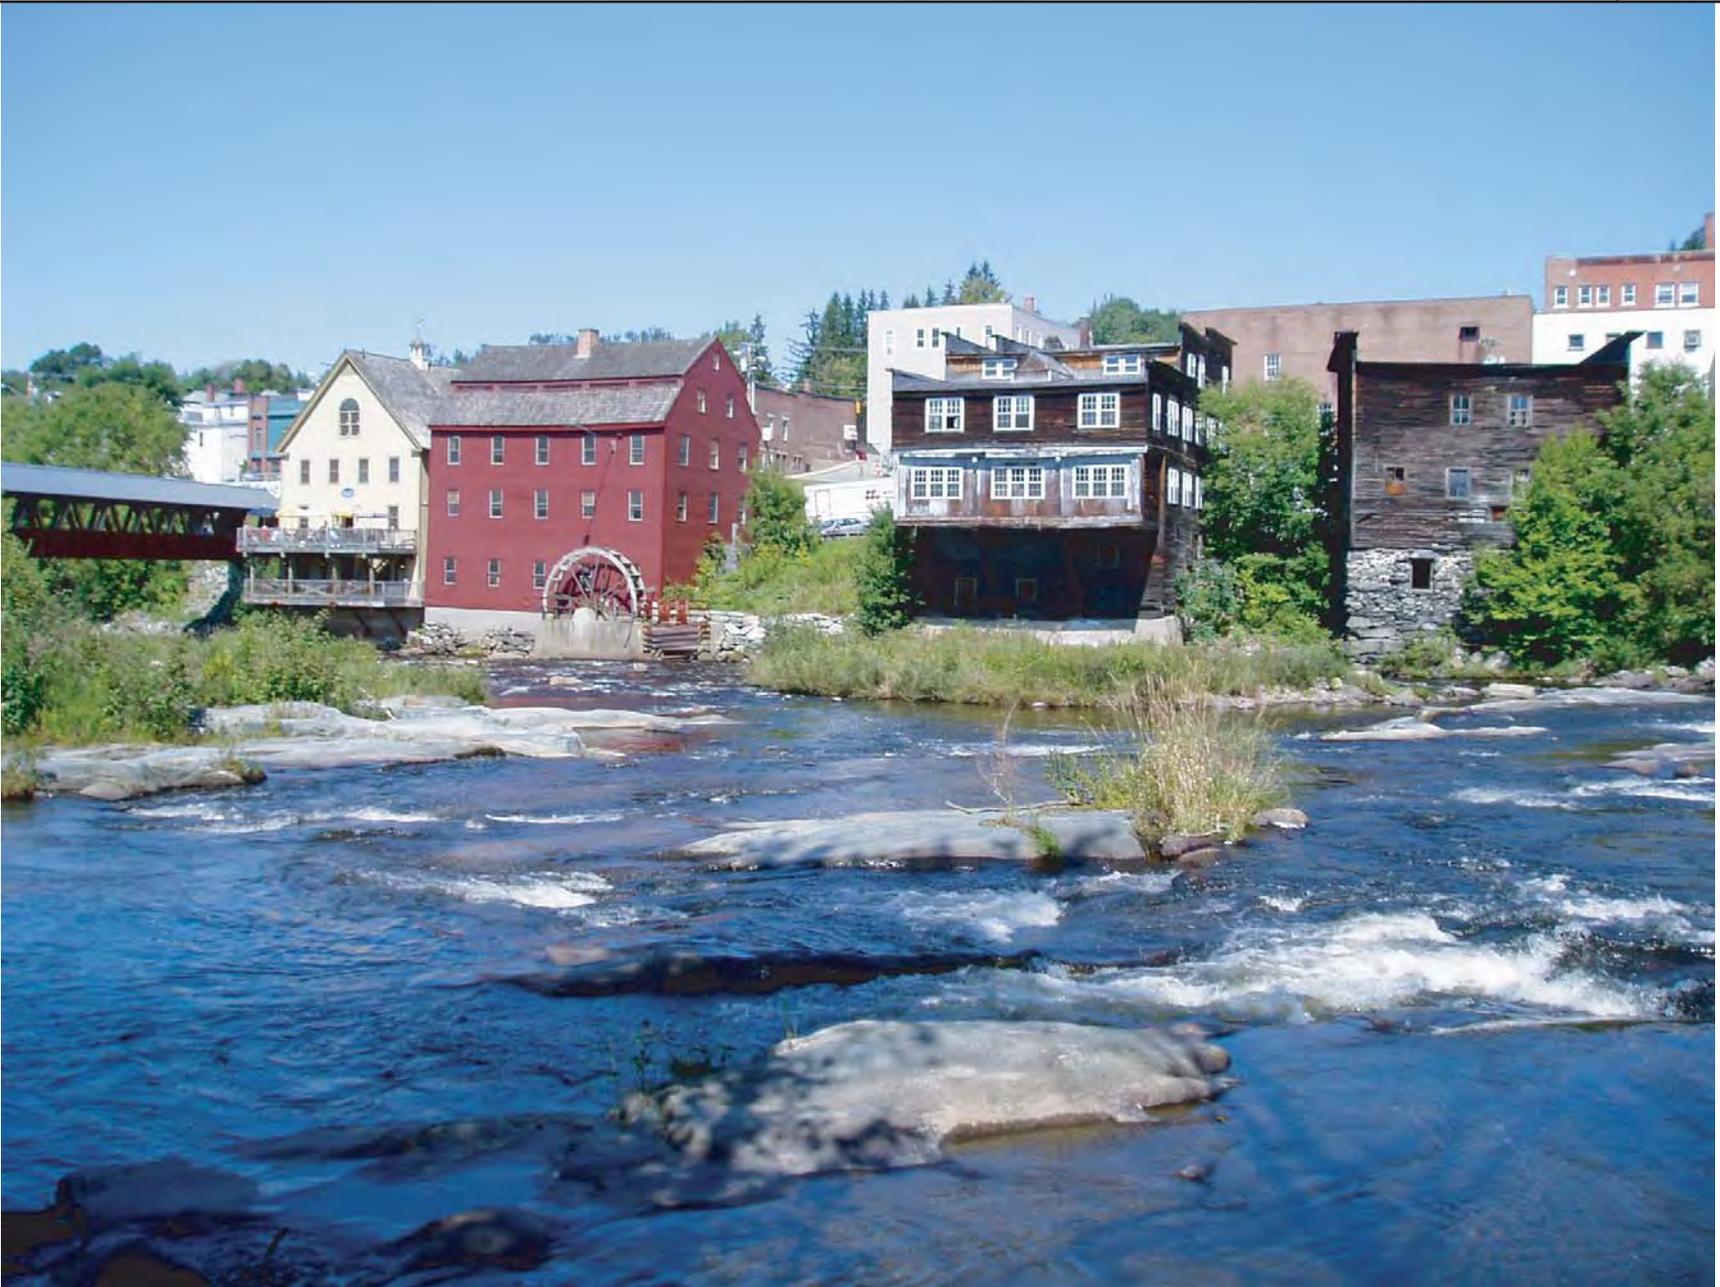
Figure 15. Bank armoring is significant through the Littleton Village section.

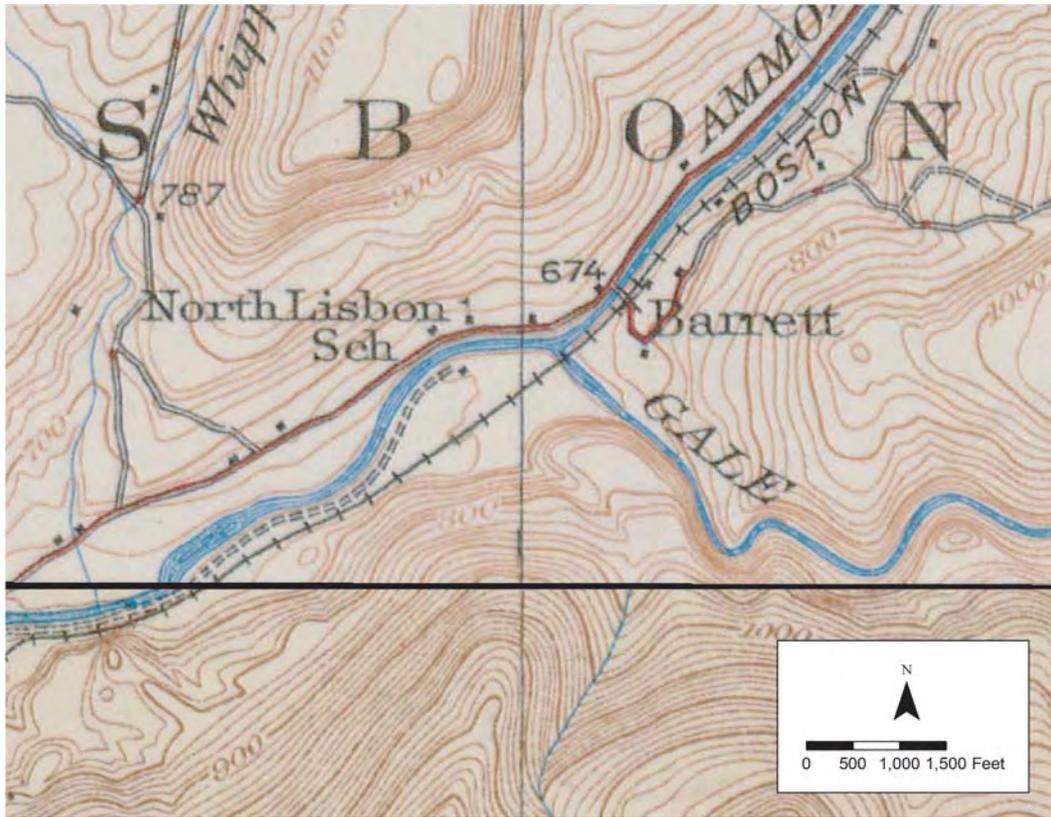
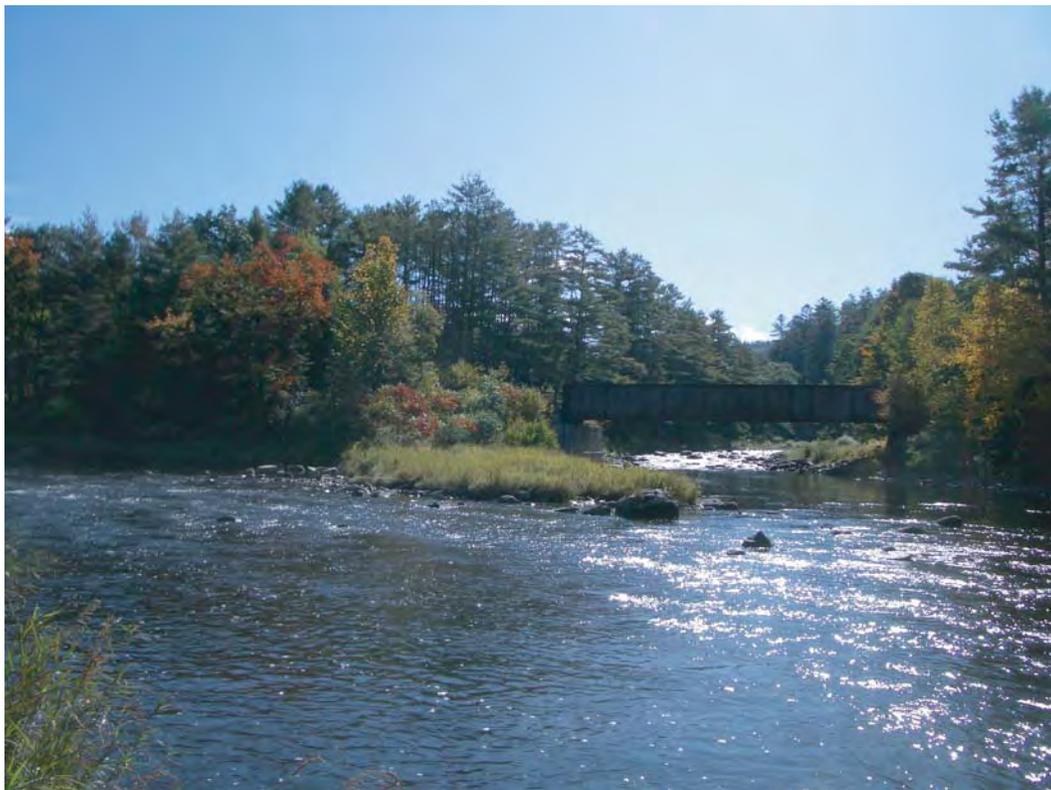
Figure 18. a) Past channel straightening of the lower Gale River has led to b) the formation of a large delta bar at the confluence with the Ammonoosuc River.
