Ammonoosuc River Geomorphic Assessment, Floodplain Conservation, and River Corridor Planning

Connecticut River Joint Commissions
Lebanon, NH

Dr. John Field
Field Geology Services
Farmington, ME

October 2011

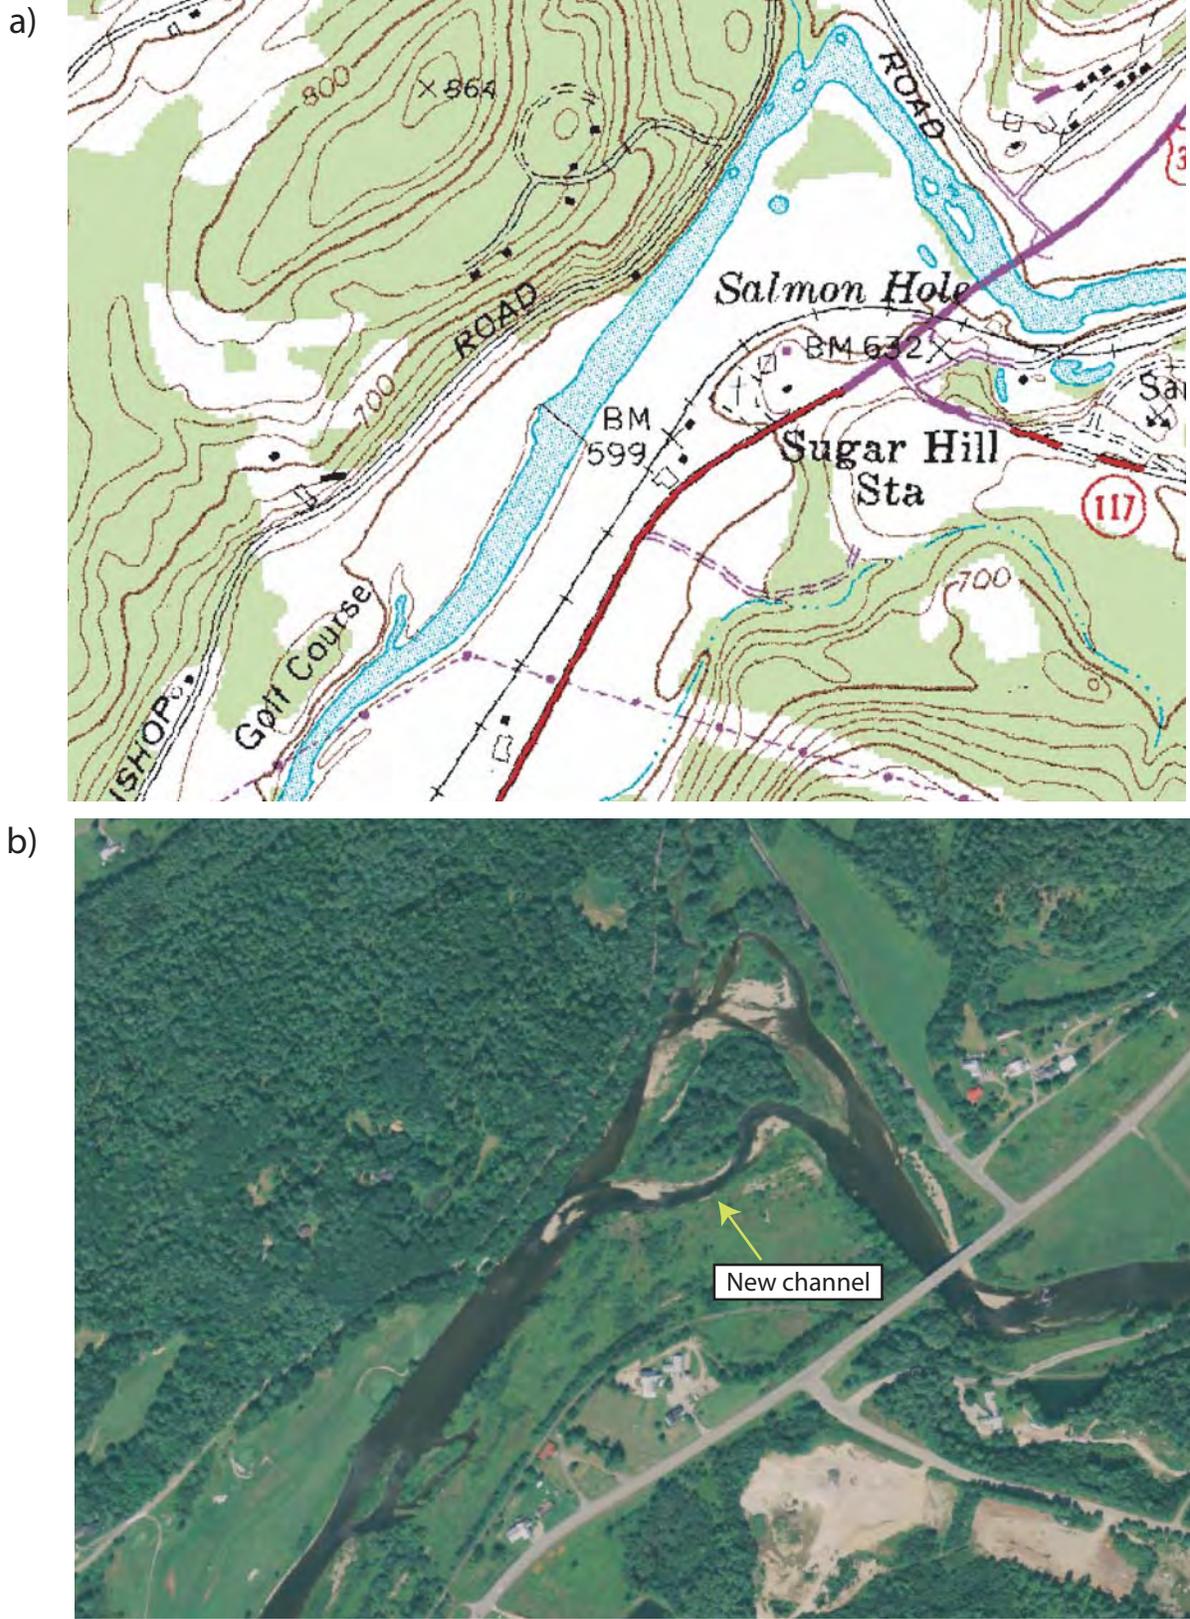
Figure 19. a) Topographic map from 1980s and b) aerial photograph from 2008 show formation of new channel on the inside bend of a meander at Salmon Hole.

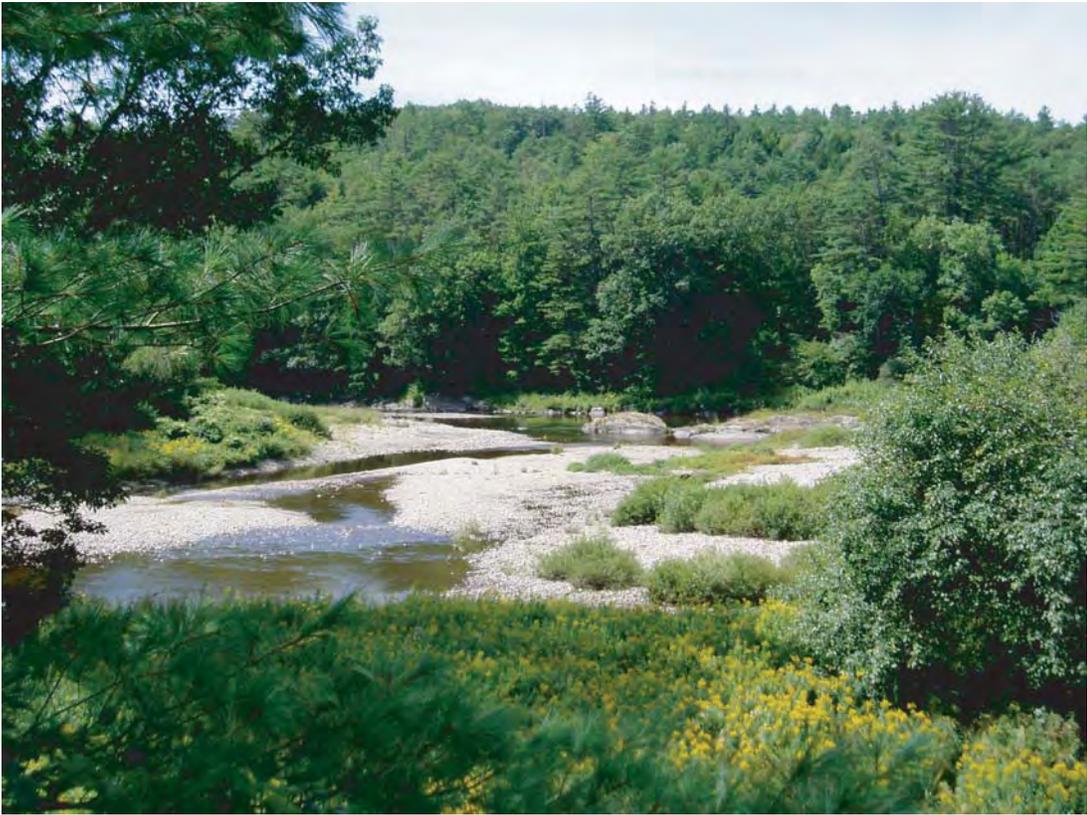
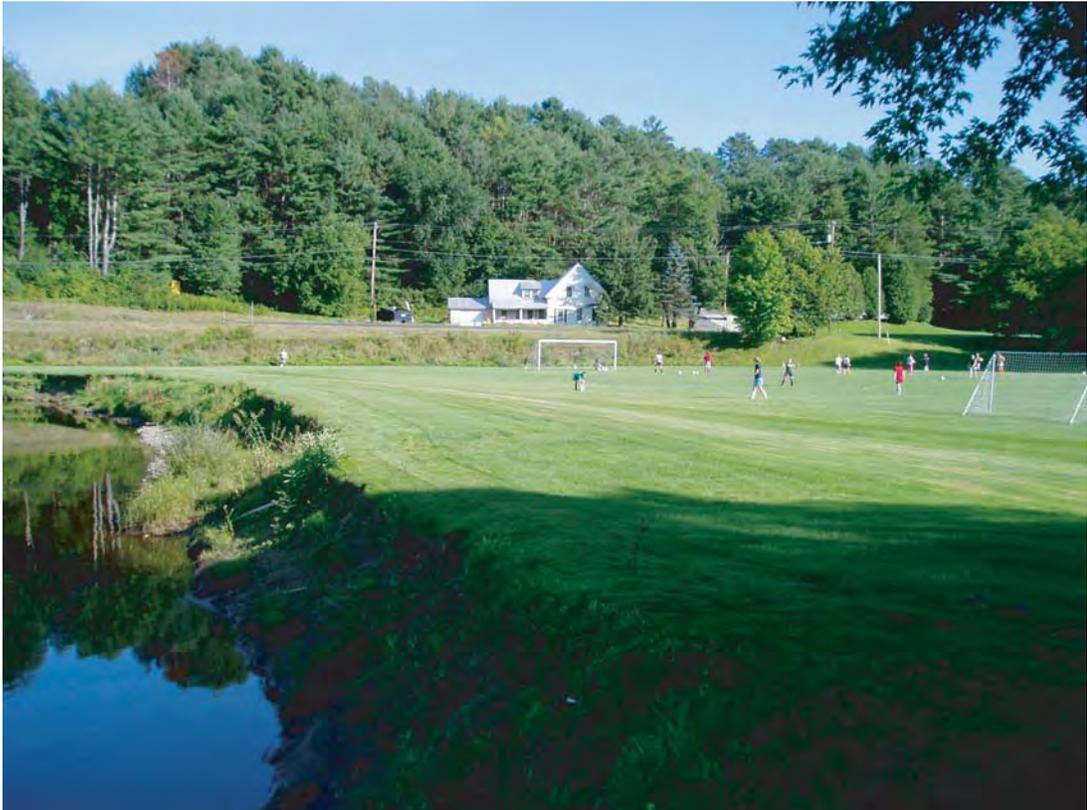
Figure 20. High sediment supply from Salmon Hole is resulting in the formation of a) large unvegetated gravel bars that, in turn, divert flow and cause b) erosion of the adjacent banks such as at the practice soccer field in Lisbon.

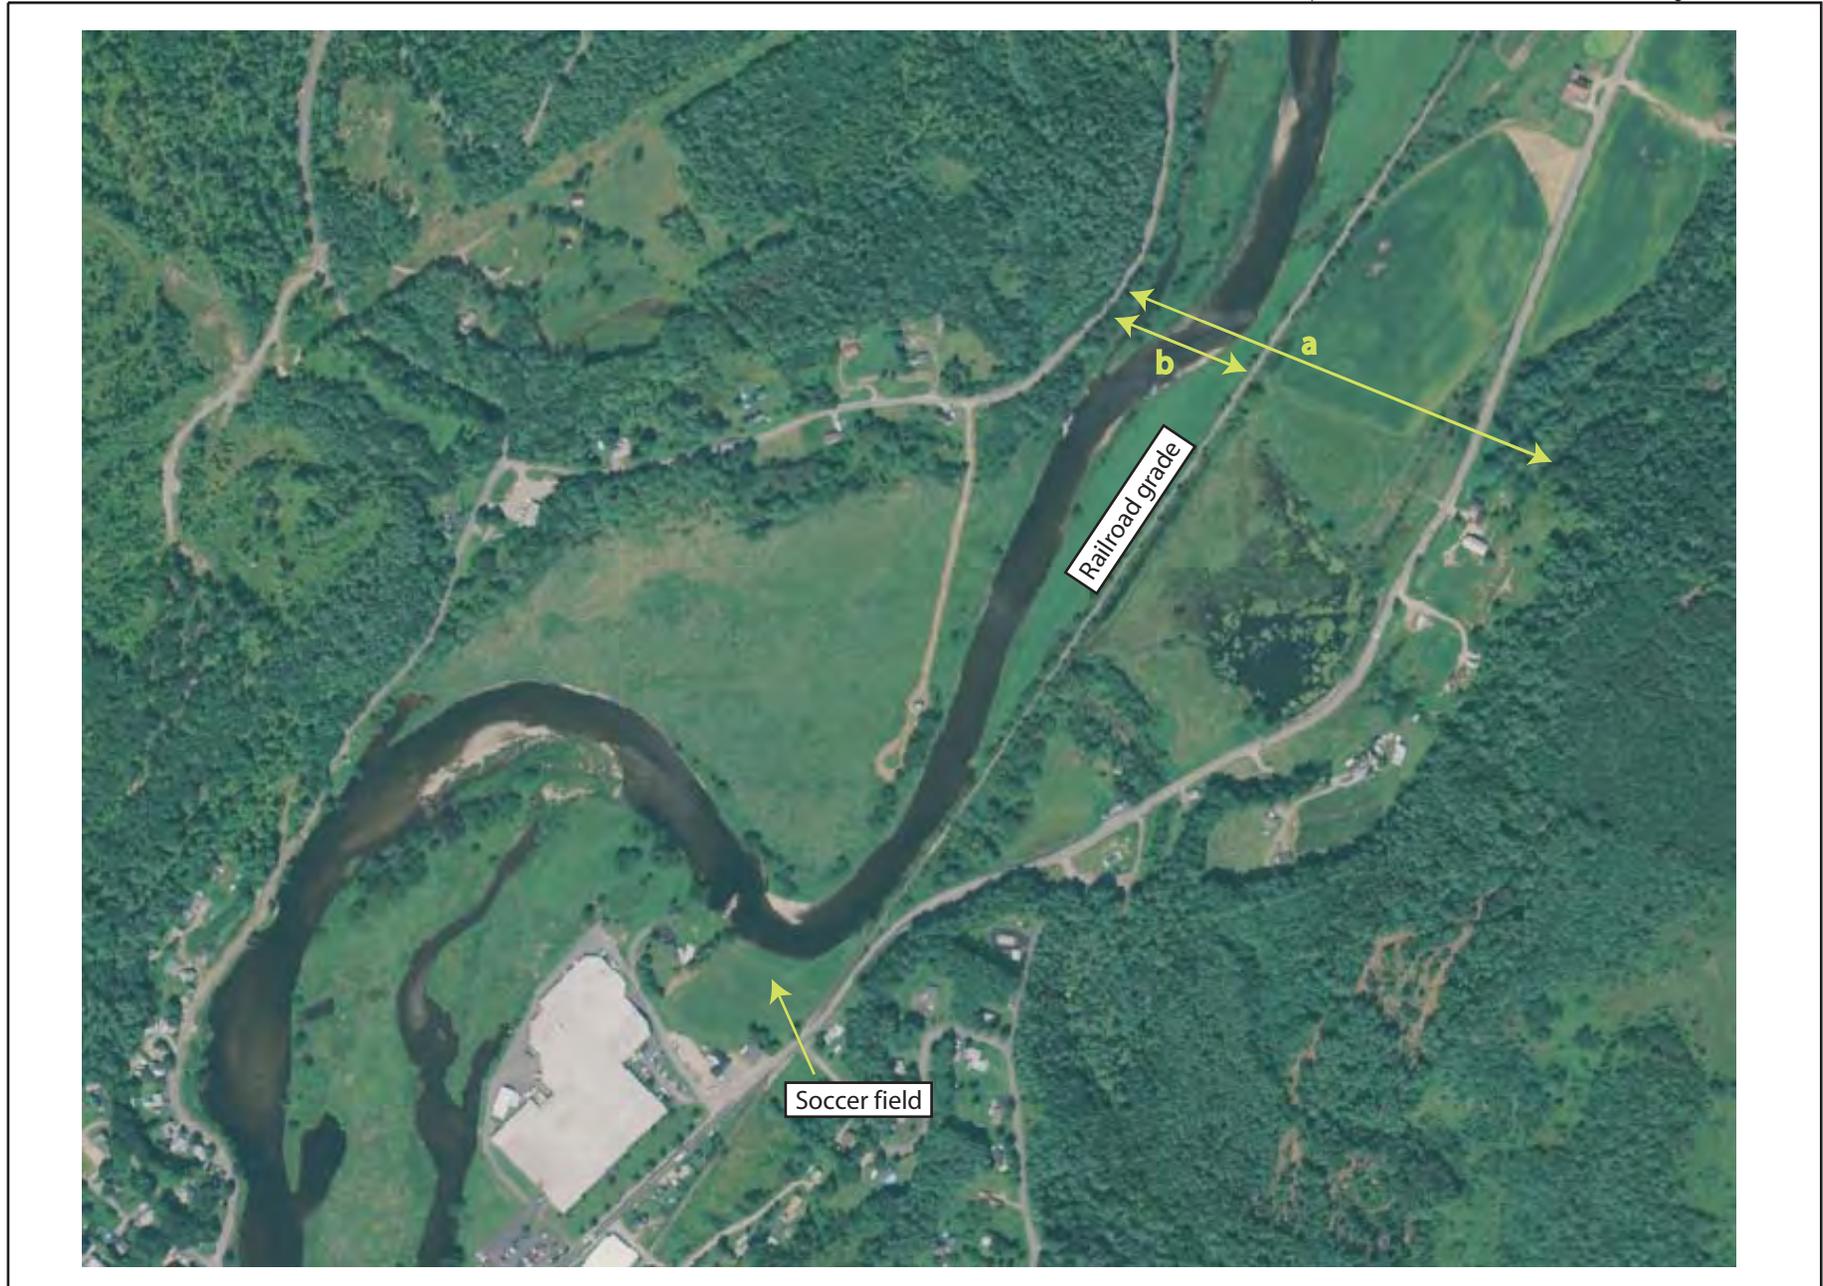
Figure 21. The eroding bank at the practice soccer field in Lisbon (see Figure 20b) is at the end of a long artificially straightened section of the channel. Note railroad grade is blocking the river's access to a large portion of its natural floodplain (arrow a), reducing the space that the river currently has to spread out at high flow stages (arrow b).

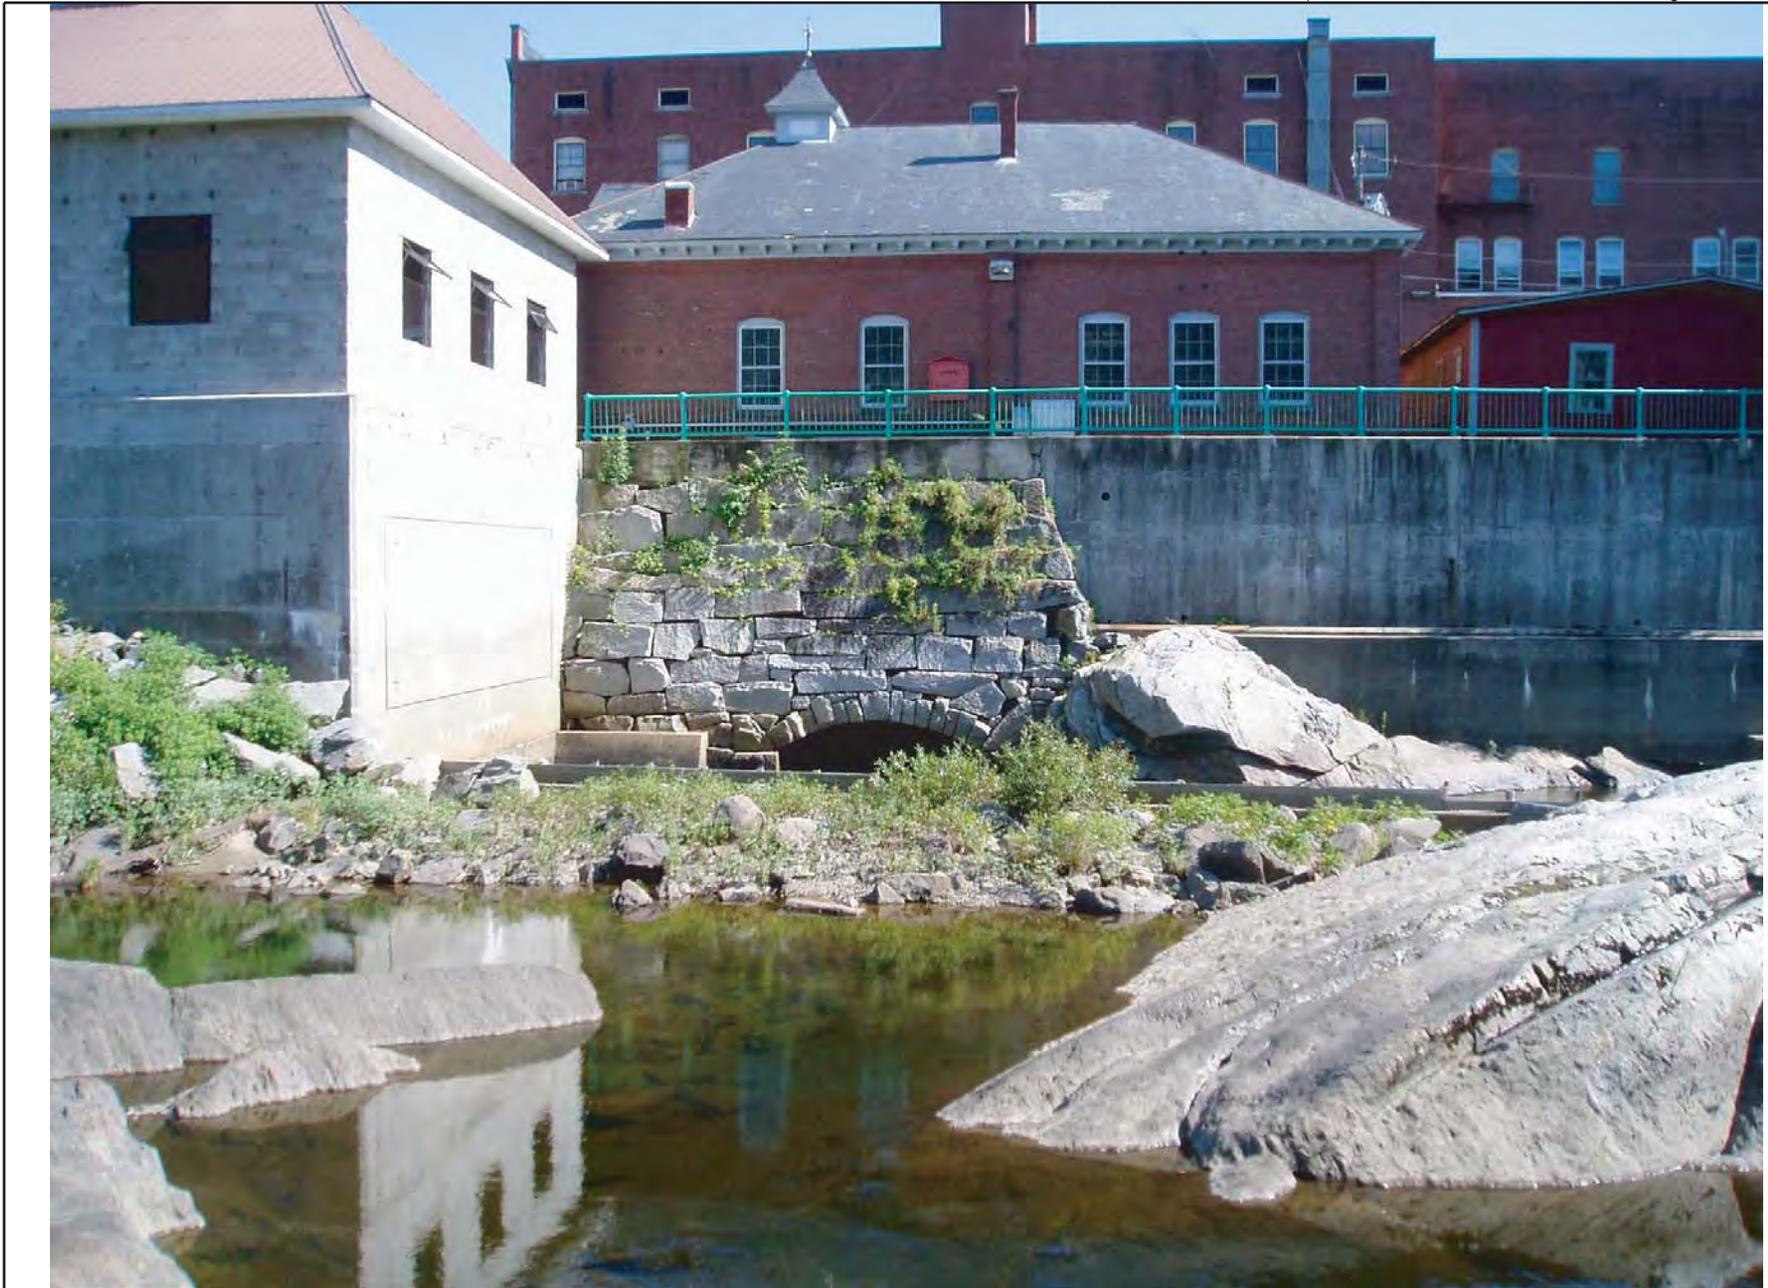
Downstream of the Lisbon Dam, the river flows through a short bedrock gorge. The segment, flowing through the center of Lisbon, is completely armored along its 473 ft length in the form of stone or concrete foundations and retaining walls (Figure 22). The School Street Bridge crosses the channel in Segment 11B.

Figure 22. The banks are armored through the Town of Lisbon.

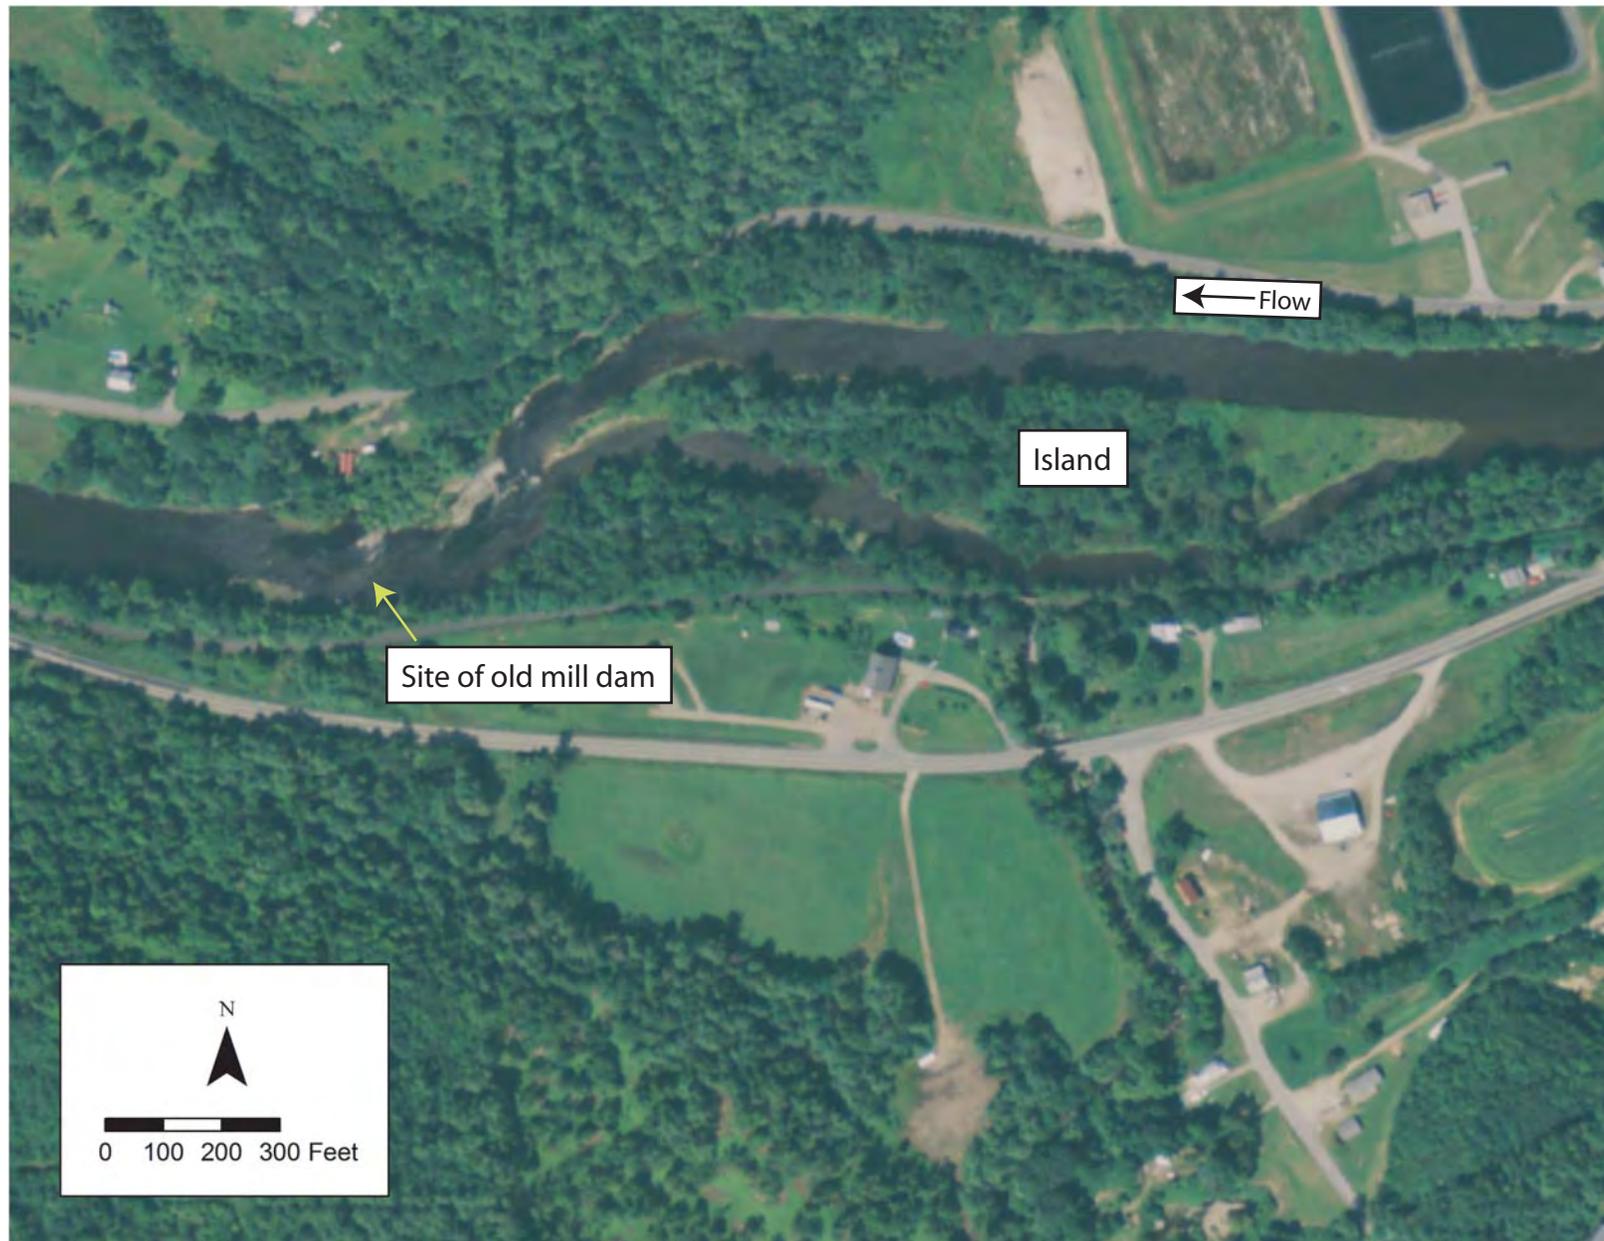
Figure 23. A large island upstream of an old mill dam in the Lower Lisbon section is comprised of fine-grained impoundment sediments.

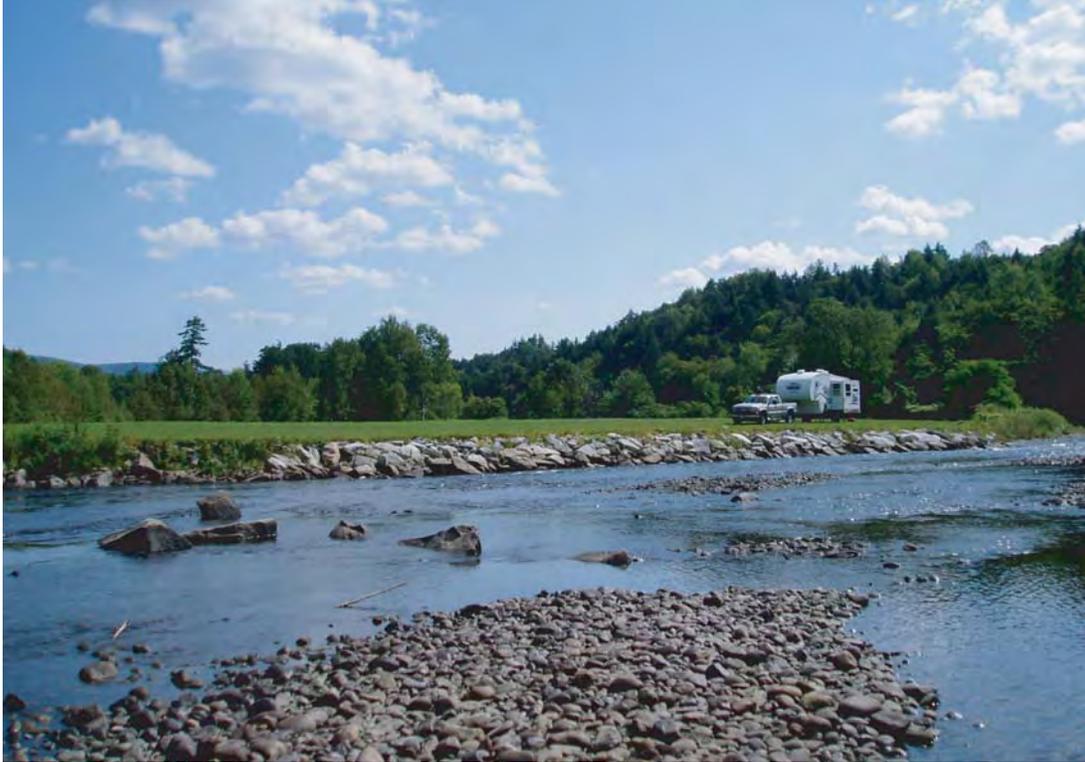
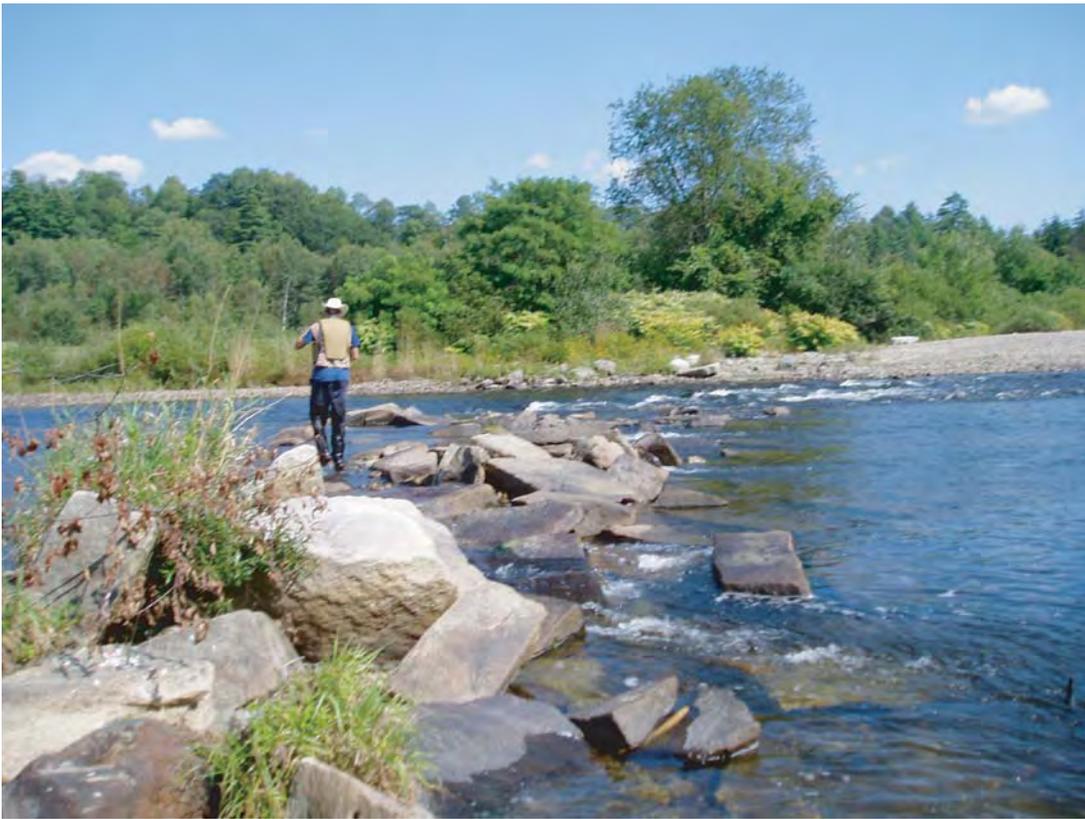
Figure 25. Large unvegetated gravel bars deposited upstream of a valley constriction have led to a) bank armoring due to rapid bank erosion and b) channel migration that has allowed channel to flow over earlier bank protection efforts.

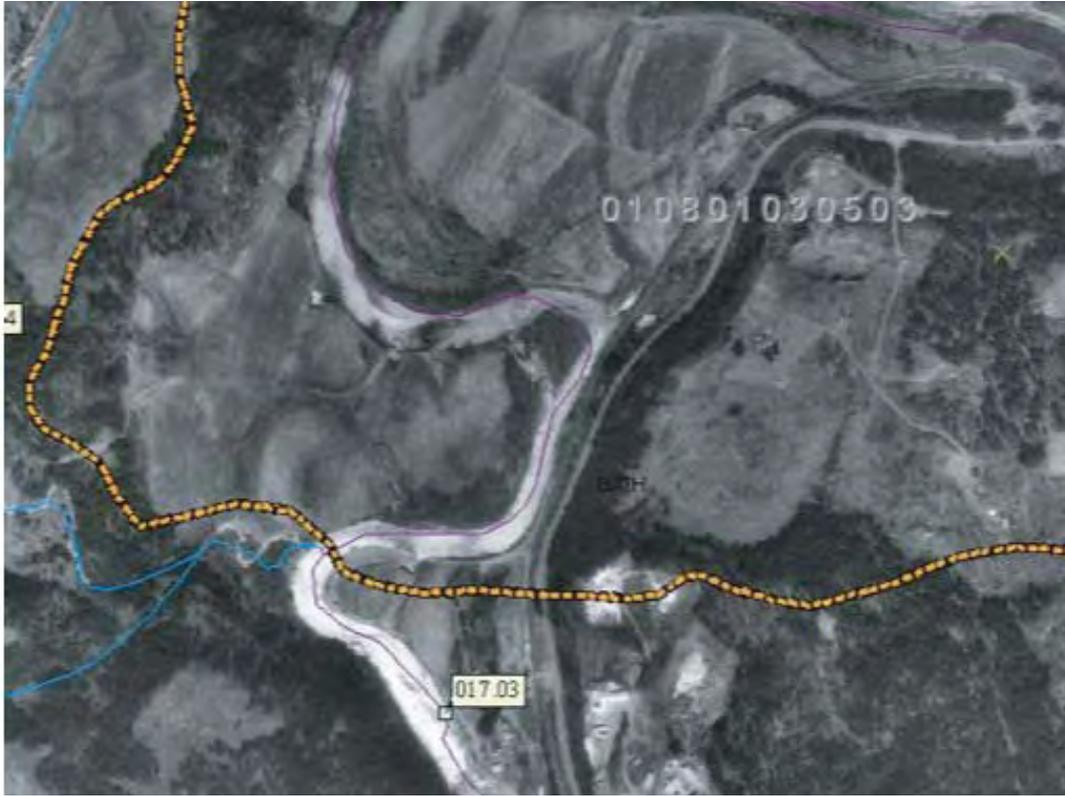
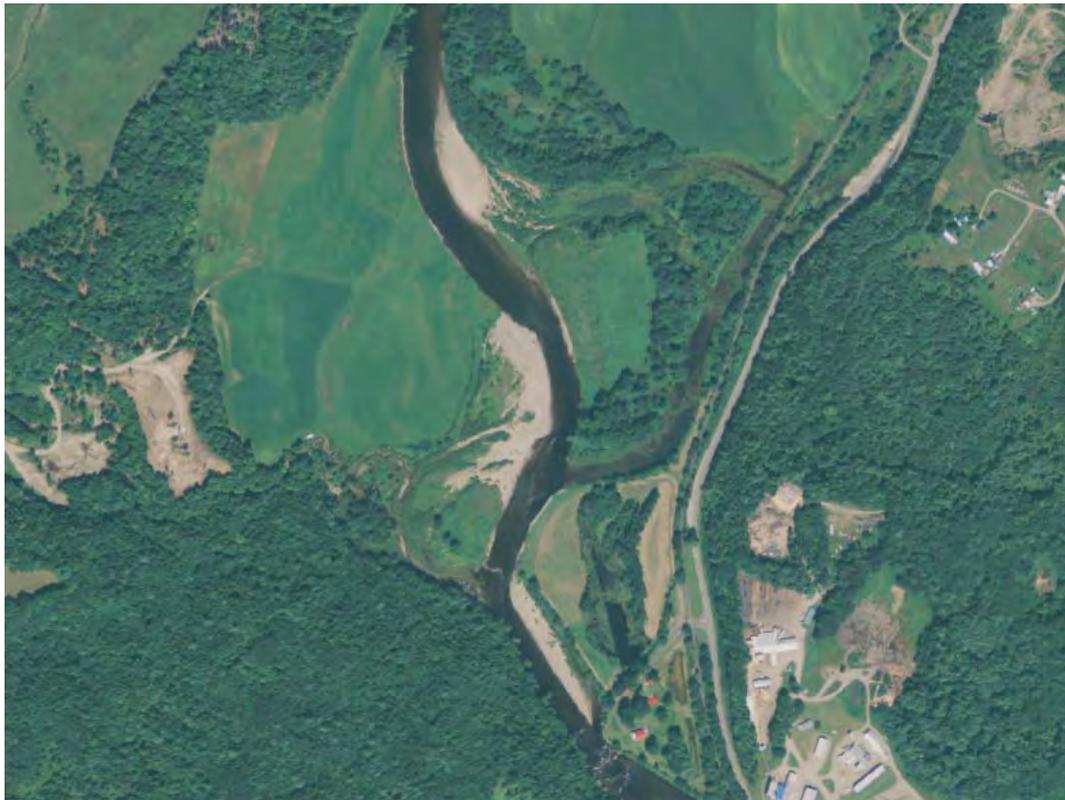
Figure 26. Historical aerial photographs from a) 1999 and b) 2008 of the area upstream of the Bath valley constriction showing channel avulsion and active channel migration.

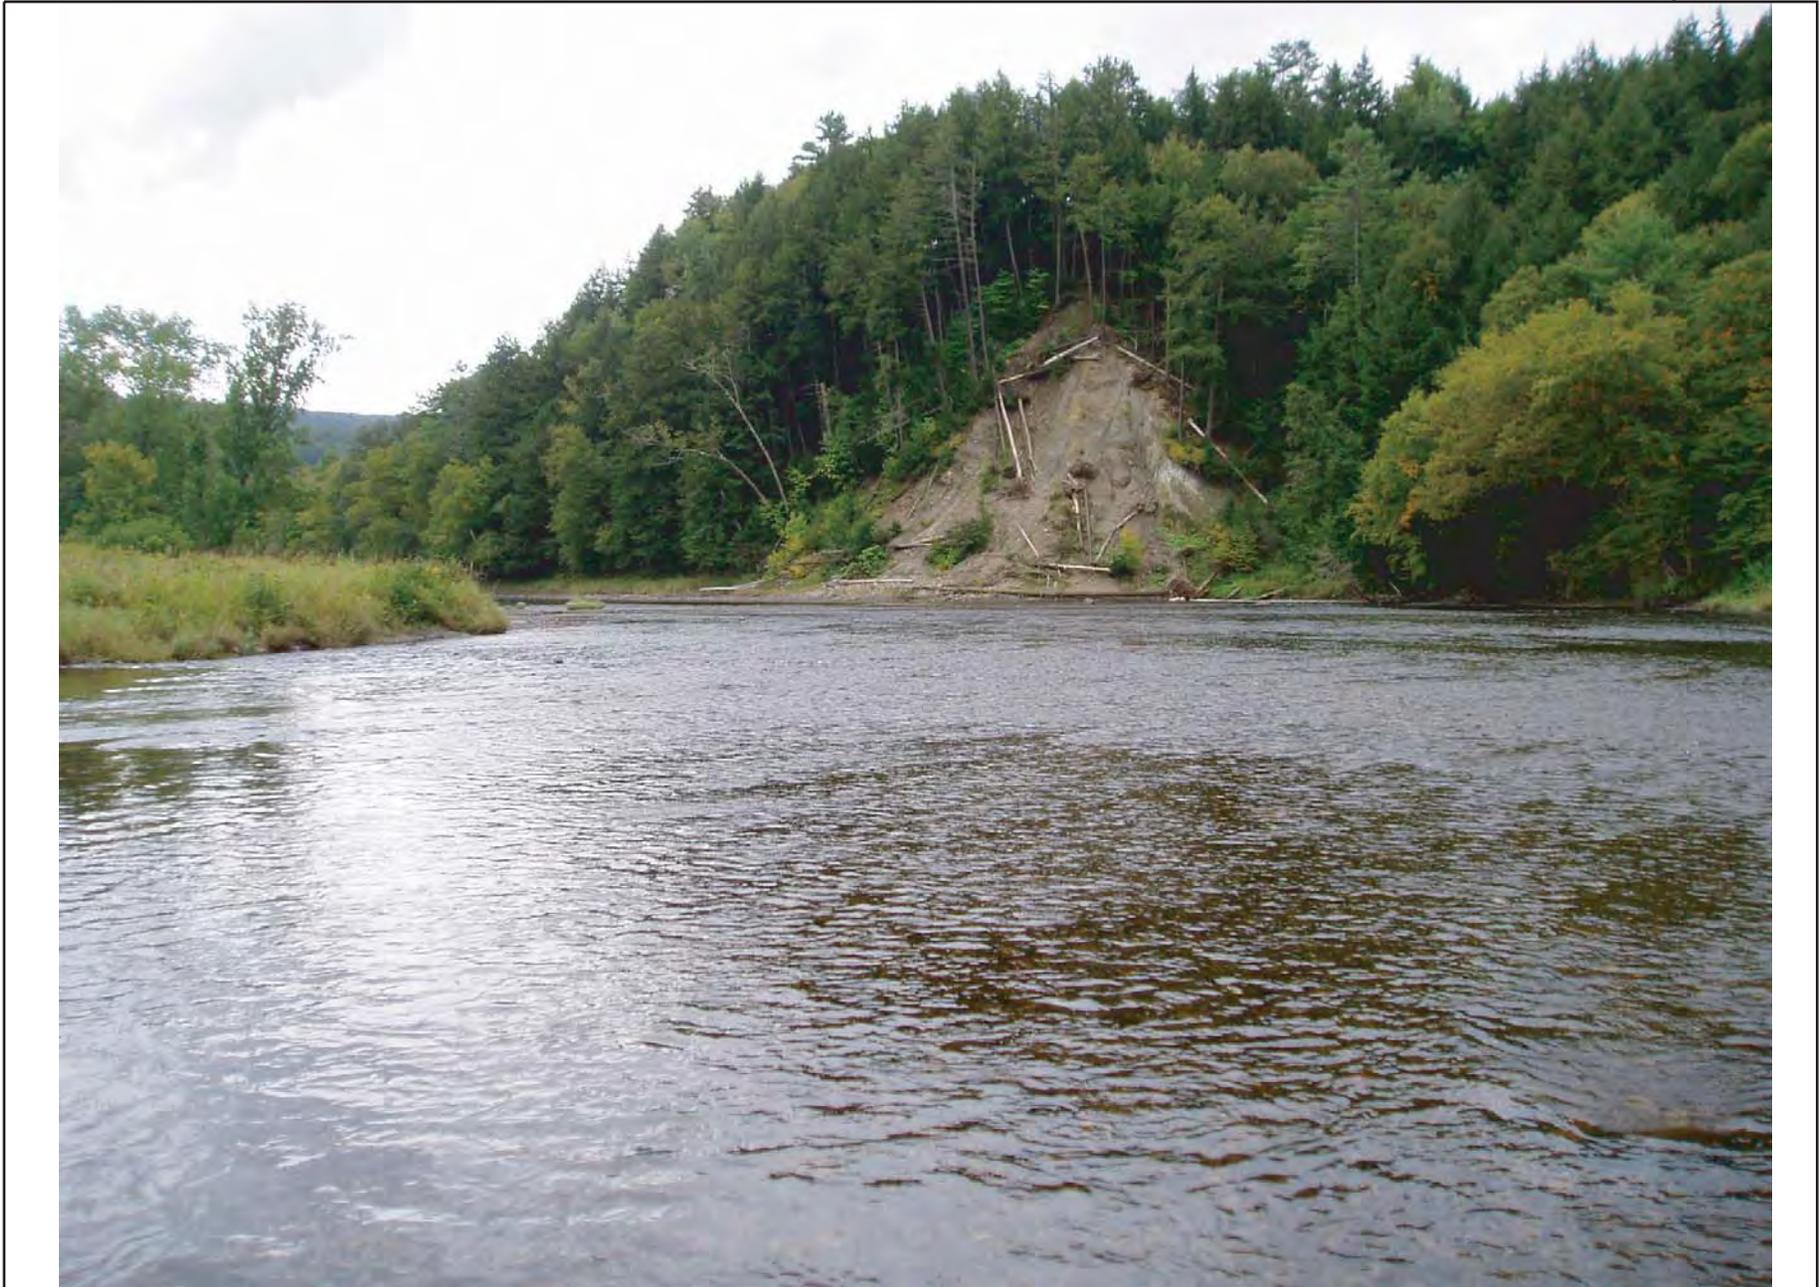
Figure 27. Large mass failure on a high bank of glacial outwash deposits occurs at the downstream end of an artificially straightened section of the river channel.

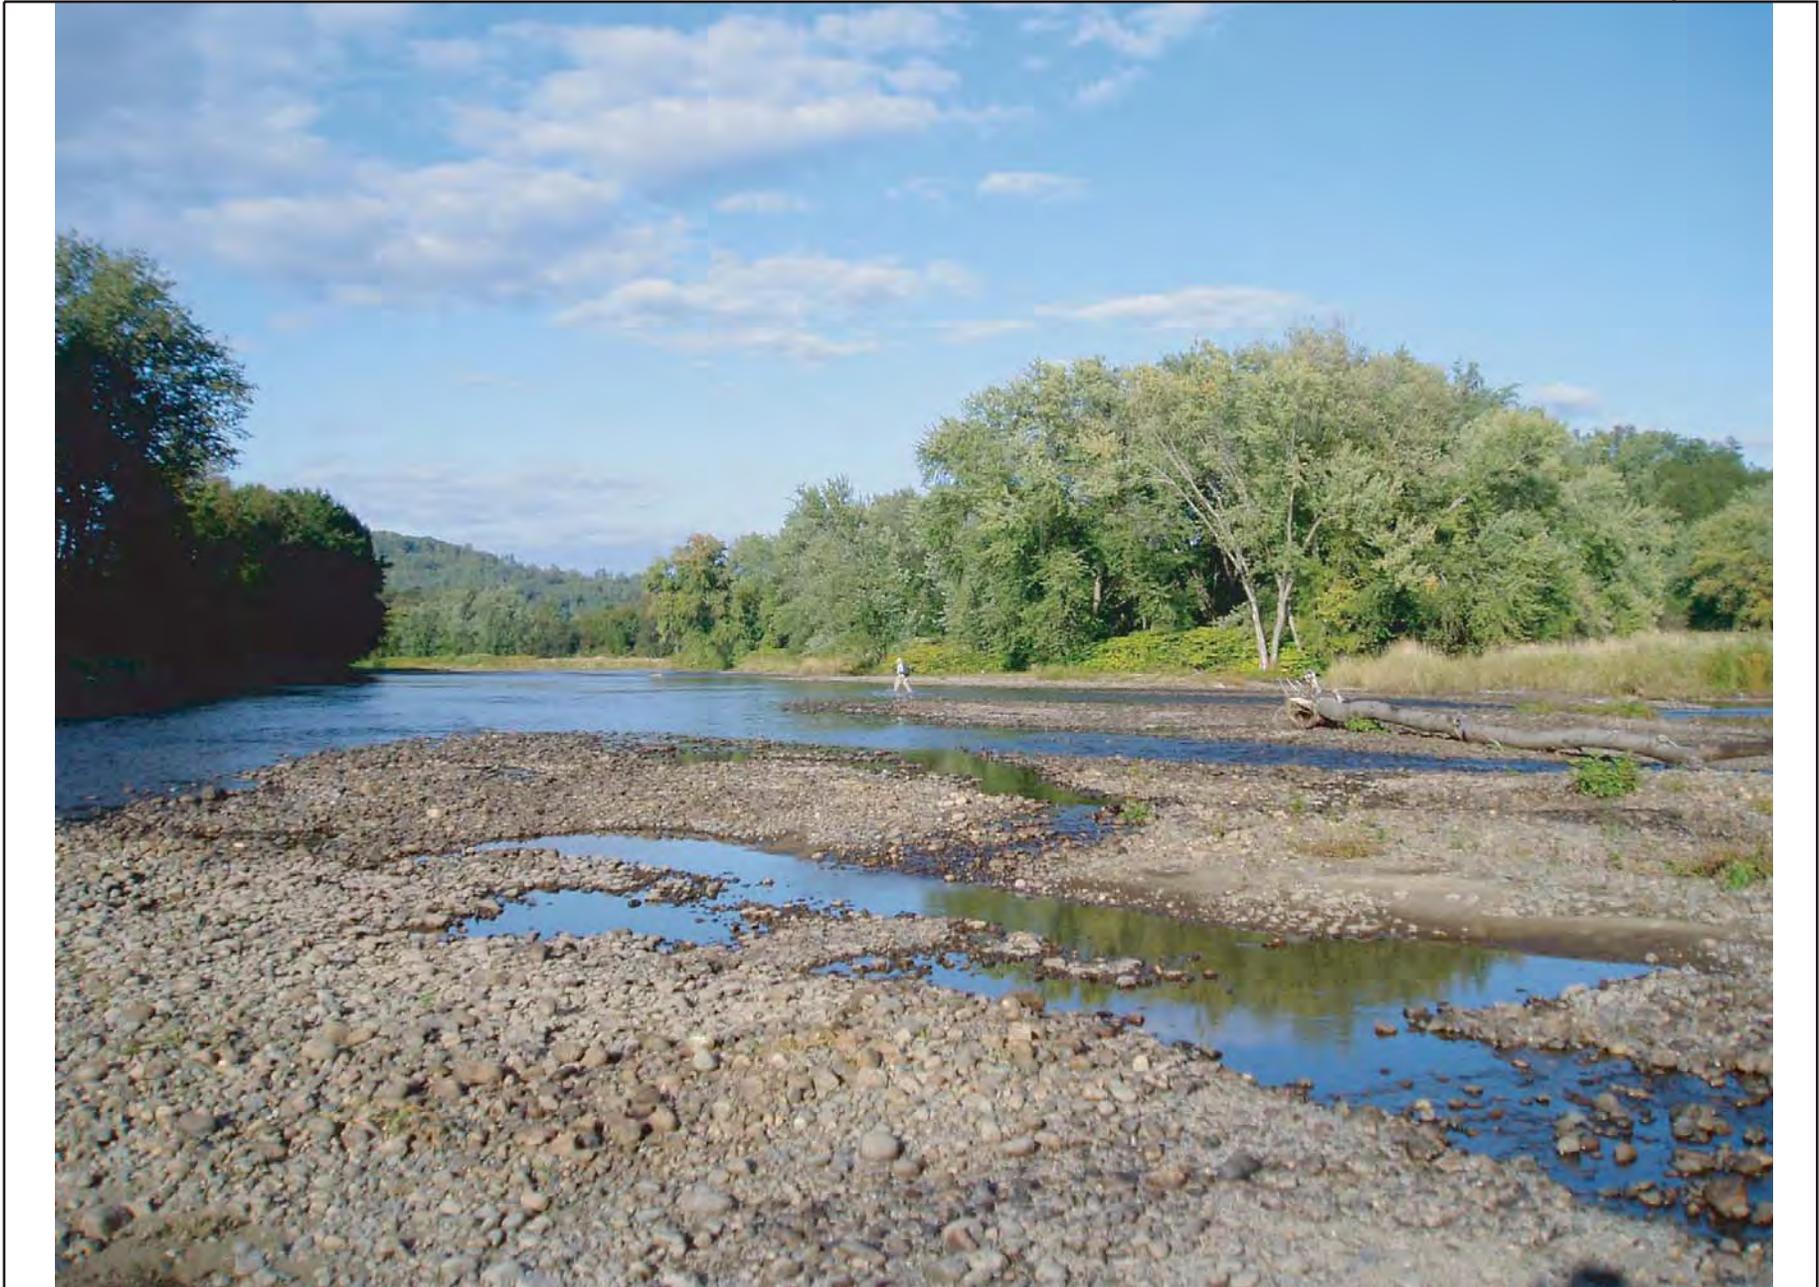
Very wide shallow gravel bed reaches that have experienced extensive bank erosion resulting from gravel bar growth characterize the Bath Upper Village section (Figure 28). Reach 7 has a width:depth ratio of 75 and Reach 5 has a ratio of 79 (Table 2). Both values are significantly higher than elsewhere along the river and much higher than a value of 20 that is generally considered at the maximum end of rivers with excellent habitat conditions. A wide shallow channel leads to increased warming of water during low flow summer periods and, therefore, leads to greater thermal stress on cold water species such as trout. Sediment derived from the large mass failure in Reach 7 (Figure 27) may be a large contributor to the excess sediment load leading to the gravel bar deposition and high width:depth ratio.

Figure 28. Deposition of large gravel bars is leading to bank erosion and the development of a wide shallow channel throughout most of the Bath Upper Village section.

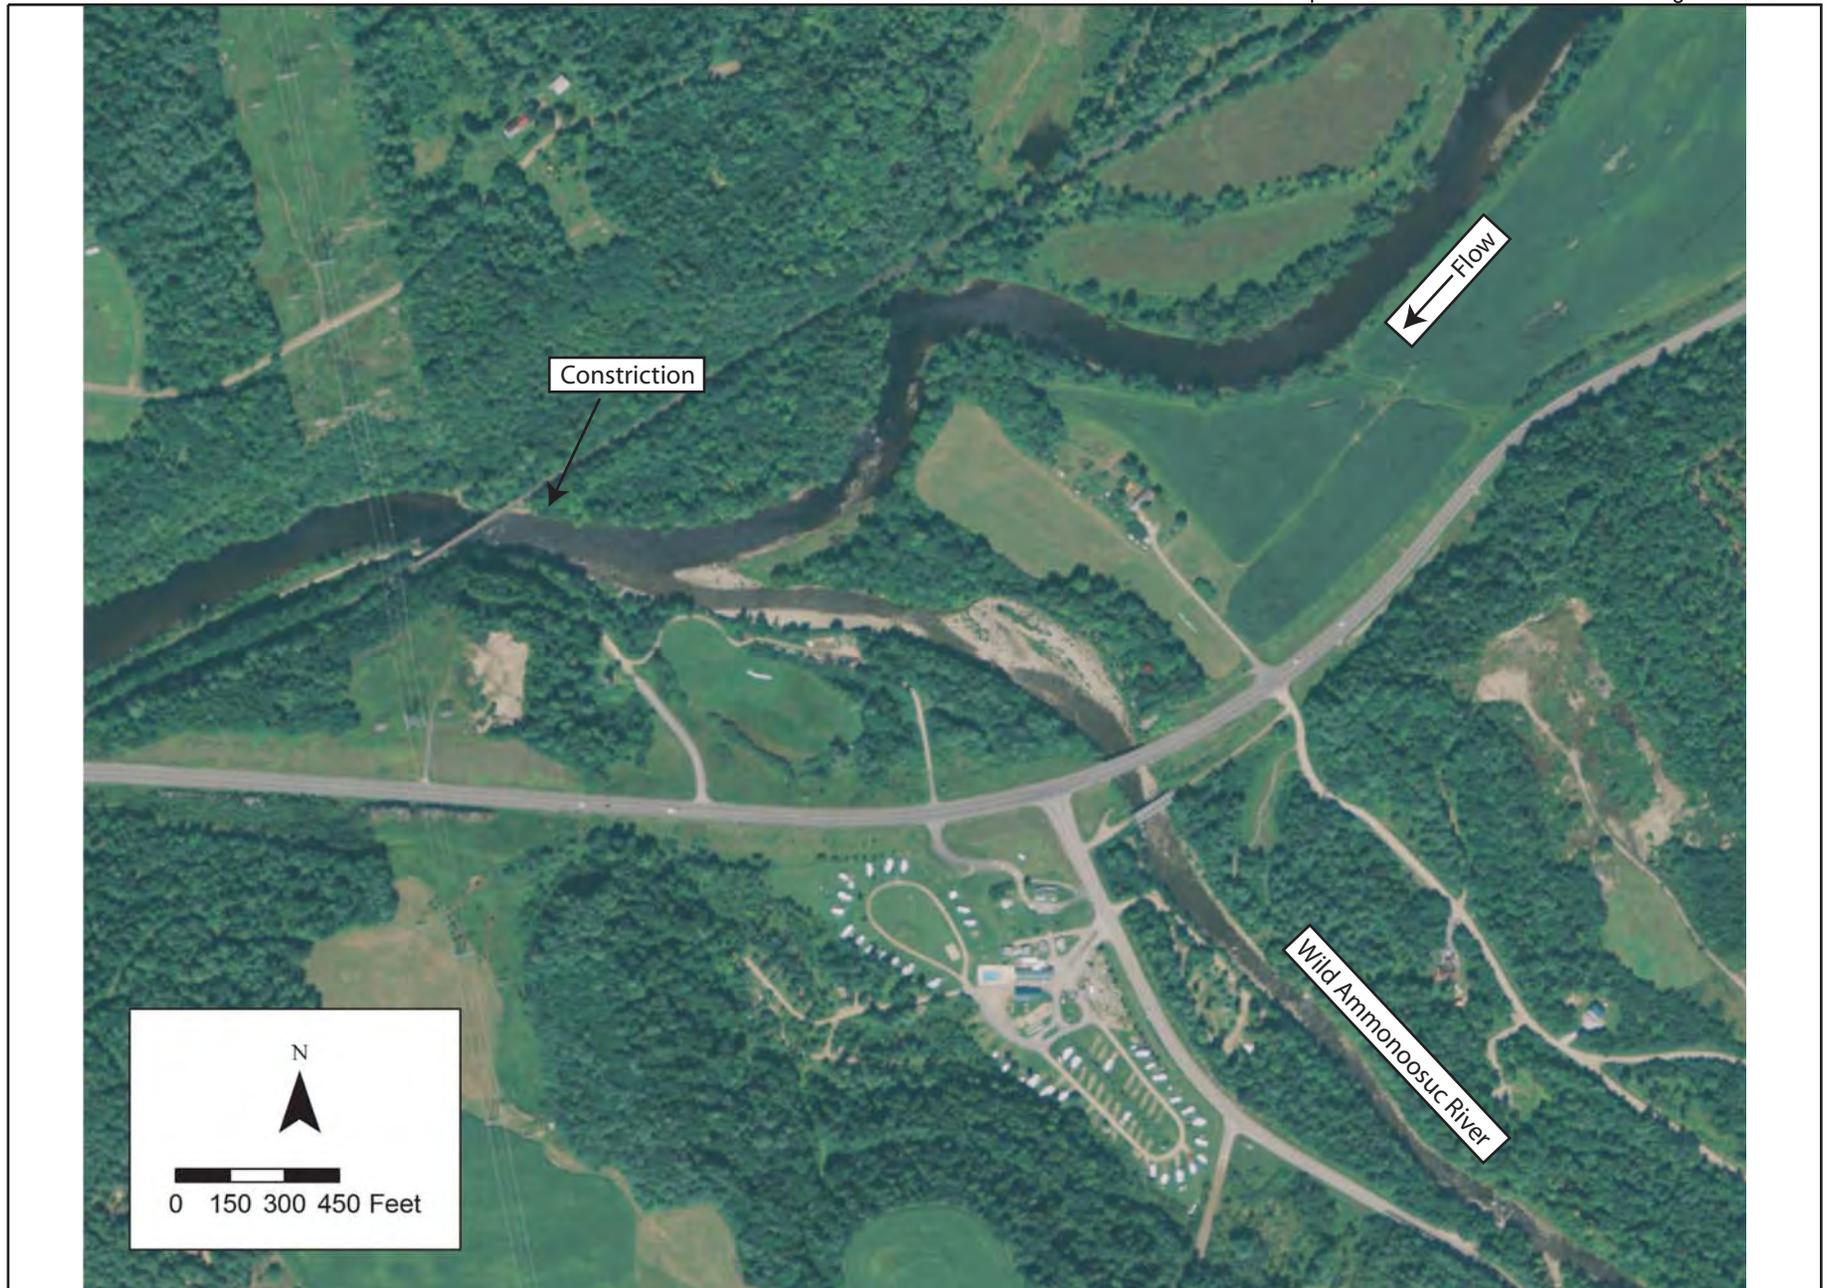
Figure 29. Gravel deposition is enhanced at the confluence of the Wild Ammonoosuc River because a valley constriction is present immediately downstream.
