Ammonoosuc River Geomorphic Assessment, Floodplain Conservation, and River Corridor Planning

Connecticut River Joint Commissions
Lebanon, NH

Dr. John Field
Field Geology Services
Farmington, ME

October 2011

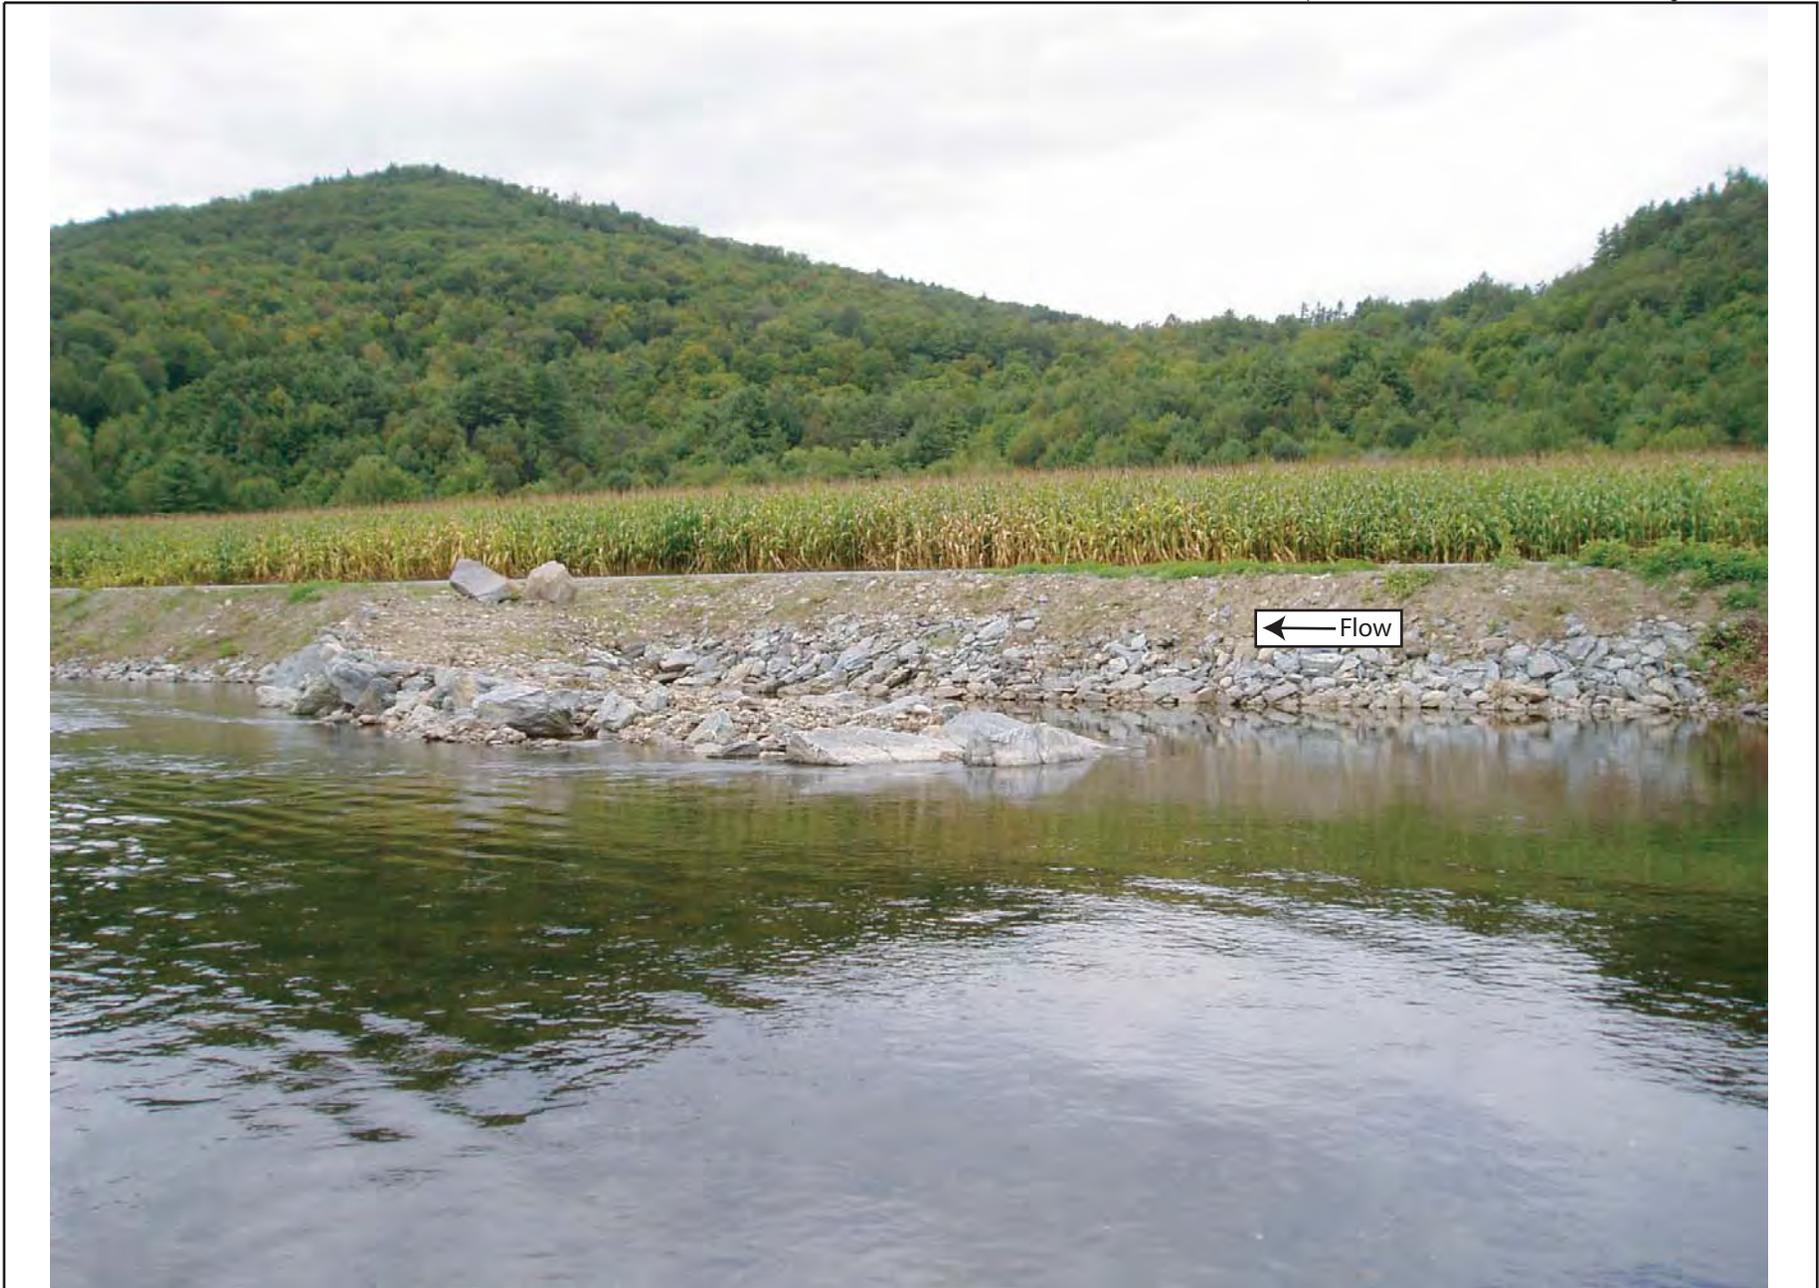
channel is reflected in the bank erosion along 34 percent of the bank length (Table 4). An additional 14 percent of the bank has been armored, primarily with riprap but most recently using flow deflectors along River Road (Figure 30). The herbaceous riparian buffer with significant Japanese Knotweed does not ameliorate the unstable condition of the river banks (Table 3).

Figure 30. Flow deflectors are a recent approach to arresting erosion along River Road.
