Wetland and Stream Restoration Opportunities in New Hampshire

Restoration and Enhancement “Menu”

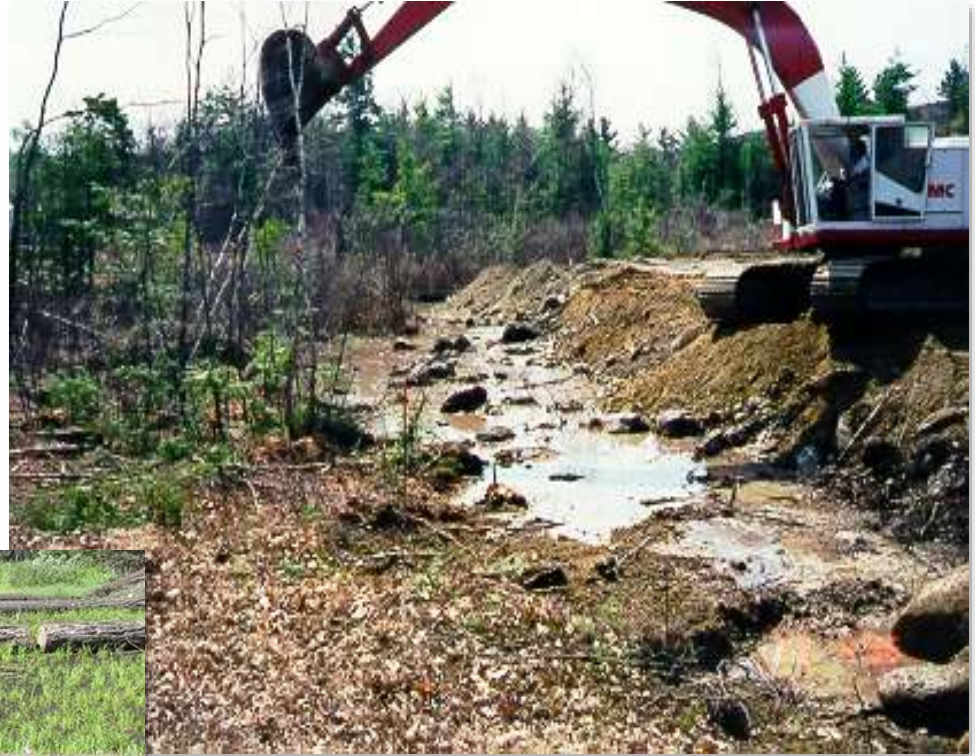
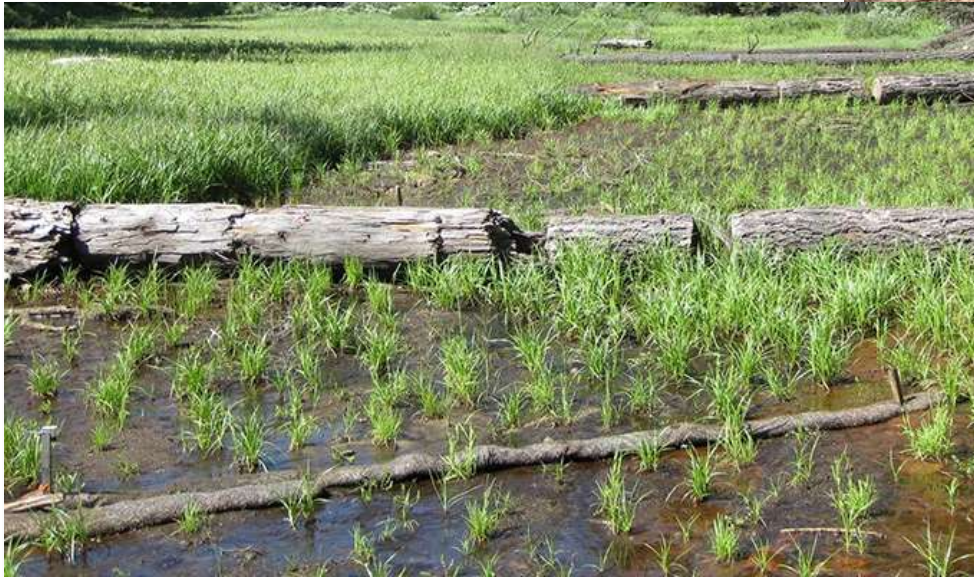
Restoring Hydrology and Vegetation

- Remove fill from degraded wetlands on conserved lands
- Remove drainage ditches and berms
- Remove old roads
- Native plantings

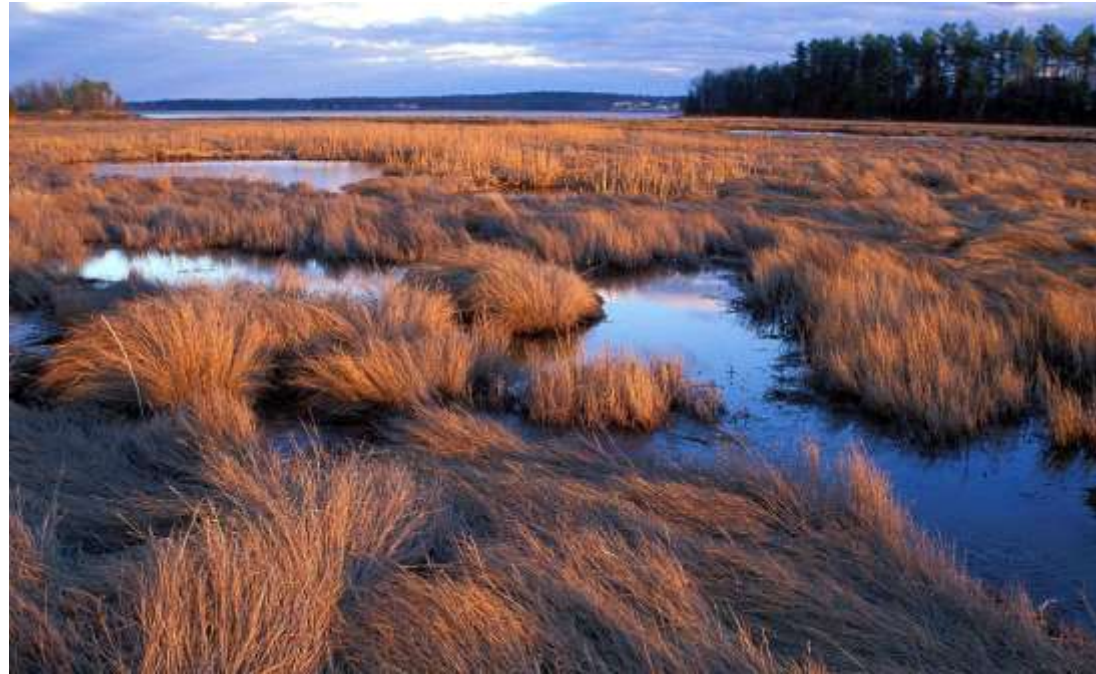
*Salt marsh at Lubberland Creek Preserve in Durham, NH.
Photo Credit: The Nature Conservancy*

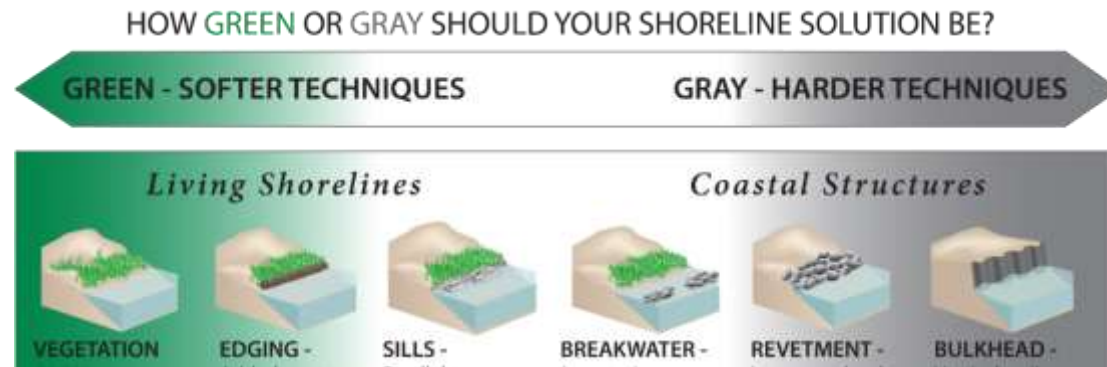
Living Shorelines

Management practice to prevent erosion and protect, restore, or enhance shoreline habitat and coastal processes

- Strategic placement of plants, natural rock, and sand fill
- Regrading topography to match natural shoreline

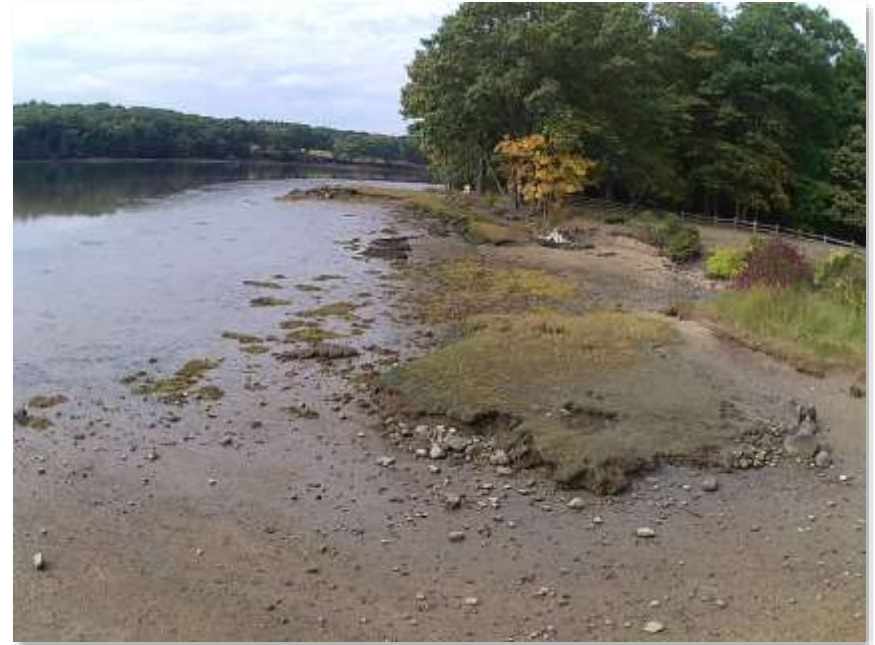
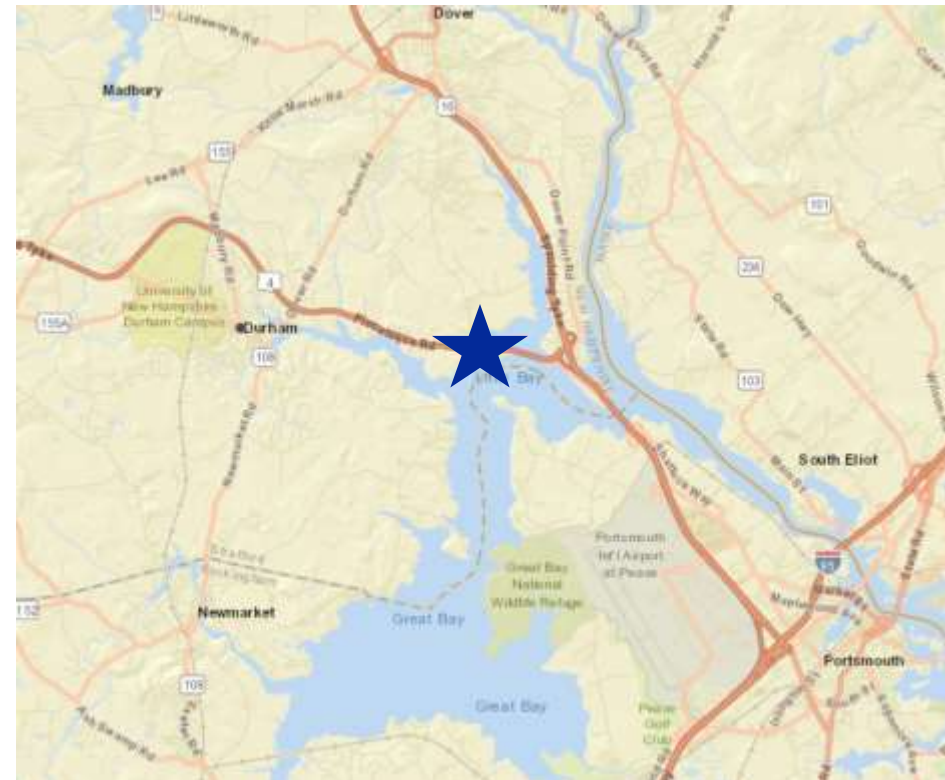
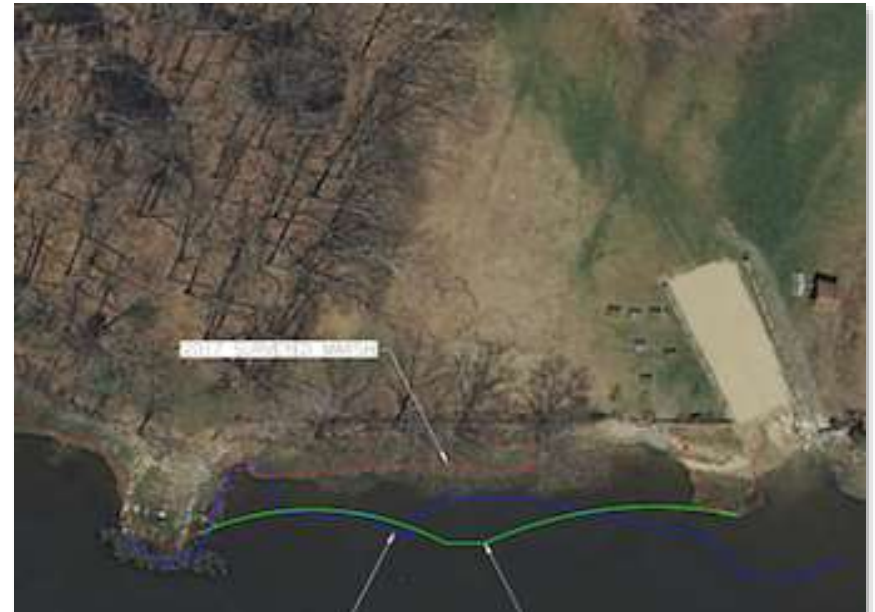
Wagon Hill Erosion Management

- Shoreline erosion at rates of up to one foot per year
- Significant loss of salt marsh

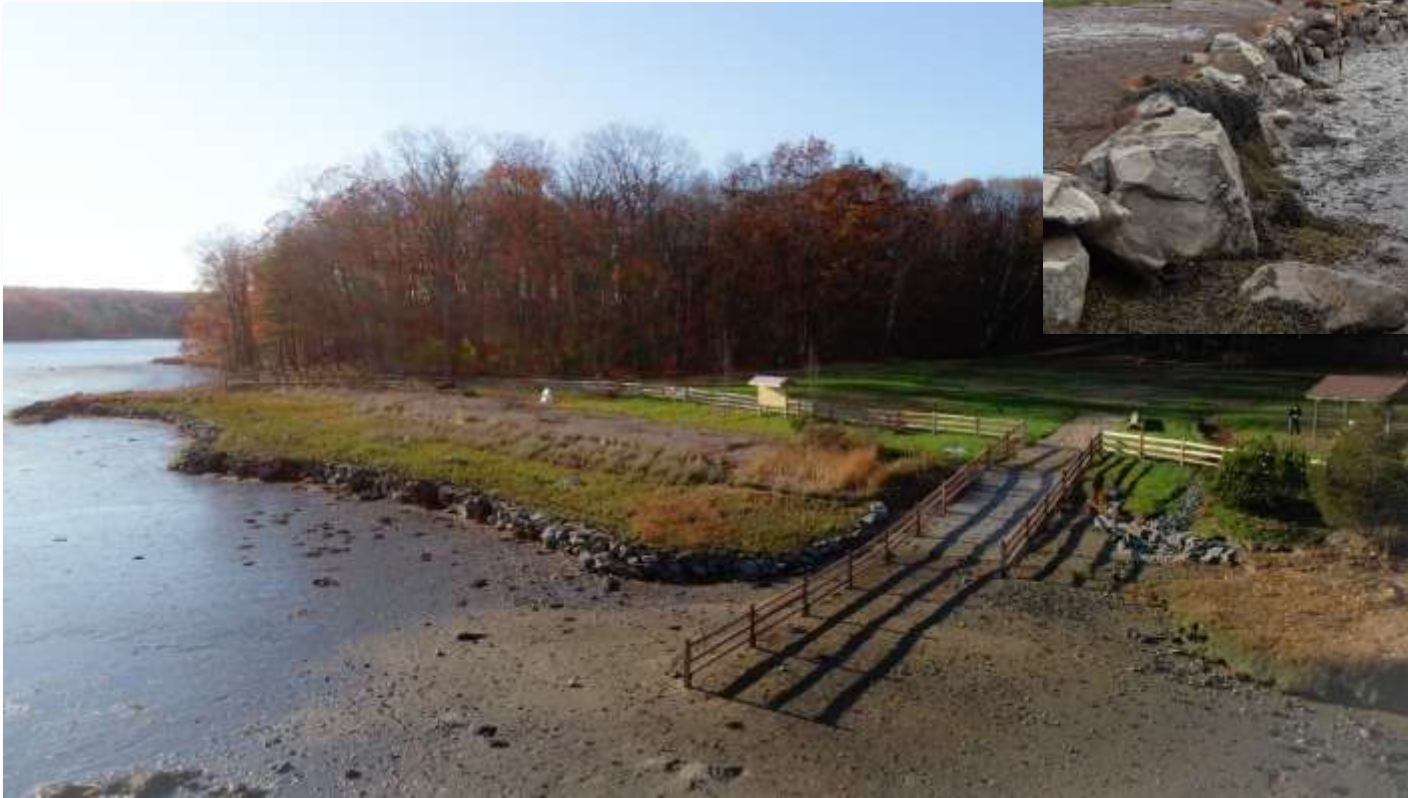
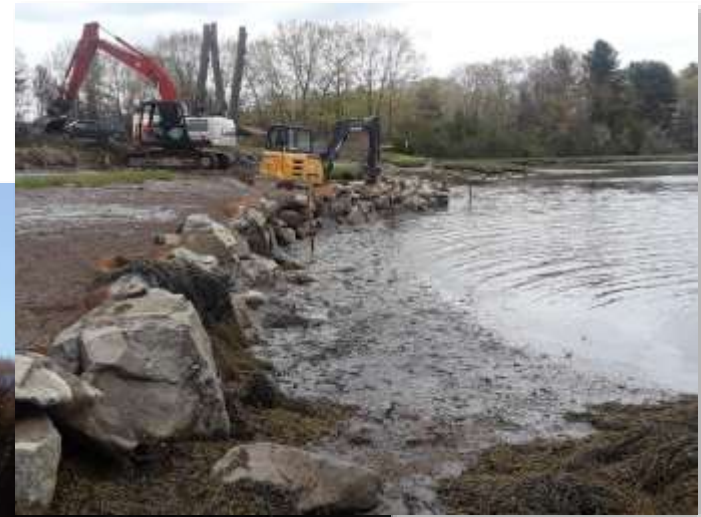
Wagon Hill Erosion Management

- Living stone sill to reduce wave energy and ice damage
- Backfilled to restore salt marsh area with gradual upland slope to enable salt marsh migration
- 30,000 saltmarsh plants
- Fence and signs to reroute foot traffic

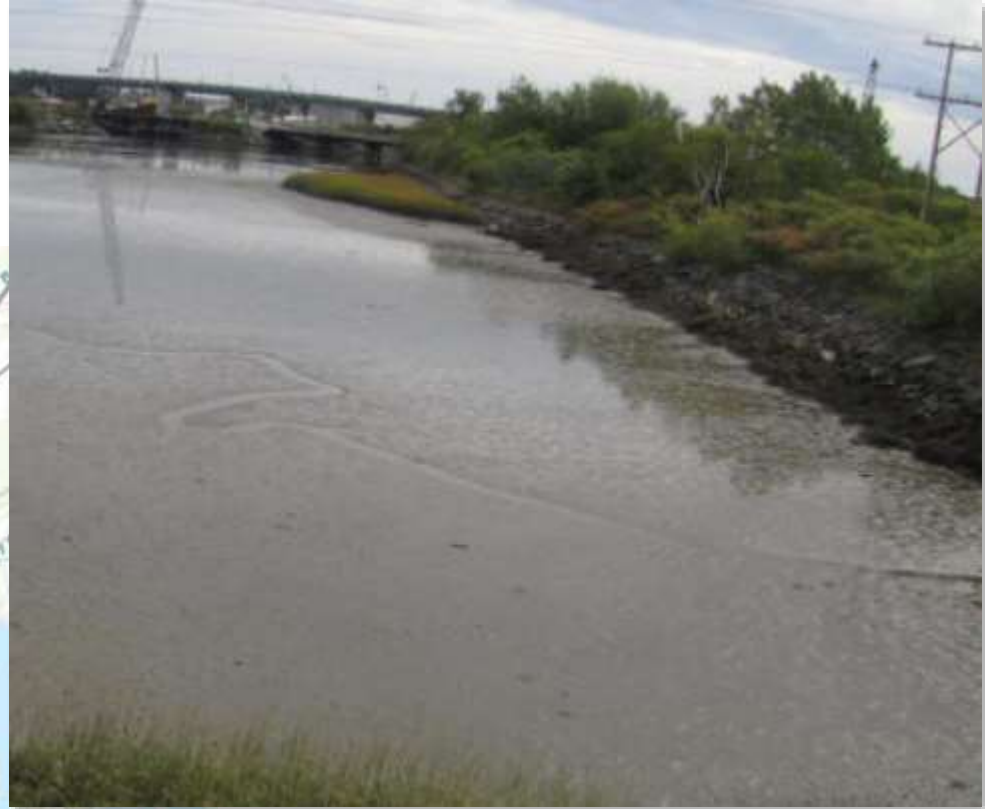
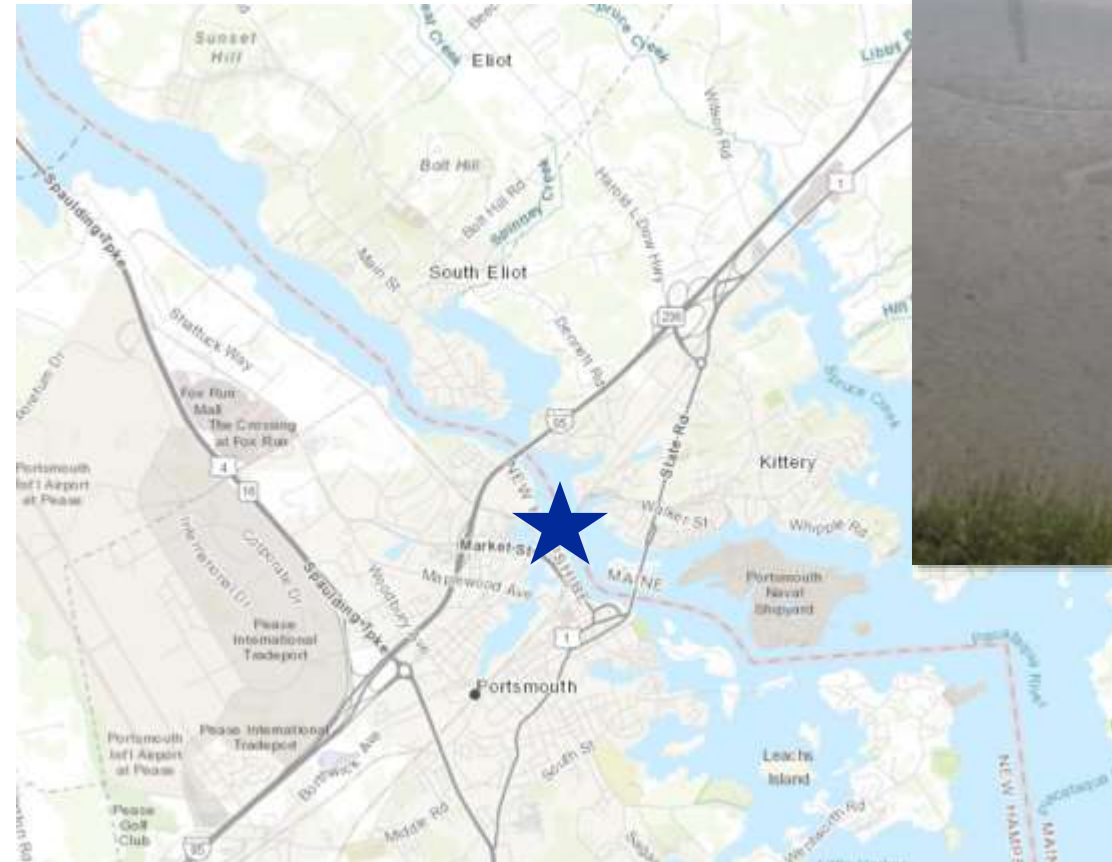
Cutts Cove fringe salt marsh

- Shoreline was filled and armored with rip-rap up to 12 feet above mean high tide

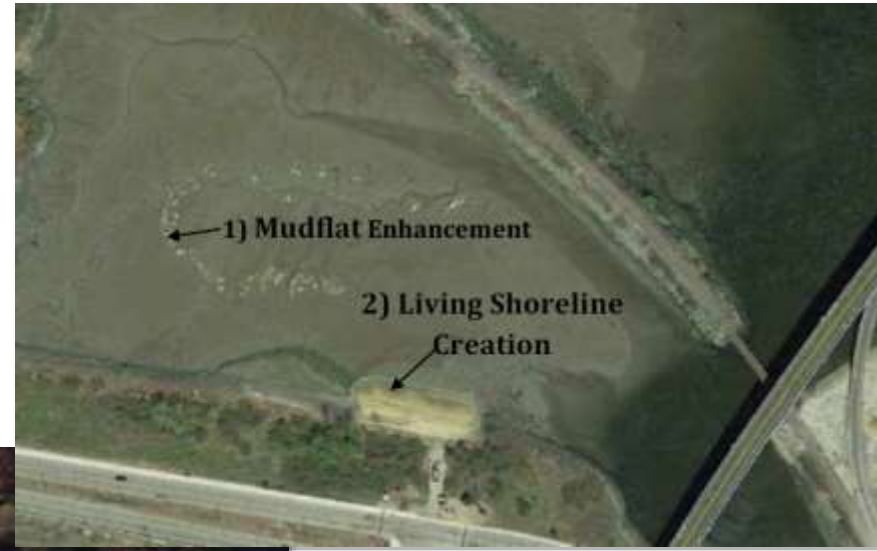
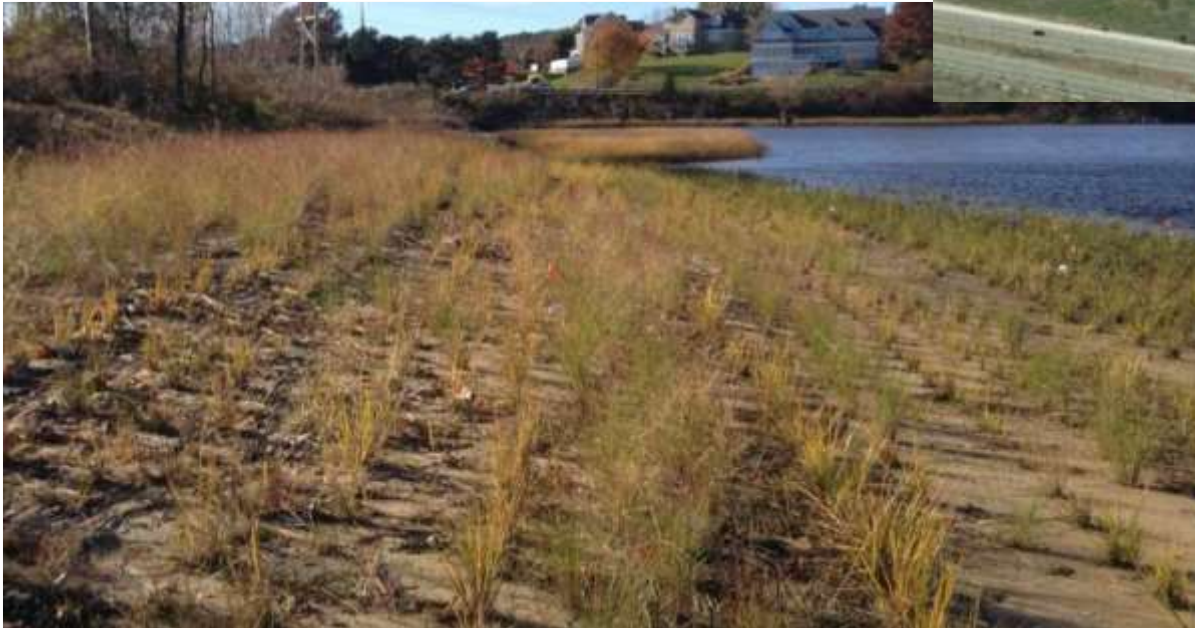
Cutts Cove fringe salt marsh

- Mudflat enhancement by native shell placement
- Removed 200 ft of armoring
- Create 6,000 SF intertidal salt marsh protected by rock sill
- Regrading and plantings in Tidal Buffer Zone for marsh migration with sea level rise

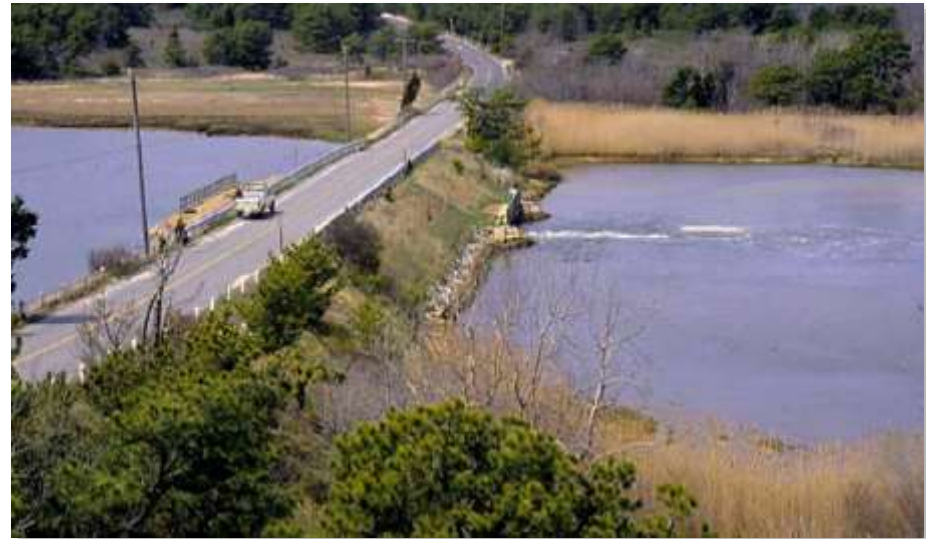
Herring River, MA National Park Service

A structure or landform that prevents normal tidal exchange in estuarine systems

- Dikes, berms, levees
- Undersized bridges and culverts
- Roads and causeways
- Dams

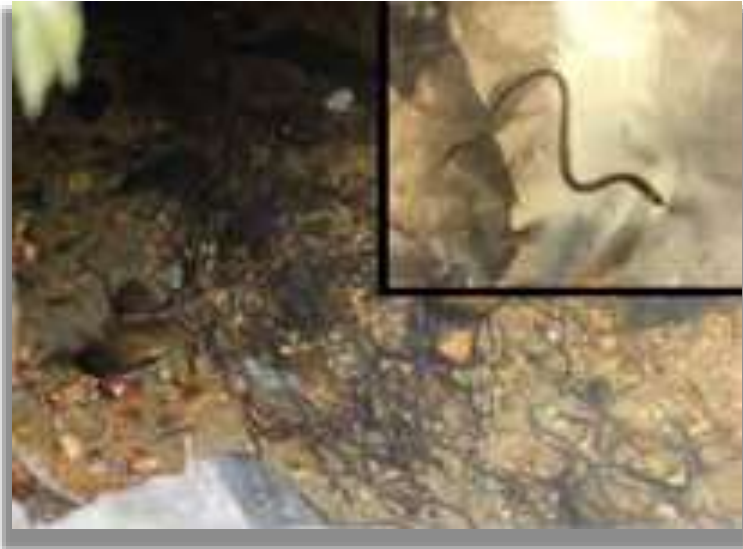
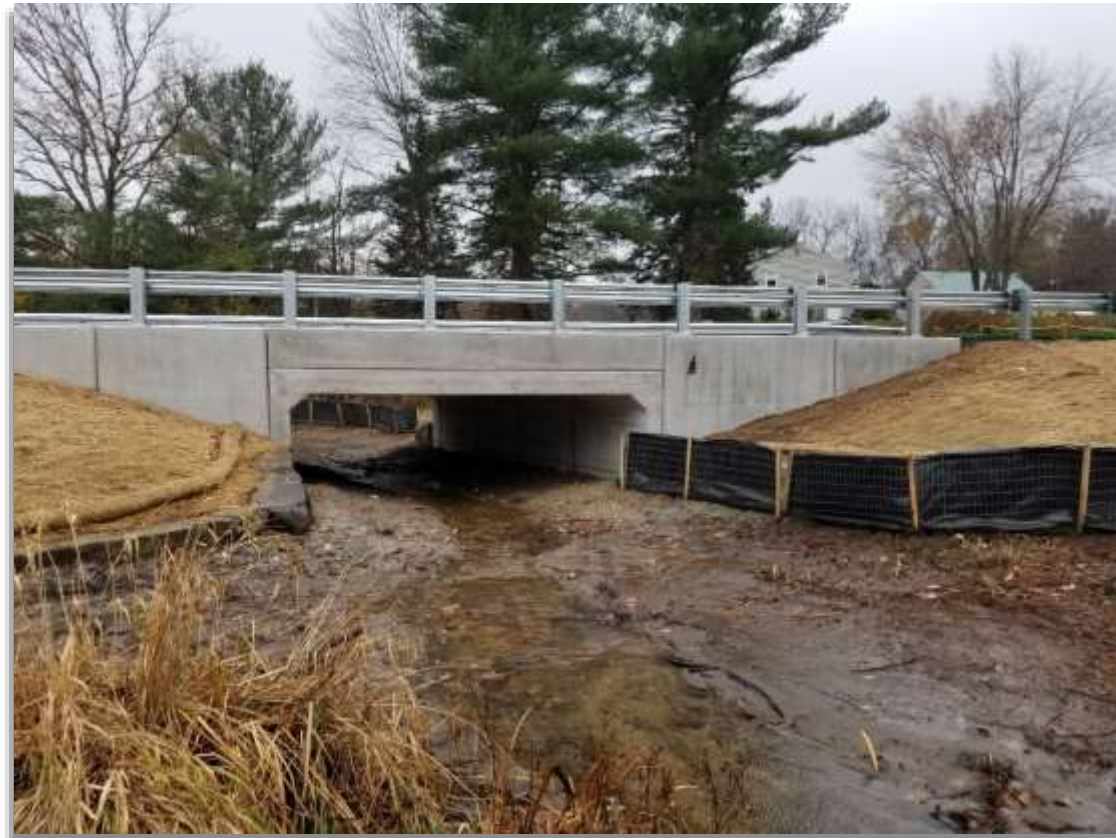
Lubberland Creek Culvert, Newmarket

- 16' box culvert with streambed simulation
- Accommodate 100-year flood with sea level rise projections
- Allows marsh migration and tidal exchange
- Restored downstream channel
- Reconnect tidal flow to 2 miles upstream wetlands
- Fish passage

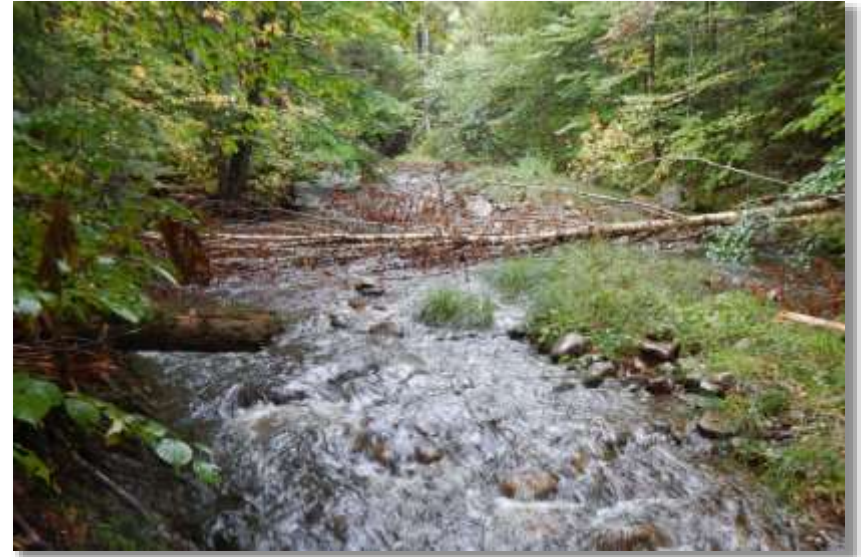
Wood additions create pool habitat for Brook Trout in Nash Stream

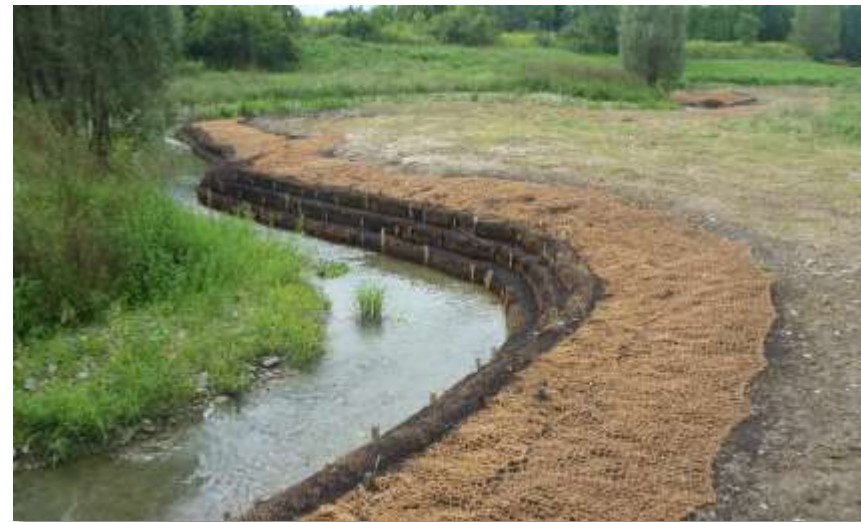
Coir logs, wood, and buffer plantings can be used to stabilize stream banks rather than hard rock

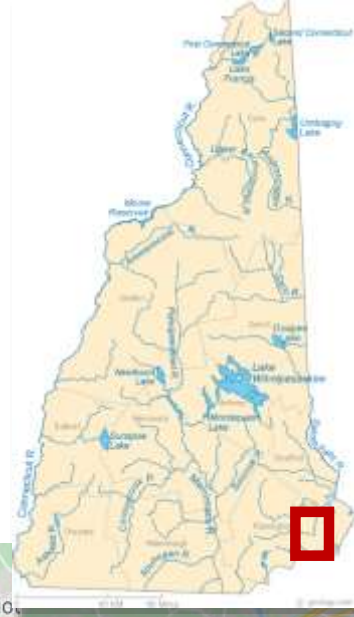
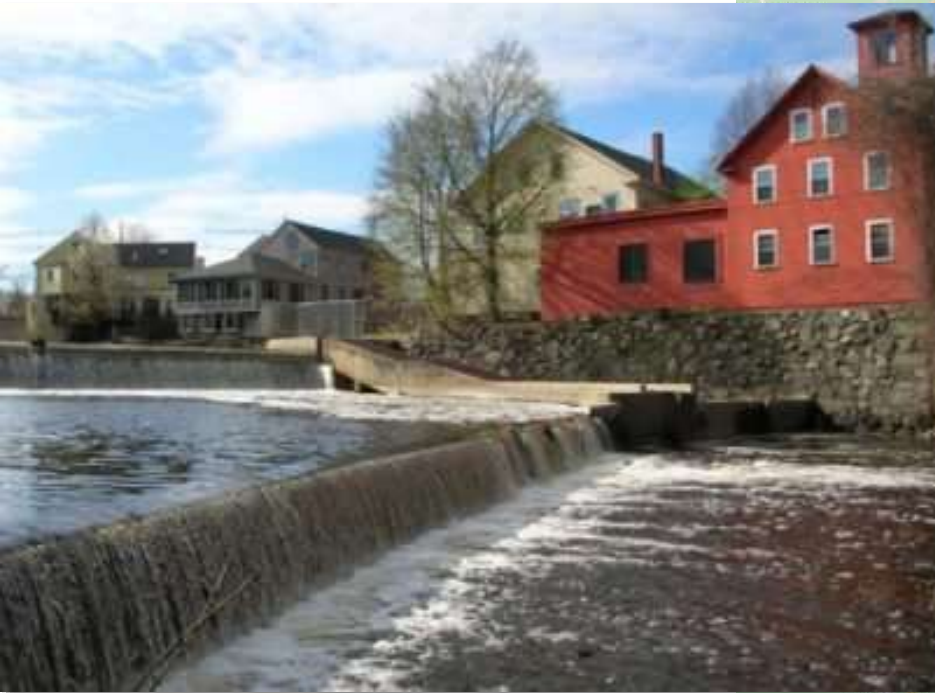
Great Exeter Dam Removal

- Lowest dam on a major tributary to the Great Bay
- Tidal/freshwater interface
- Barrier to anadromous fish migrations
 - American eel
 - River herring
 - Alewife

- Dam removed in 2016
- Reconnected 15 miles of the Exeter River and tributaries to free-flowing condition
- Re-established stream geomorphology in previously impounded area

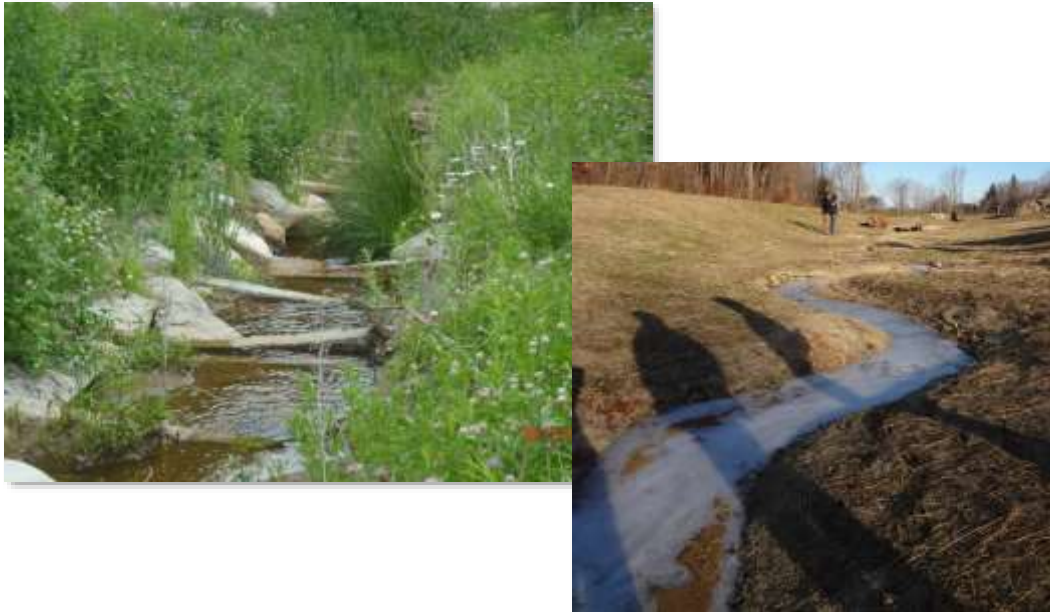
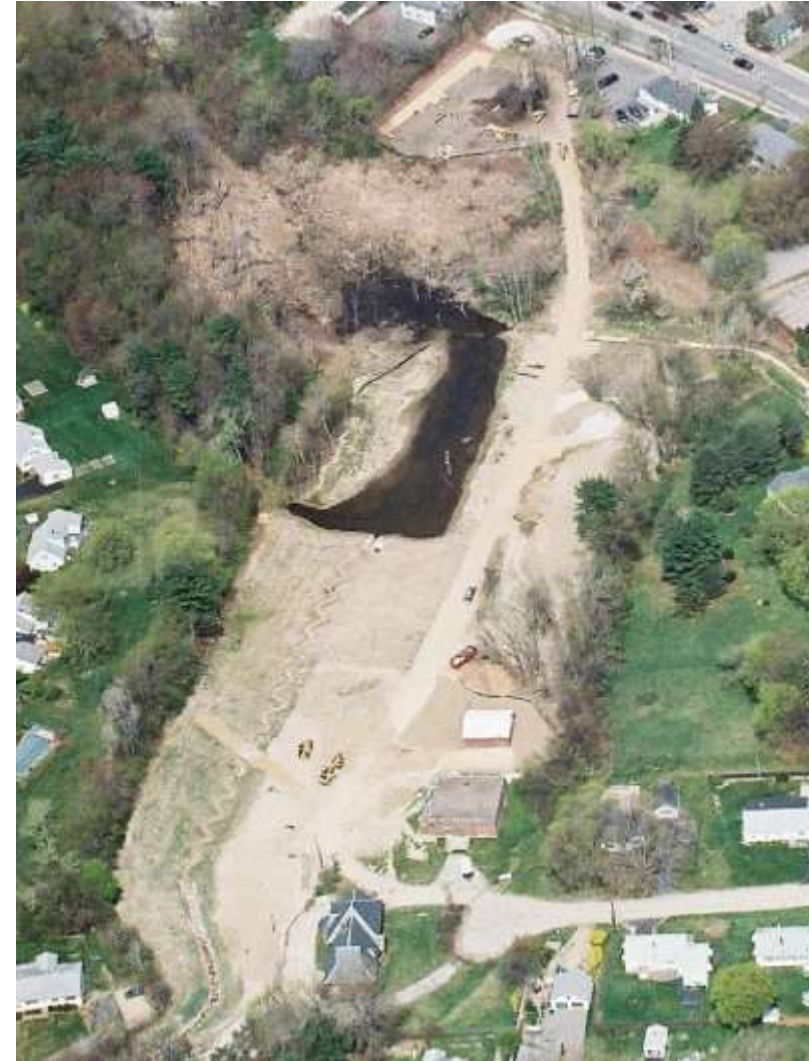
Daylighting Berry Brook in Dover

- Reconstruction of ~960' of historic stream channel that was underground
- Reconnected ~1 mile of 1st order stream and removed fish barriers
- Restored 2.5 acres of wetland
- Preserved 5 acres of land at headwaters of the Cocheco River

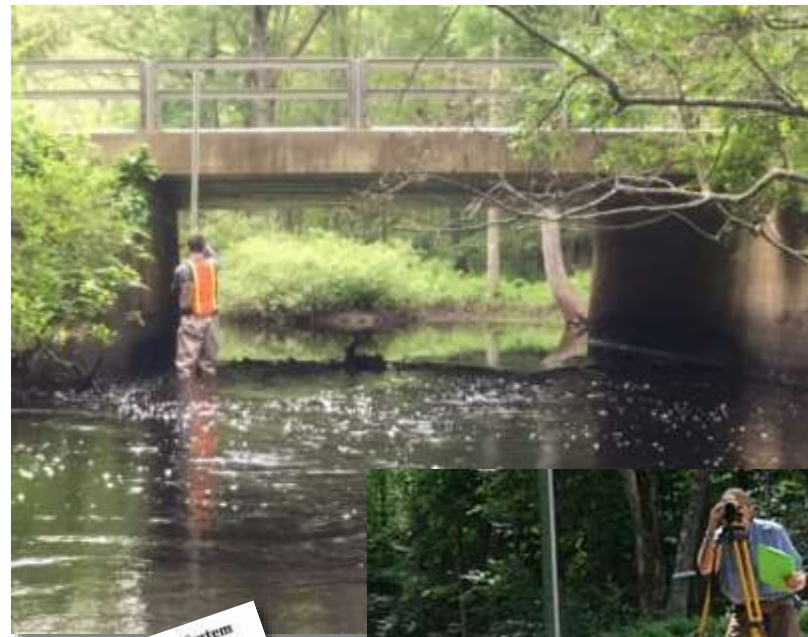
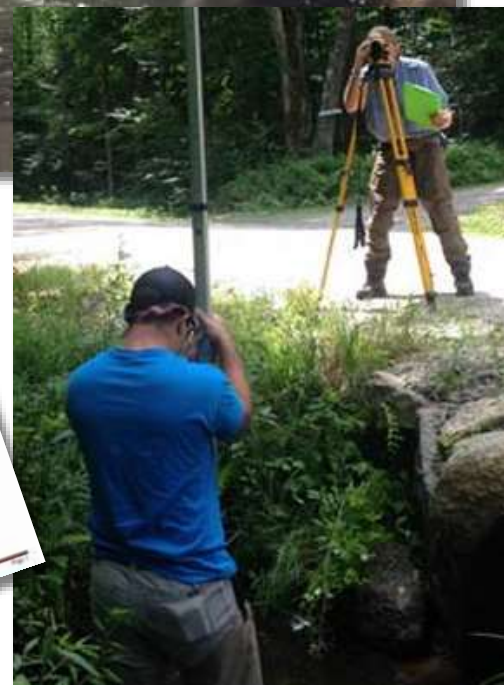
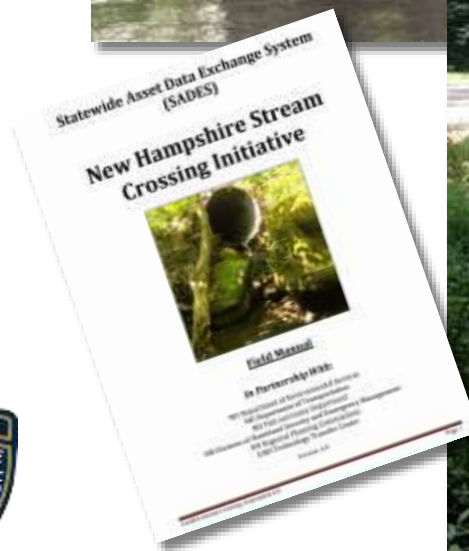
New Hampshire Stream Crossing Initiative

- Stream crossing surveys across the state
- Consistent protocol

Rank Crossings for:

- ✓ Geomorphic compatibility
- ✓ Aquatic organism passage
- ✓ Asset condition
- ✓ Flood vulnerability

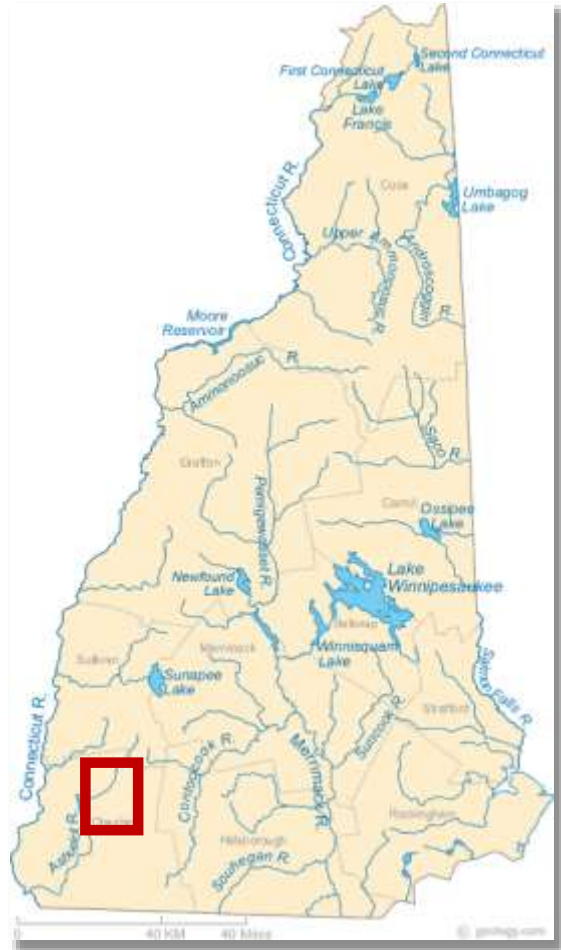
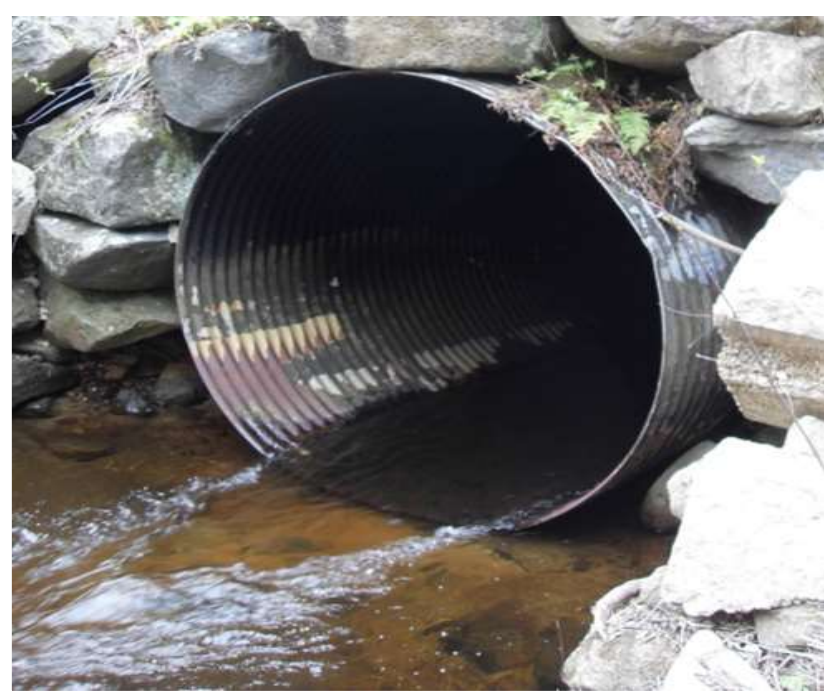
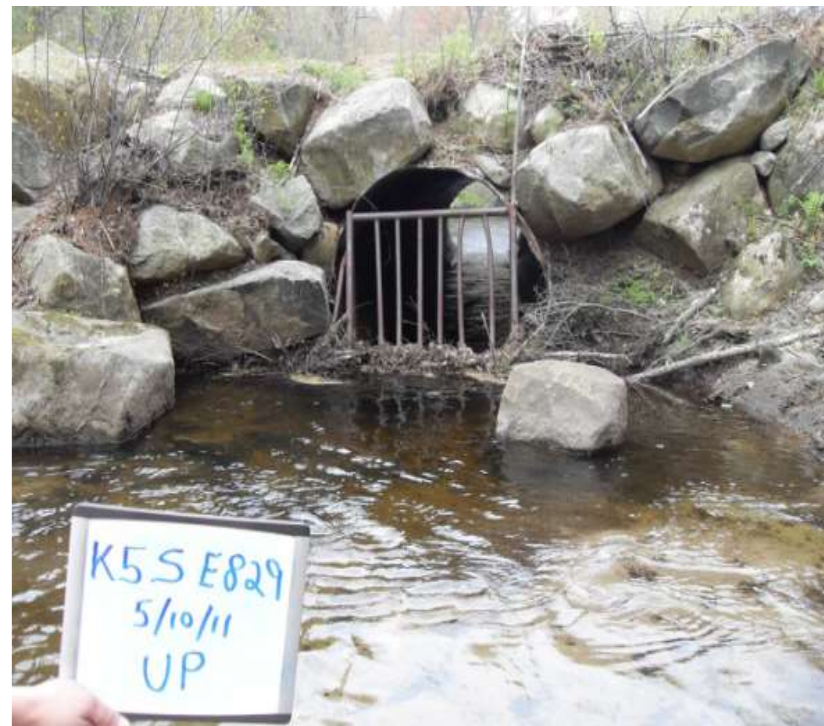
Falls Brook Culvert, Swanzey NH

- Undersized 50' long metal pipe
- Severe erosion and streambed scour
- Barrier to brook trout coldwater spawning

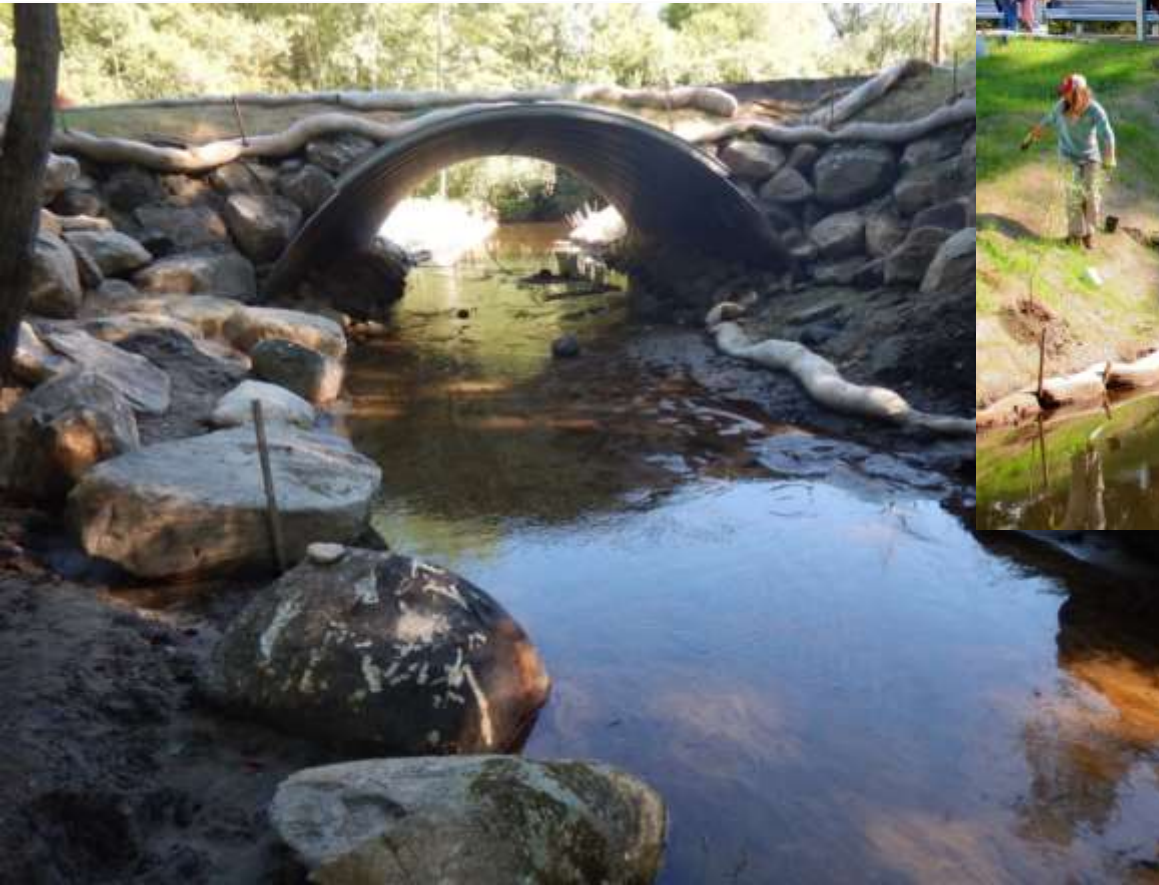
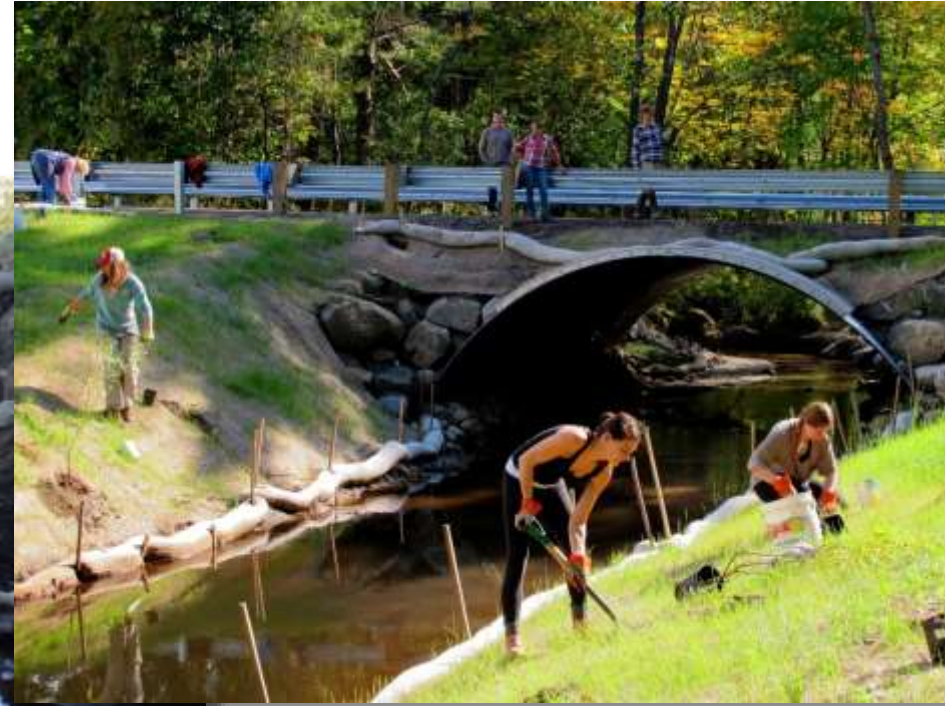
Falls Brook Culvert, Swanzey

- Upgraded to 23-foot span open-bottom arch
- Plantings and bank stabilization
- Fish passage restored to 10 miles of upstream coldwater habitat

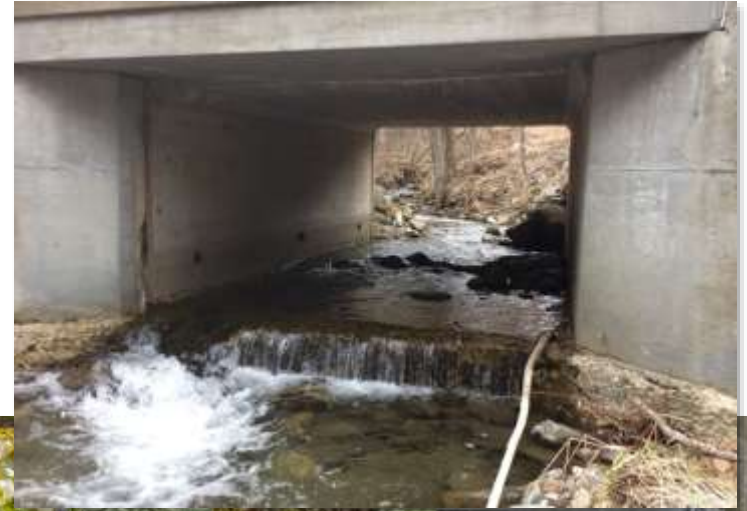
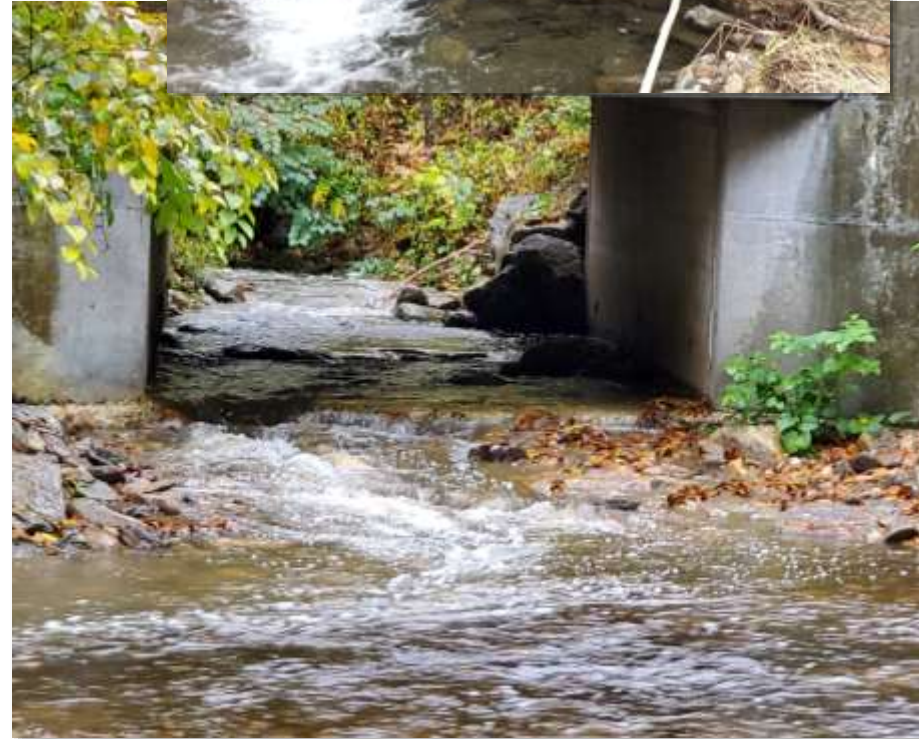
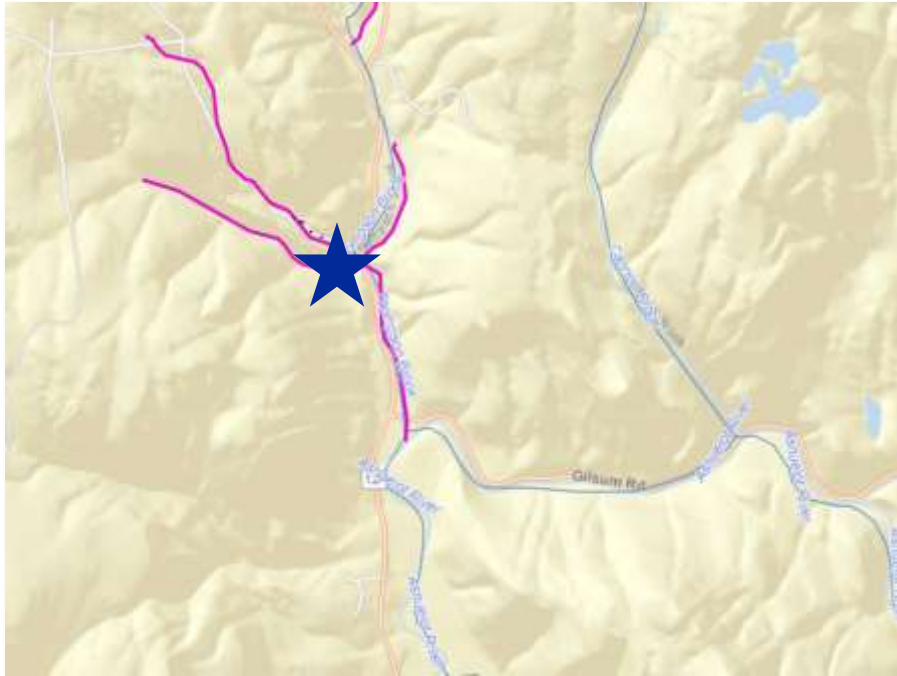
Thompson Brook, Surry

- 3' perched box culvert
- Downstream grade controls to recreate step-pool habitat
- Reduce perch to 6"
- Passable by brook trout
- Access to ~1 mile coldwater habitat

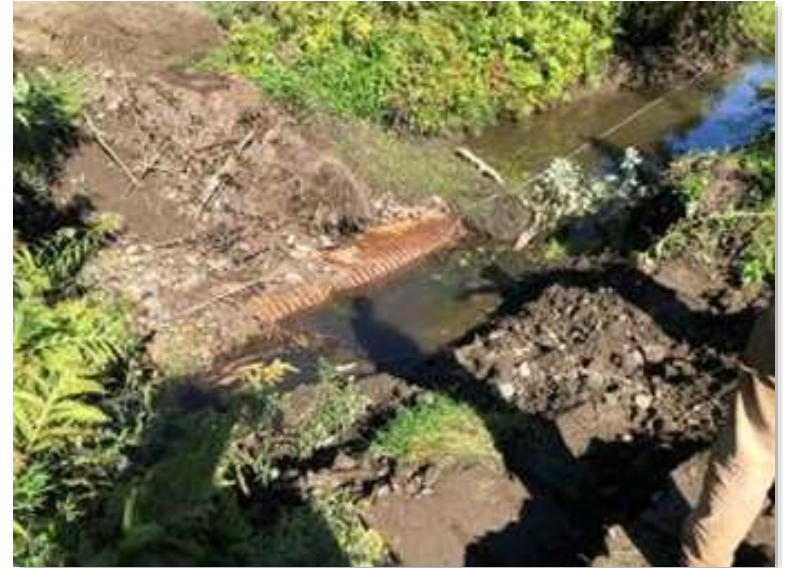
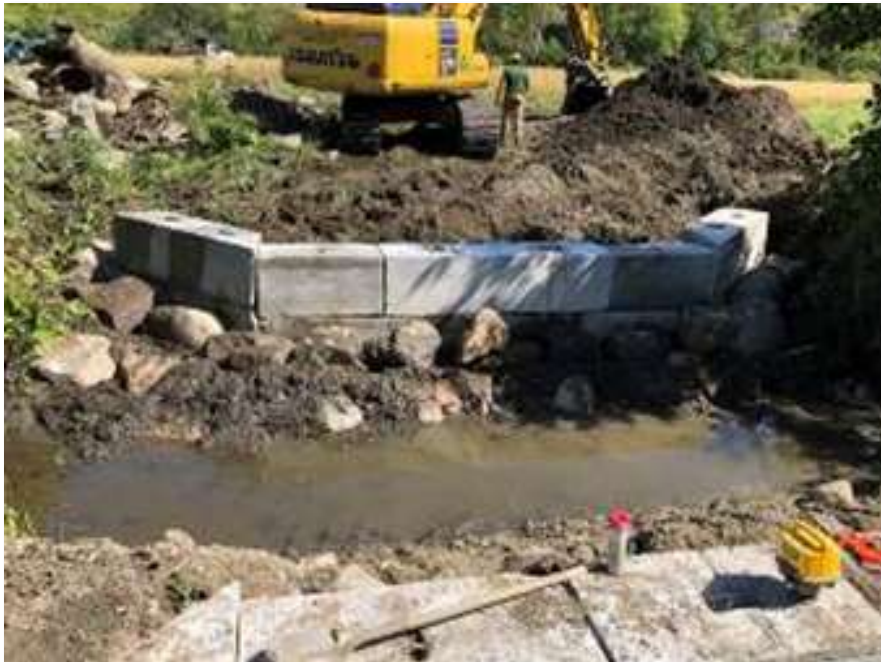
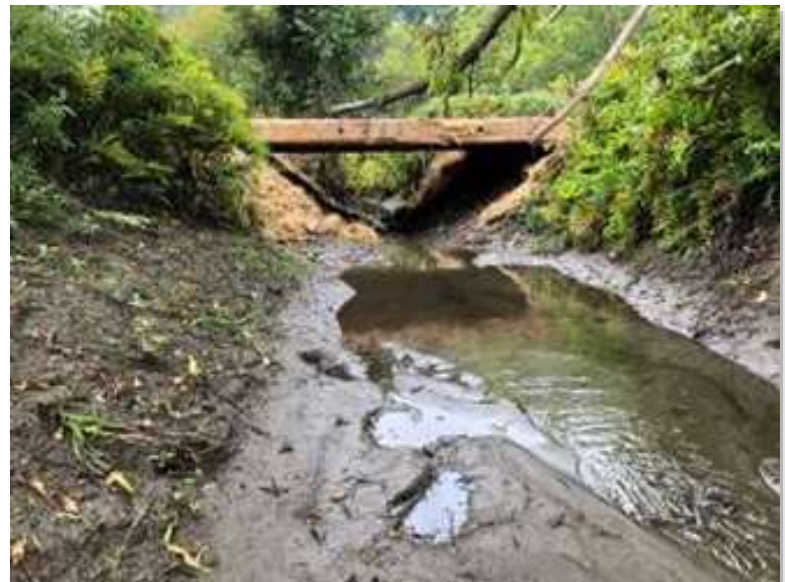
Agriculture/Forestry Stream Crossing, Colebrook

- Degraded, metal pipe culvert
- Barrier to fish passage and washed out, banks failing
- Replaced with open span skidder bridge
