Wetland and Stream Restoration Opportunities in New Hampshire

Restoration and Enhancement “Menu”

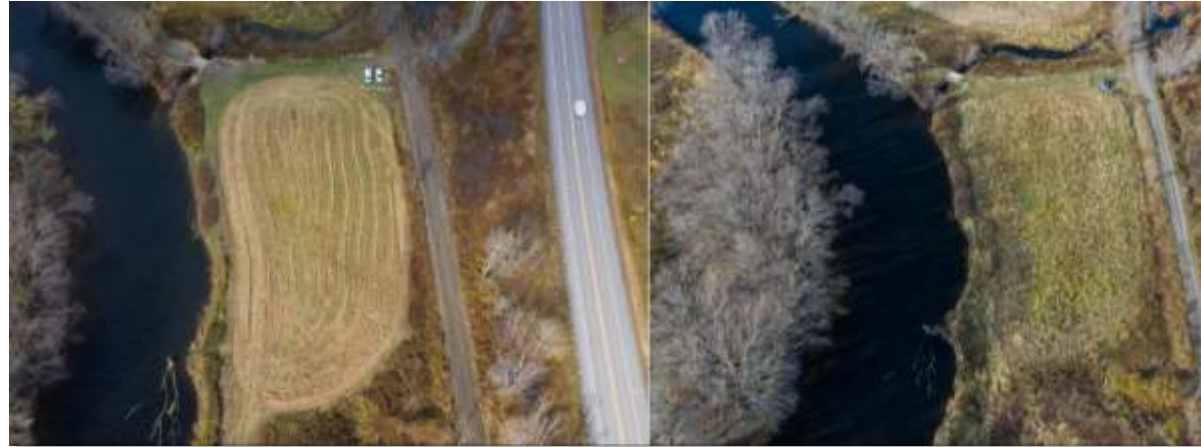
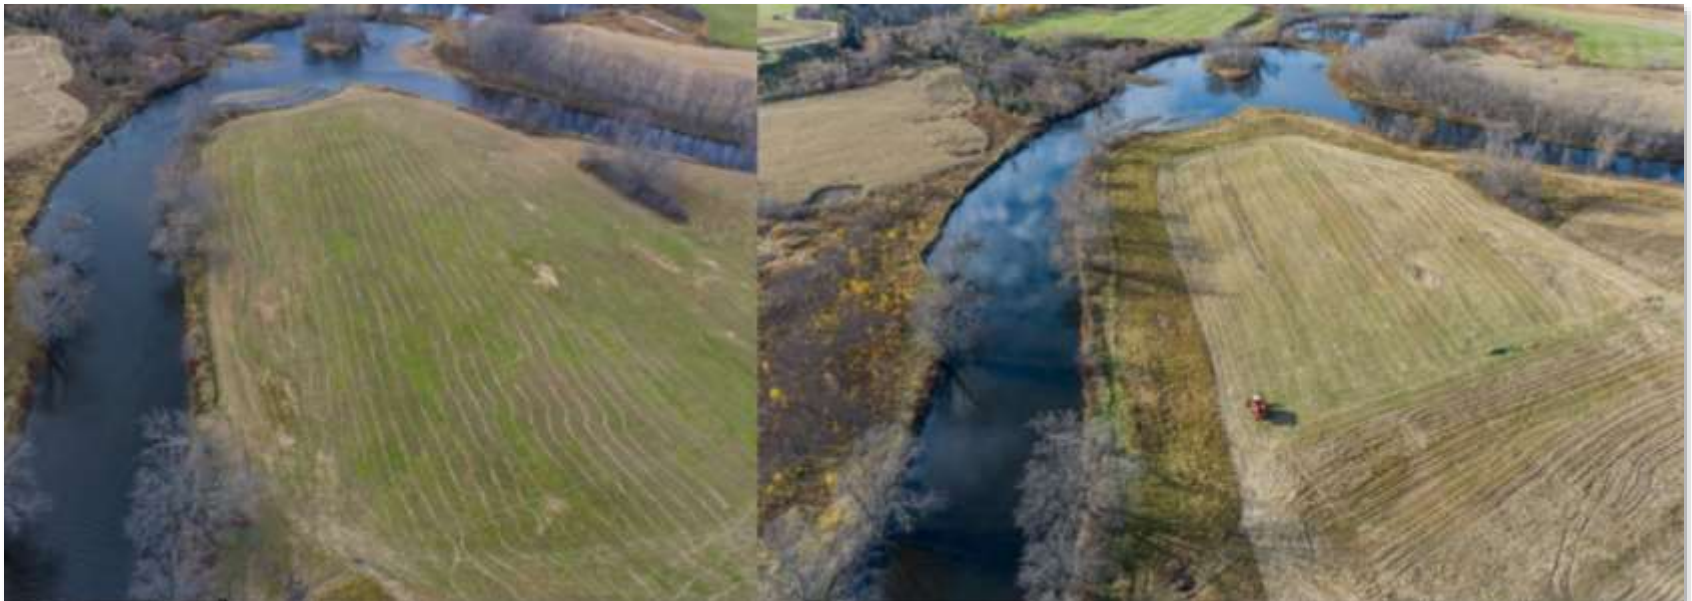
Upper CT Floodplain Plantings

- Replant old agriculture fields and increase the riparian buffer to 100'
- Treatment of invasives
