NEW HAMPSHIRE DEPARTMENT OF Environmental Services

ENVIRONMENTAL BULLETIN

Mendums Pond Dam Repair Project
Barrington and Nottingham
Frequently Asked Questions (FAQs)

Issued July 23, 2015

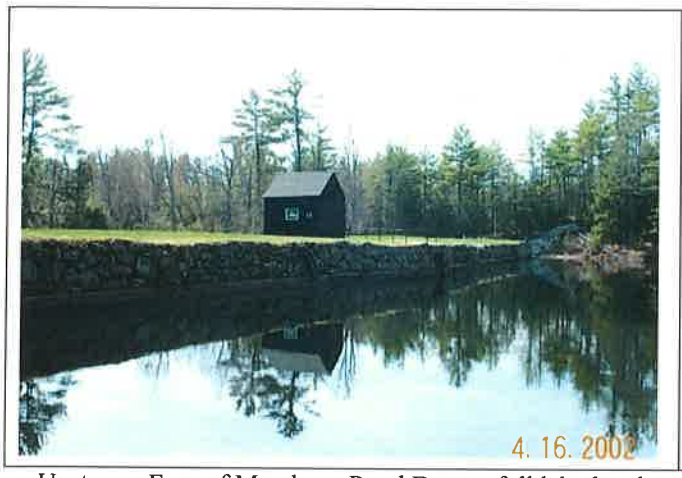
Upstream Face of Mendums Pond Dam at full lake level

Downstream face and outlet works of Mendums Pond Dam
