Ammonoosuc River Geomorphic Assessment, Floodplain Conservation, and River Corridor Planning

Connecticut River Joint Commissions
Lebanon, NH

Dr. John Field
Field Geology Services
Farmington, ME

October 2011

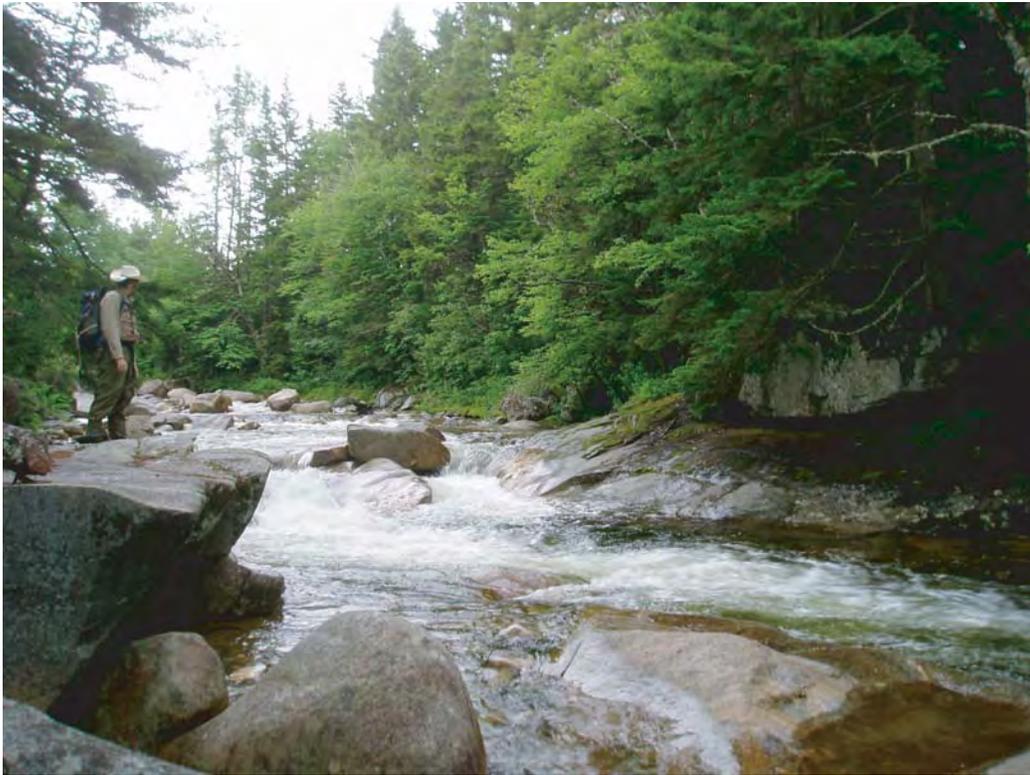
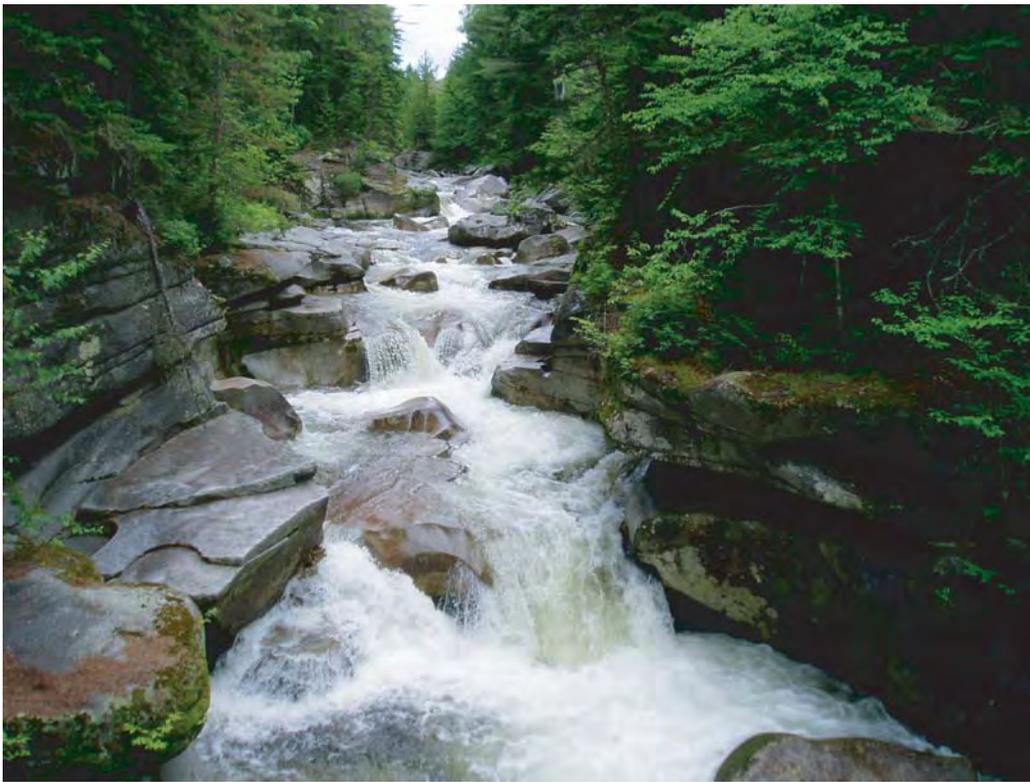
Figure 6. Bedrock in the headwater areas occurs along the channel in the form of a) gorges and b) waterfalls.

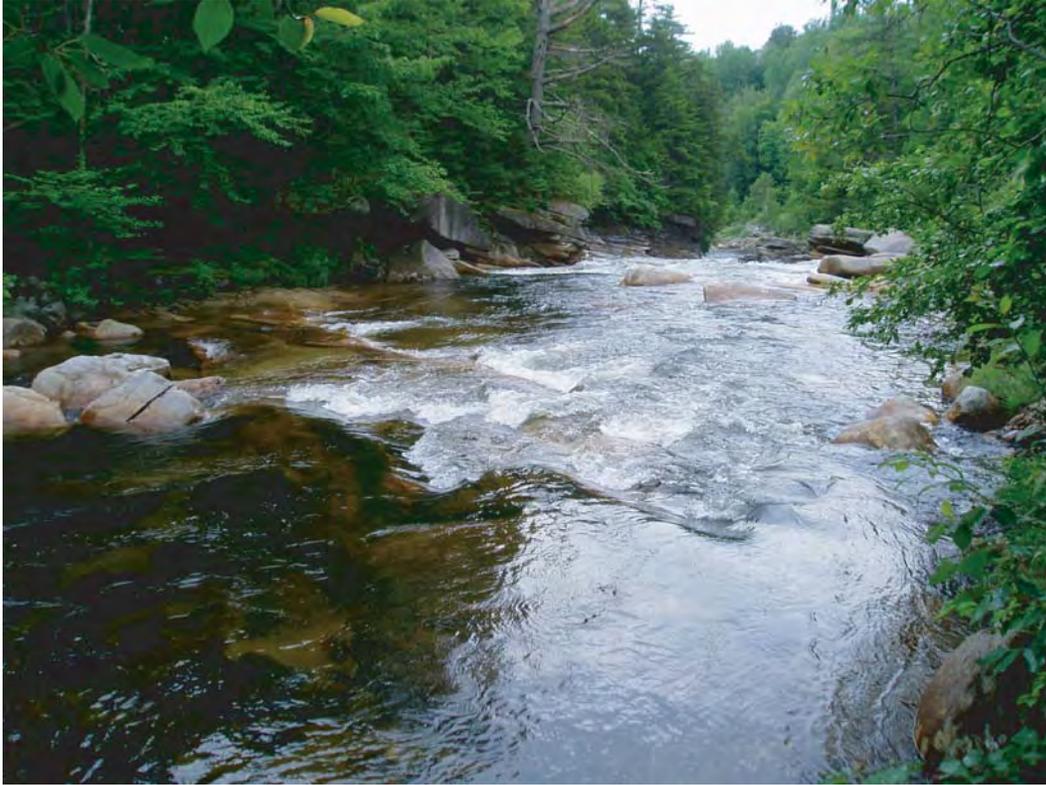
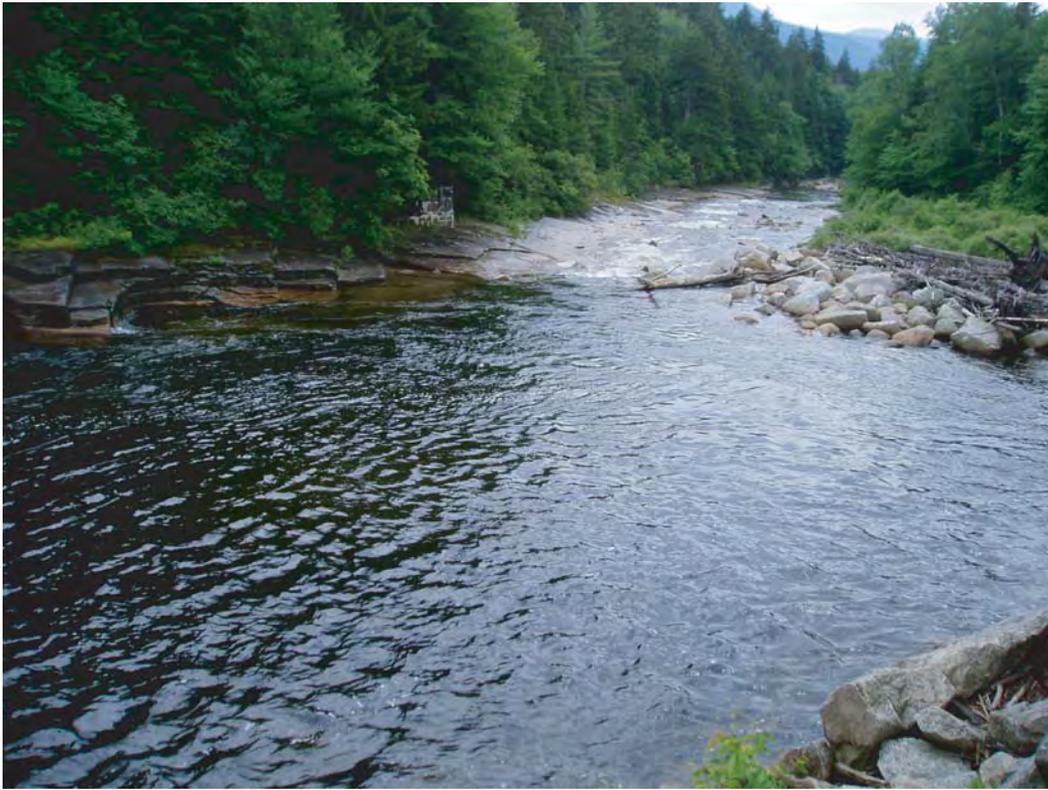
Figure 9. Lower falls showing a) bedrock constriction and grade control at the upstream end and b) a large scour pool and bedrock channel downstream of the falls.

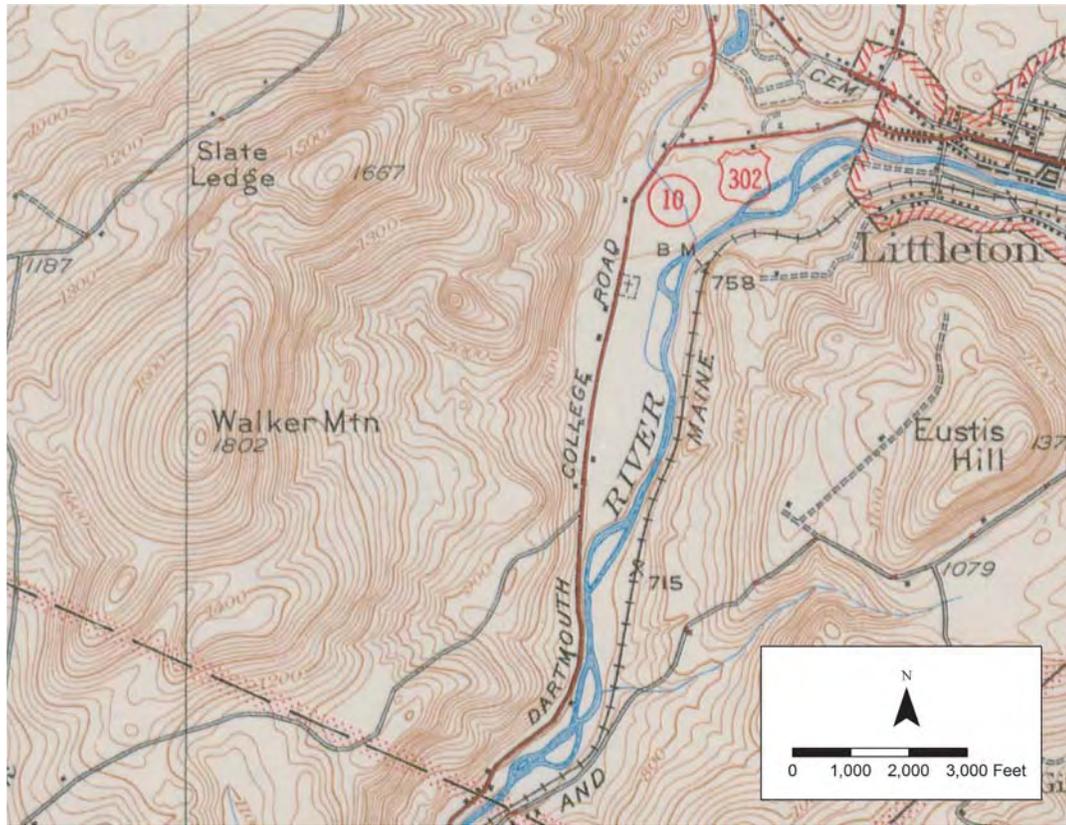
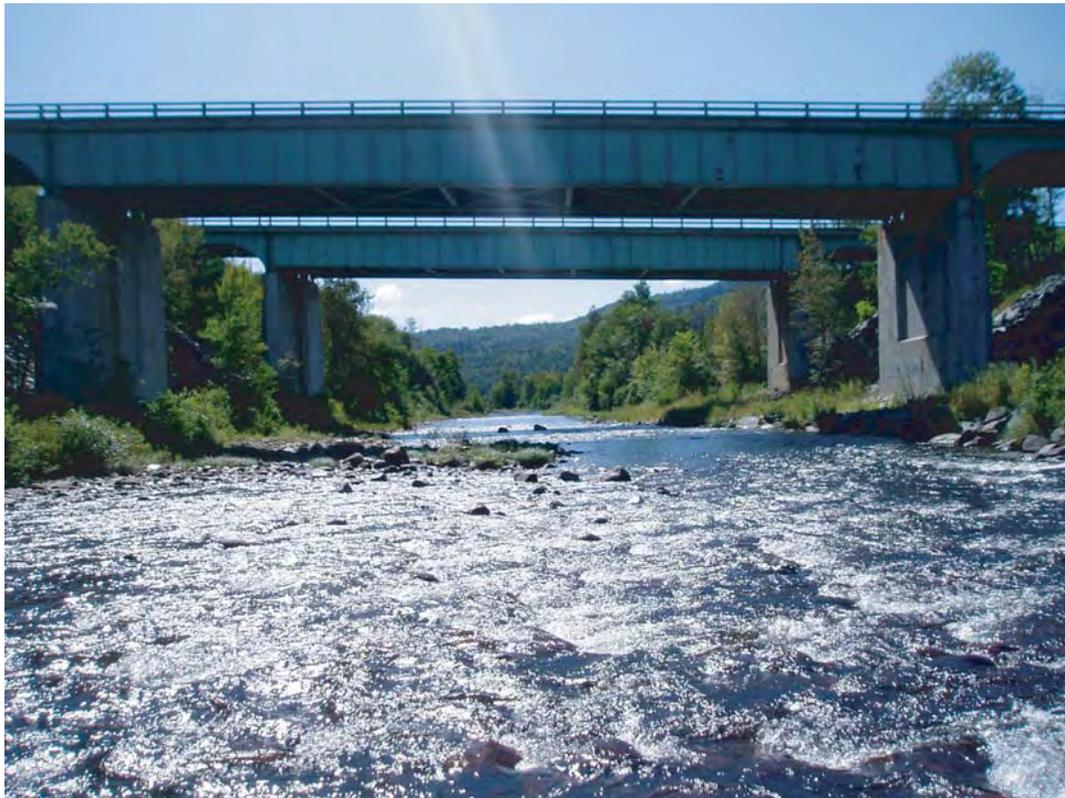
The Lower Littleton section of the Ammonoosuc River is adjusting to many of the same pressures accompanying development, encroachment, and historic channel alteration of the Town of Littleton section upstream. Like upstream, the channel has been extensively straightened (Table 4), but unlike the upstream section these reaches retain a strong connection to the floodplain as reflected in the C-type channel designation, high entrenchment ratio, and relatively low incision ratio (Table 2). As can be seen on historical maps and aerial photographs, Reach 19 was historically an anastomosing river transporting sediment and water in a series of interconnected channels (Figure 16a). By 1929, the river was artificially straightened and realigned along the high bank on the east side of the valley. With development of the adjacent floodplain, historically active side channels and wetlands have been infilled, although some new wetlands have been created to compensate for this loss (Figure 17). Natural side channels and interconnected wetlands have an important influence on the river's morphology and aquatic habitat as they provide storage for sediment and water at various flow stages. The network of side channels that once existed would have provided a longer flow path (with a lower gradient), higher flow complexity (with the ability to sort and deposit sediment), and increased cover and velocity refuge for aquatic organisms. Furthermore, the undeveloped floodplain with intact side channels and wetlands would have provided greater flood storage to reduce flood peaks and increase base flow during low flow periods. By cutting off access to side channels and straightening the river, the risk of flooding and erosion has increased significantly both in this section and adjacent downstream reaches.

Figure 16. Historical topographic maps show a) a multi-threaded anastomosing channel in the Lower Littleton section prior to b) artificial straightening of the channel as seen from the I-93 bridges.

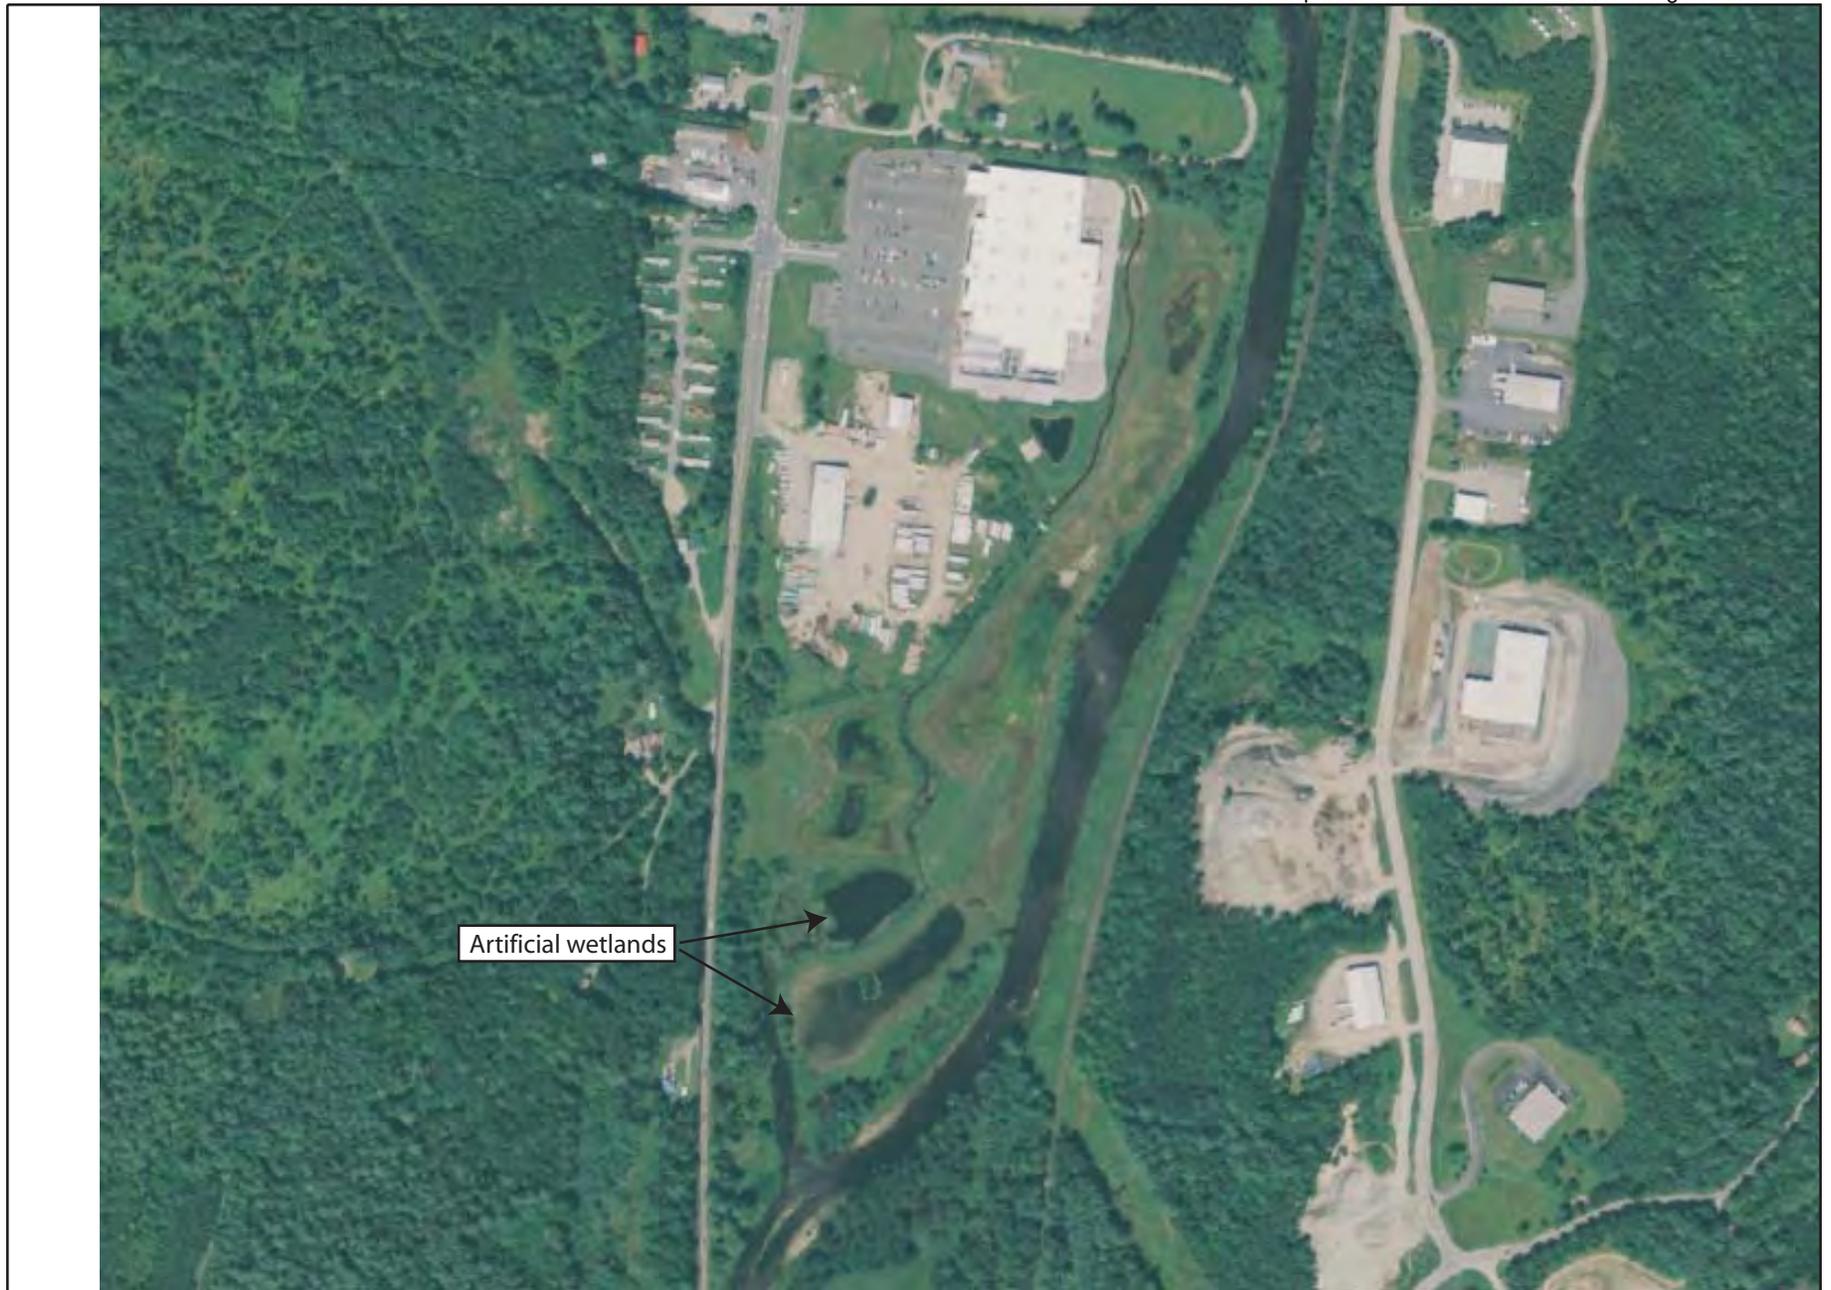
Figure 17. Infilling of wetlands during development of the floodplain has been compensated, in part, by the creation of artificial wetlands.

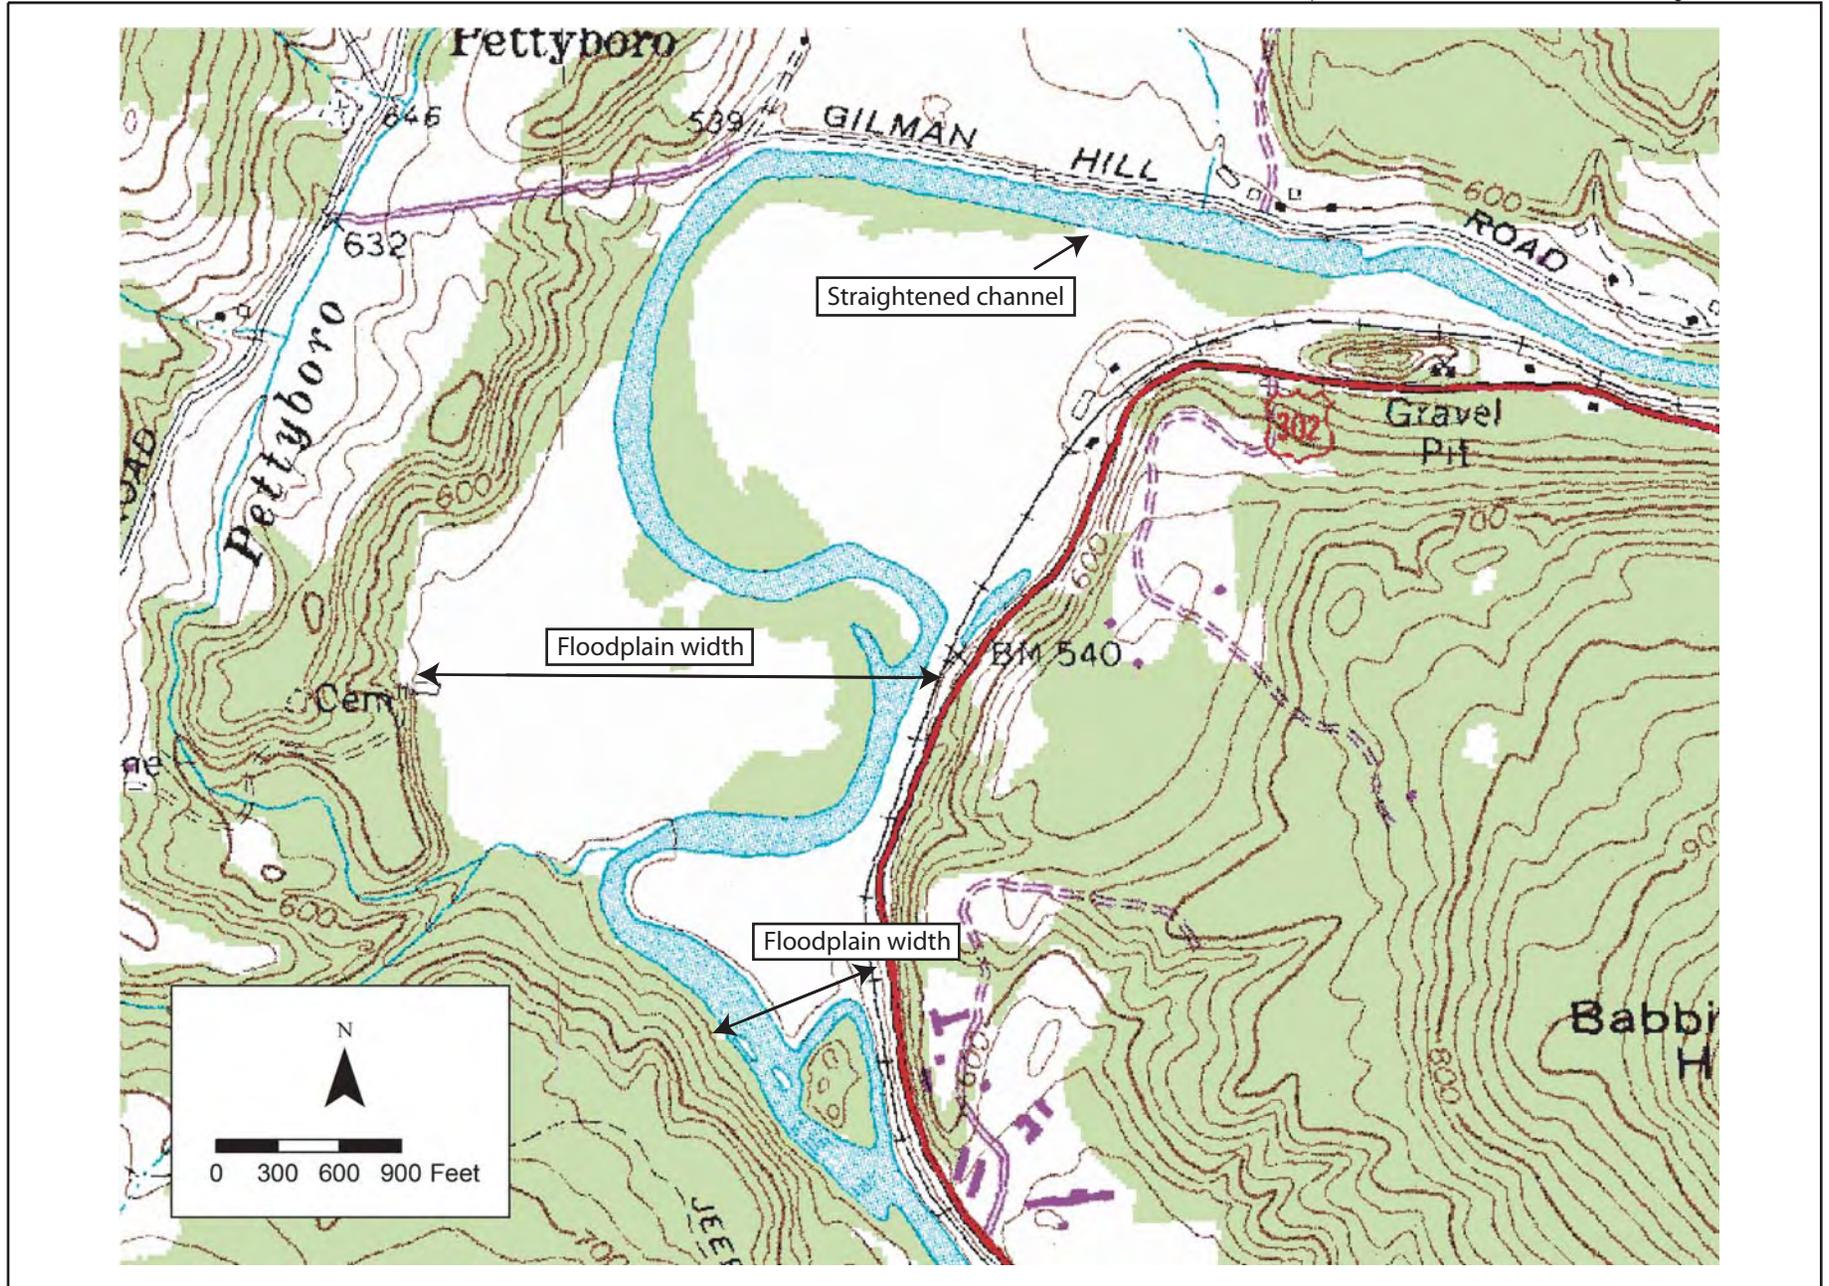
The herein named Bath Meadow section is an unconfined reach that begins along Gilman Hill Road in the Town of Bath and continues through a wide alluvial valley until reaching a valley constriction created by a bedrock knob (Figure 24). The impoundment of floodwaters immediately upstream of the constriction results in significant gravel deposition, bank erosion, and rapid channel migration (Figure 25). The dynamic and unstable nature of the channel in this location has caused a recent channel avulsion that has cutoff a high-amplitude meander formed as the result of recent gravel deposition (Figure 26).

The gravel deposition at the downstream end of the reach has been enhanced by significant channel straightening upstream (Table 4; Figure 24) that has increased the

Figure 24. Topographic map showing significant floodplain narrowing at the downstream end of the Bath Meadow section. Note also artificial channel straightening further upstream.
