Baboosic Lake Association

Baboosic Lake Storm water Improvement Project

Photo Documentation

December 5, 2012

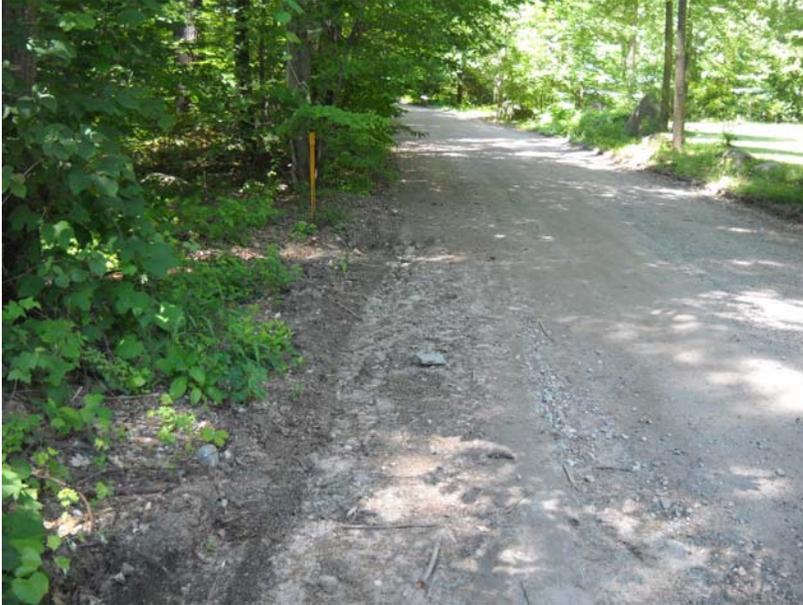
Site #5 upper, pre-construction:

Photo 1, site #5 prior to construction, taken by CEI

- Install riprap armoring to slow runoff from running down the paved section of roadway directly into catch basin or down the gravel roadway.
- Install plunge pool prior to catch basins to store runoff and settle out TSS and nutrients prior to discharge into the drainage swale and lake.

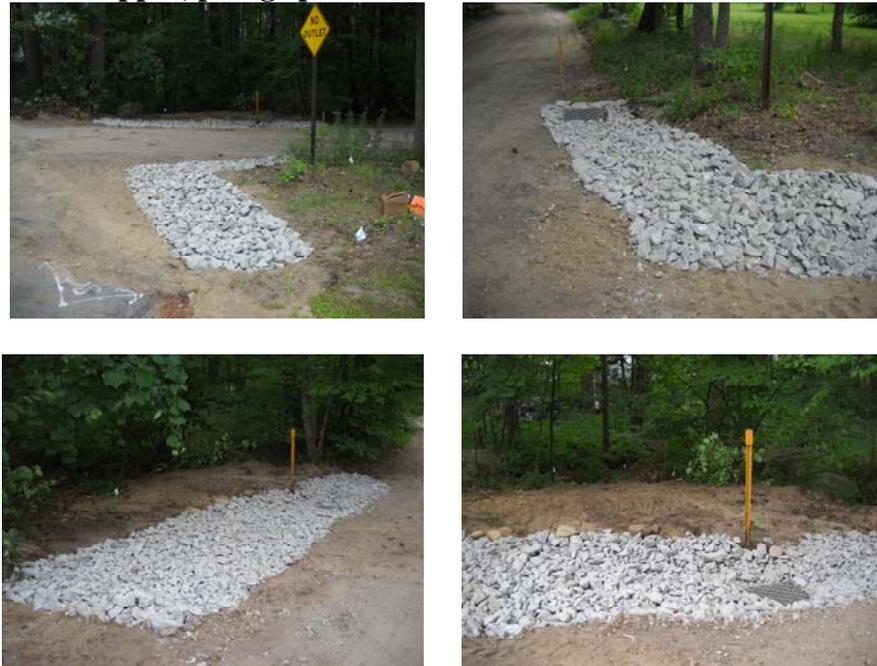
Site #5 upper, plunge pool construction:

Photos 2-5: site #5 upper- riprap plunge pool during construction, taken by CEI.

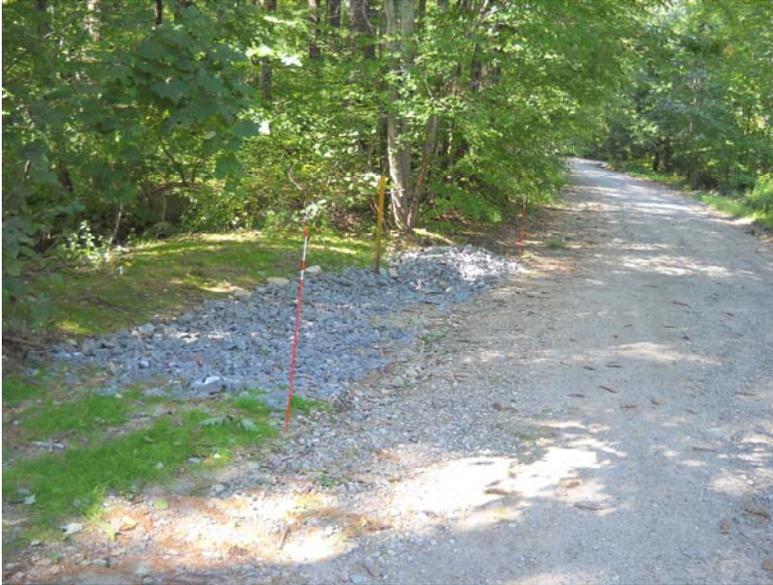
Site #5, post-construction of the riprap plunge pool

Photo 6: site #5 upper riprap plunge pool post construction, taken by CEI.

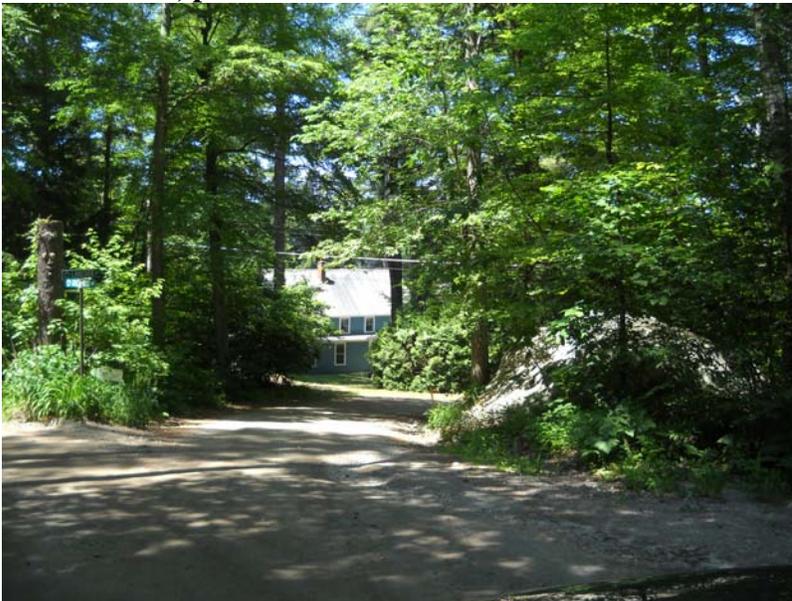
Site #5 lower, pre-construction:

Photo 7, site #5 lower prior to construction, taken by CEI

- **Install riprap armoring to slow runoff from running down the gravel roadway and to prevent scour of the drainage ditch.**

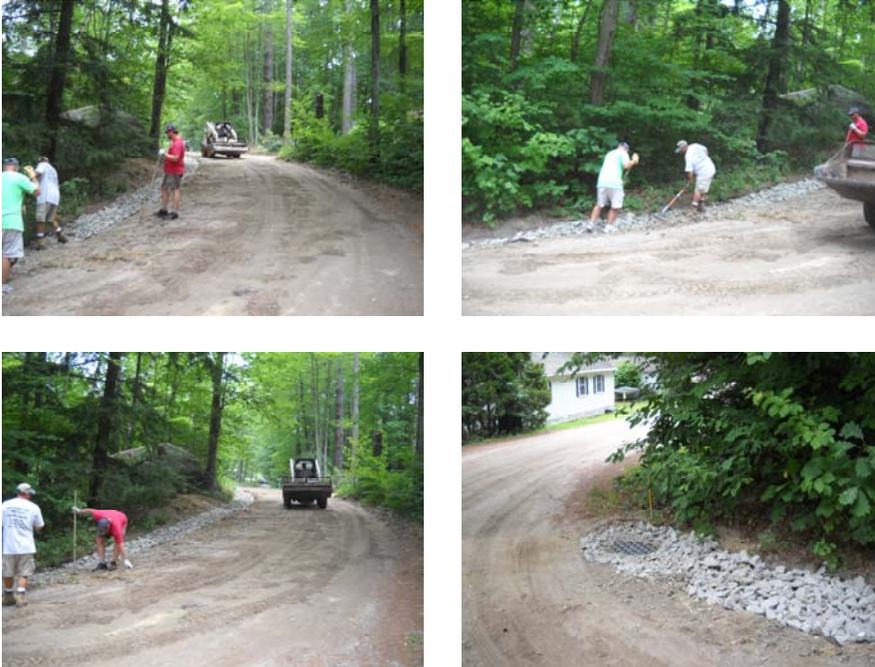
Site #5 lower, riprap swale construction:

Photos 8-11: site #5 riprap swale during construction, taken by CEI.

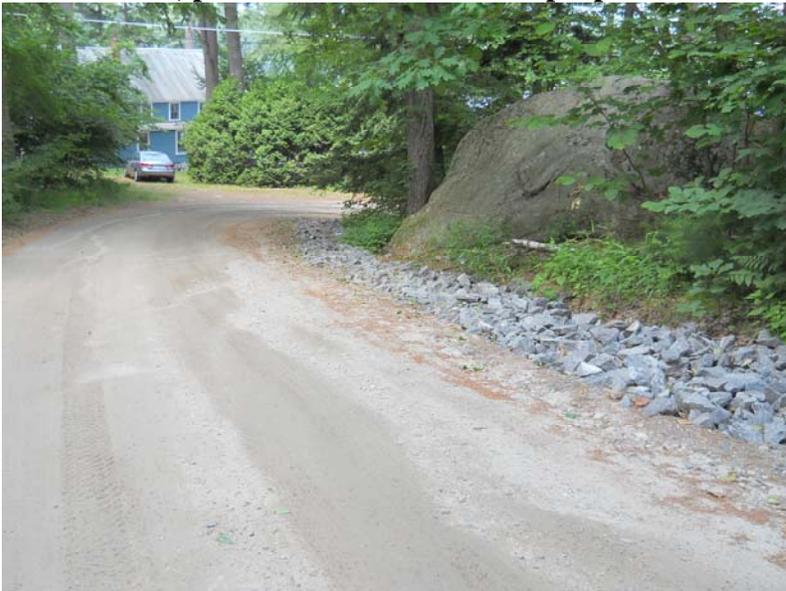
Site #5 lower, post-construction of the riprap swale

Photo 12: site #5 lower riprap swale post construction, taken by CEI.

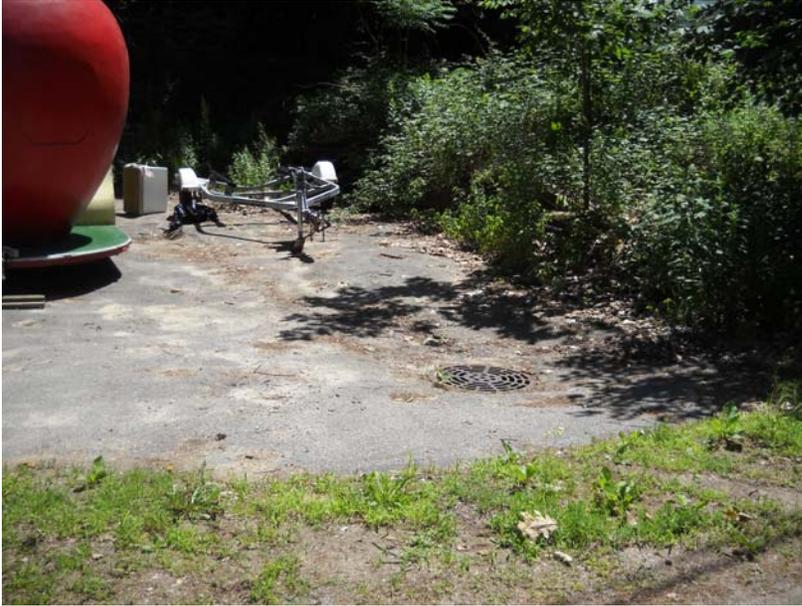
Site #6, pre-construction:

Photo 13, site #6 prior to construction, taken by CEI

- **Remove existing paved area around catch basin.**
- **Install riprap armoring to slow runoff and groundwater from running down the steep slope and over the gravel roadway.**
- **Install vegetation and swale to stabilize area and treat runoff for TSS and nutrients prior to discharge into drainage system that discharges into the lake.**

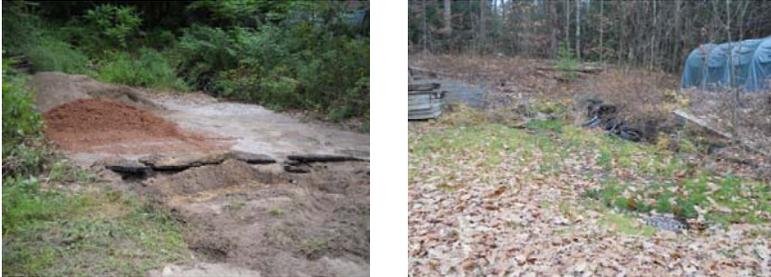
Site #6 pavement removal, re-vegetation construction:

Photos 14-15: site #6 re-vegetation and swale during construction, taken by CEI.

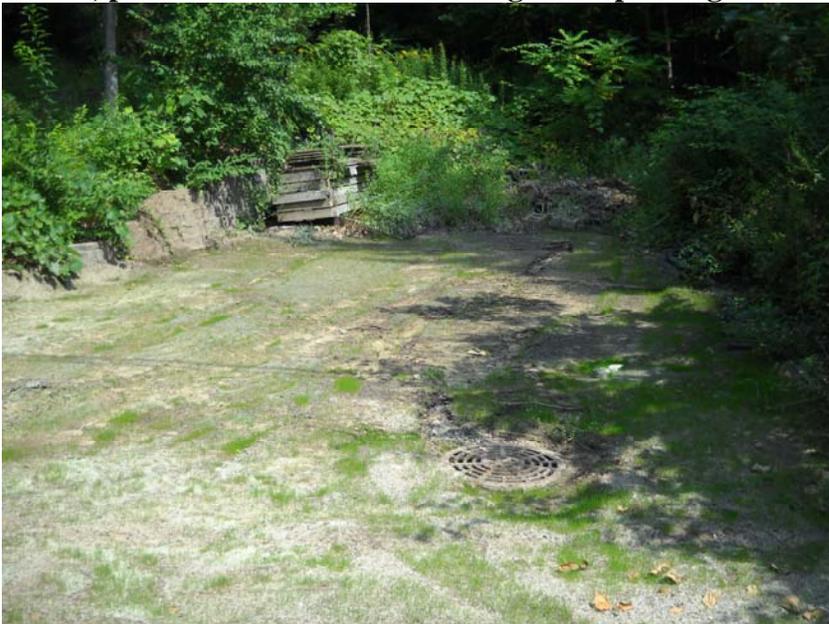
Site #6, post-construction of the re-vegetated parking area and swale

Photo 16: site #6 post construction, taken by CEI.

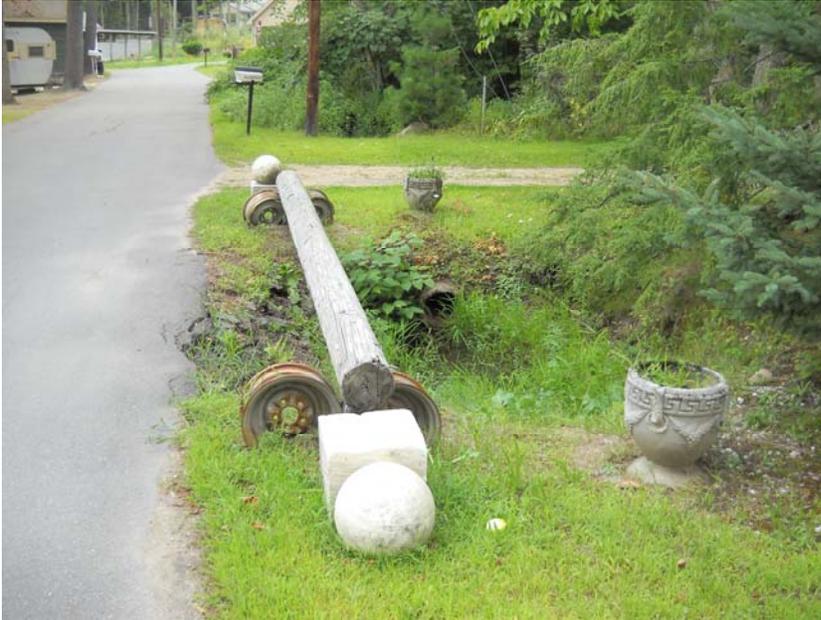
Site #7, pre-construction:

Photo 17, site #7 prior to construction, taken by CEI

- **Install plunge pool prior to outfall pipes and roadway culverts to store runoff and settle out TSS and nutrients prior to discharge into the lake.**
- **Stabilize headwall and roadway shoulder to prevent erosion**

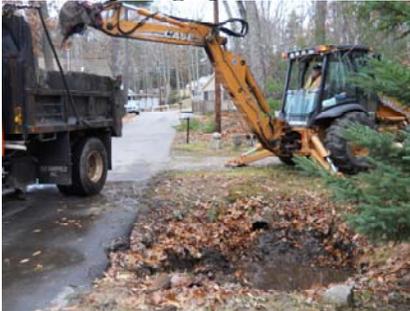
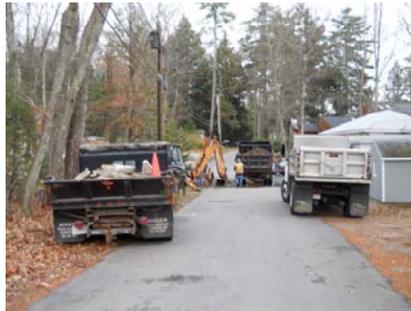
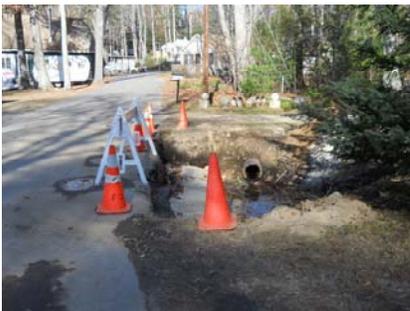
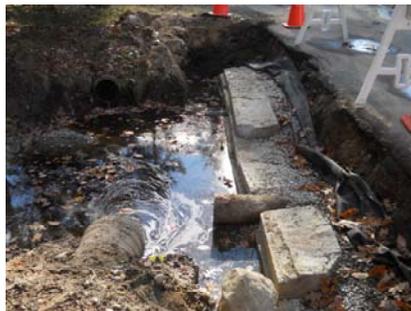
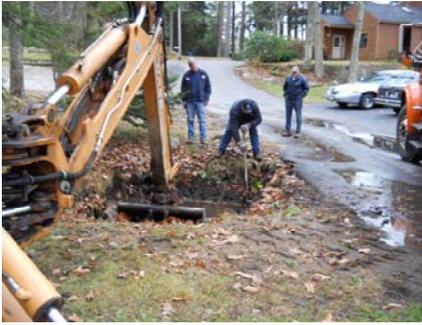
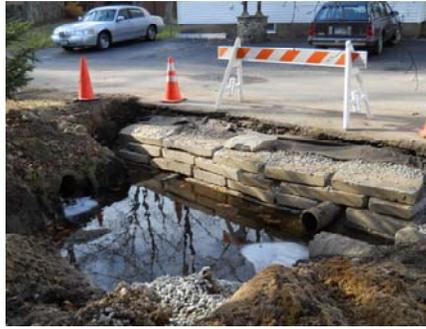
Site #7, plunge pool construction:

Photos 18-23: site #7- plunge pool during construction, taken by CEI.

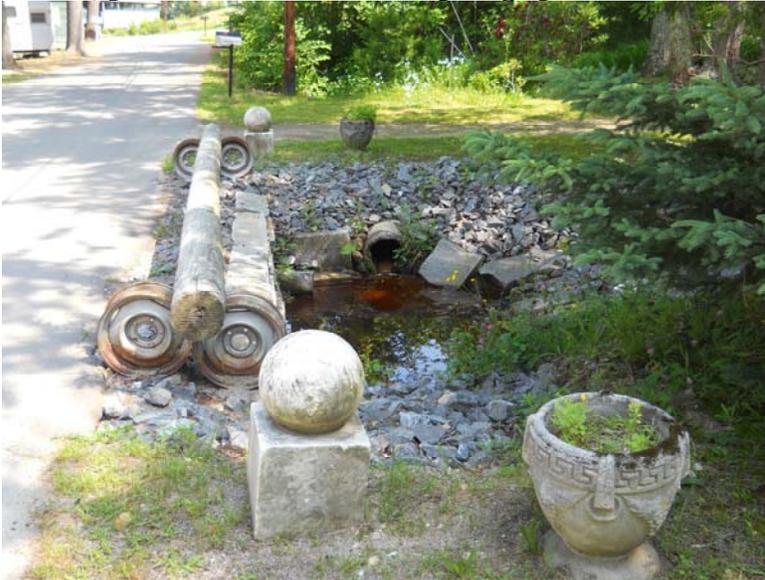
Site #7, post-construction of the plunge pool

Photo 24: site #7 riprap plunge pool post construction, taken by CEI.

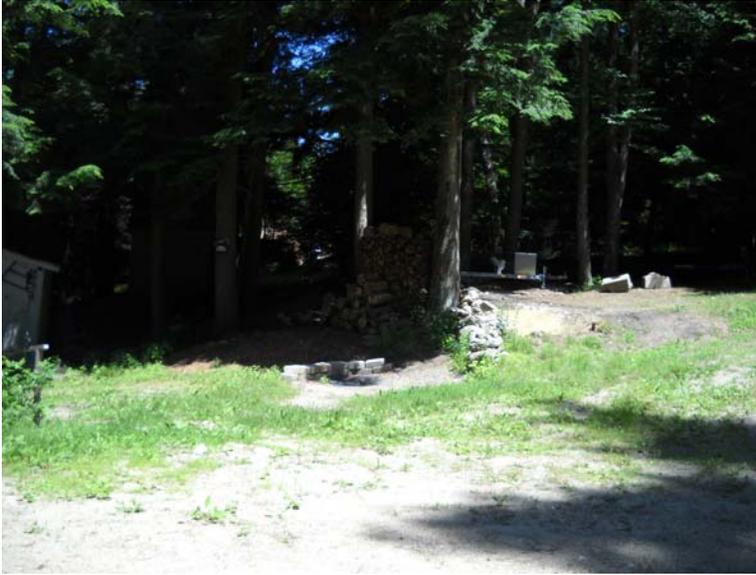
Site #8, pre-construction:

Photo 25, site #8 prior to construction, taken by CEI

- **Install crushed stone infiltration trench to promote infiltration of stormwater runoff from slopes adjacent to the gravel roadway**
- **Install riprap lined forebay to store runoff from the gravel roadway and settle out TSS prior to discharge into a raingarden.**
- **Install raingarden with subsurface crushed stone storage area to promote infiltration of stormwater**
- **Install mulch, filtering materials and plants in rain garden to remove nutrients and other pollutants prior to discharge into the lake**

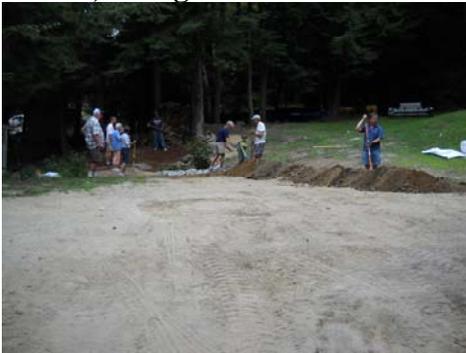
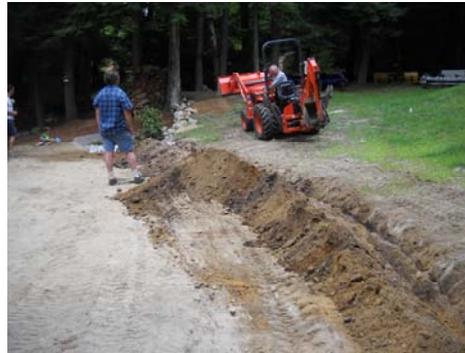
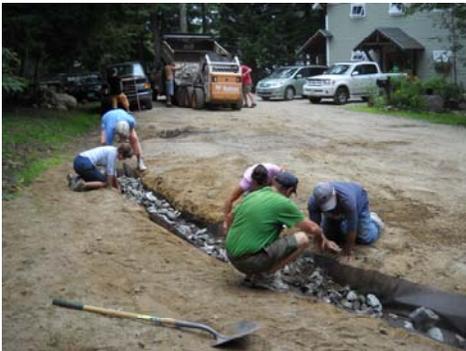
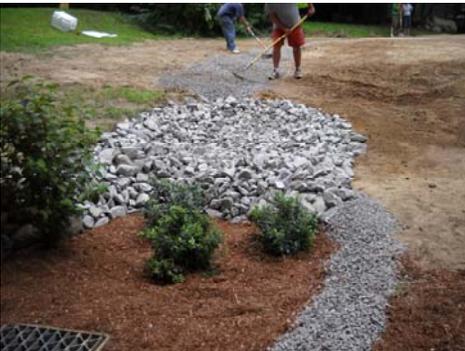
Site #8, rain garden construction:

Photos 26-29: site #8- rain garden during construction, taken by CEI.

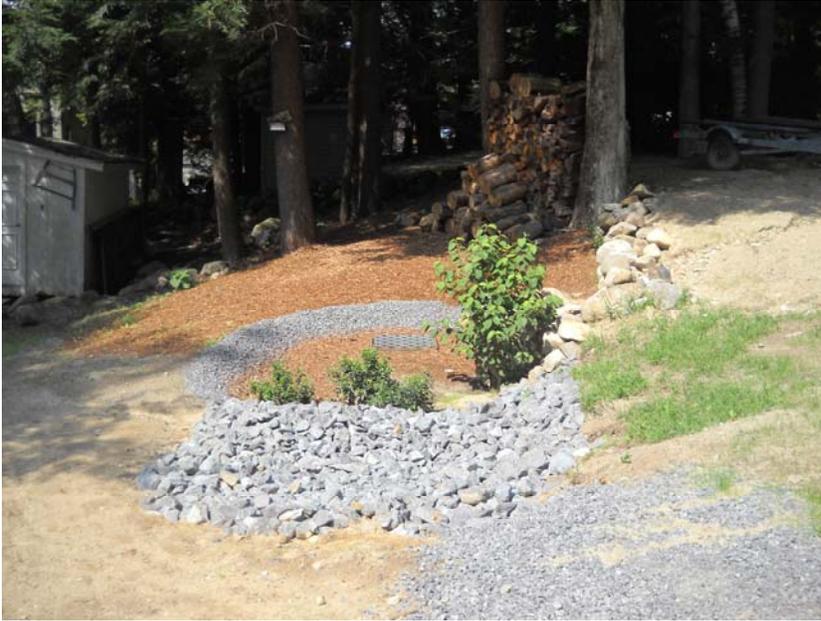
Site #8, post-construction of the rain garden

Photo 30: site #8 riprap forebay and raingarden post construction, taken by CEI.

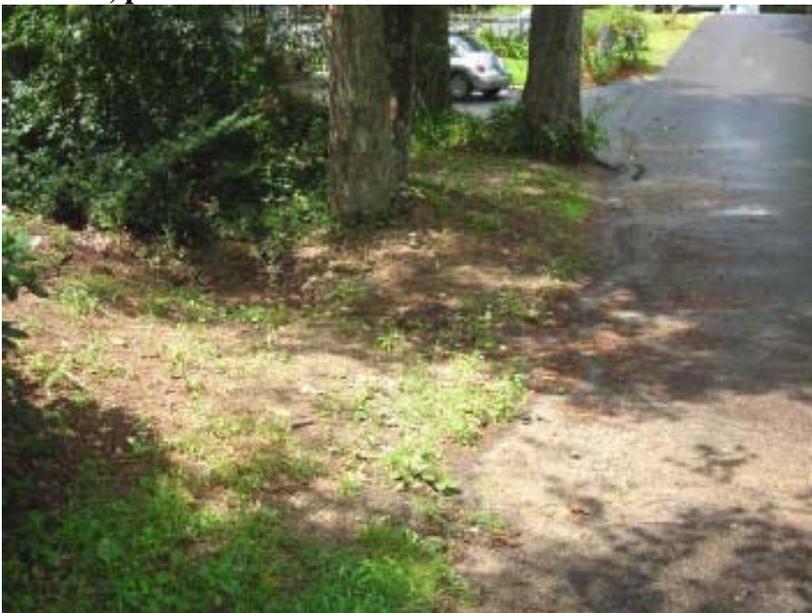
Site #10, pre-construction:

Photo 31, site #10 prior to construction, taken by Geosyntec

- **Install riprap lined forebay to store runoff from the paved roadway and settle out TSS prior to discharge into a raingarden.**
- **Install raingarden with subsurface crushed stone storage area to promote infiltration of stormwater**
- **Install mulch, filtering materials and plants in rain garden to remove nutrients and other pollutants prior to discharge into the lake**

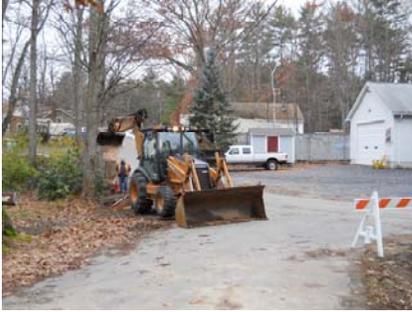
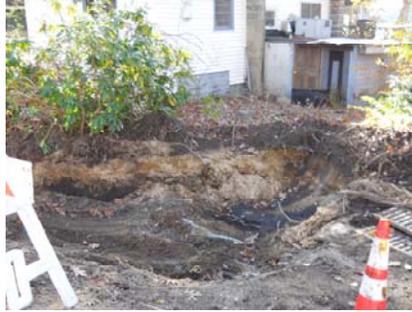
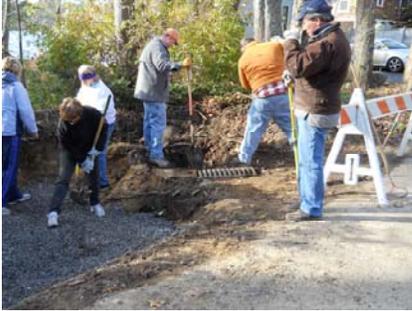
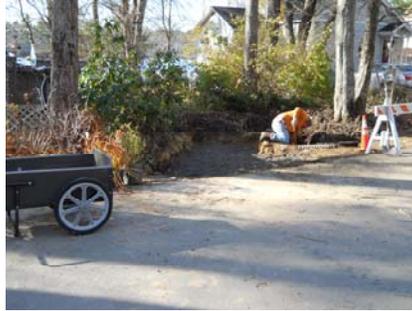
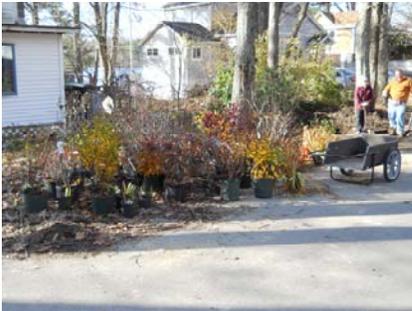
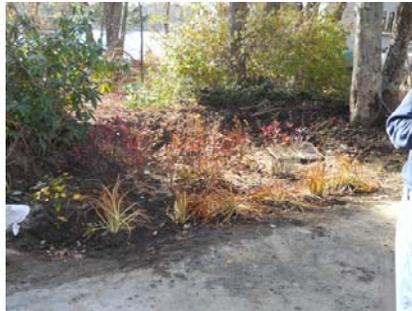
Site #10, rain garden construction:

Photos 32-37: site #10- rain garden during construction, taken by CEI.

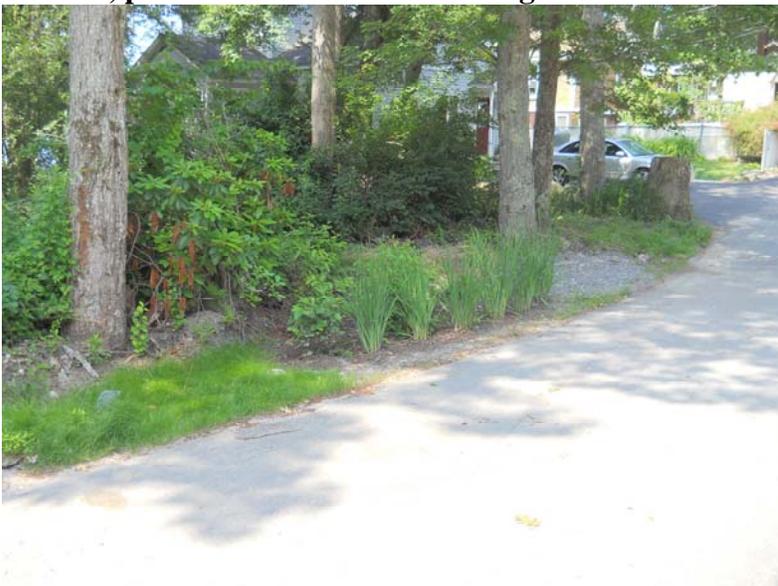
Site #10, post-construction of the rain garden

Photo 38: site #10, riprap forebay and raingarden post construction, taken by CEI.

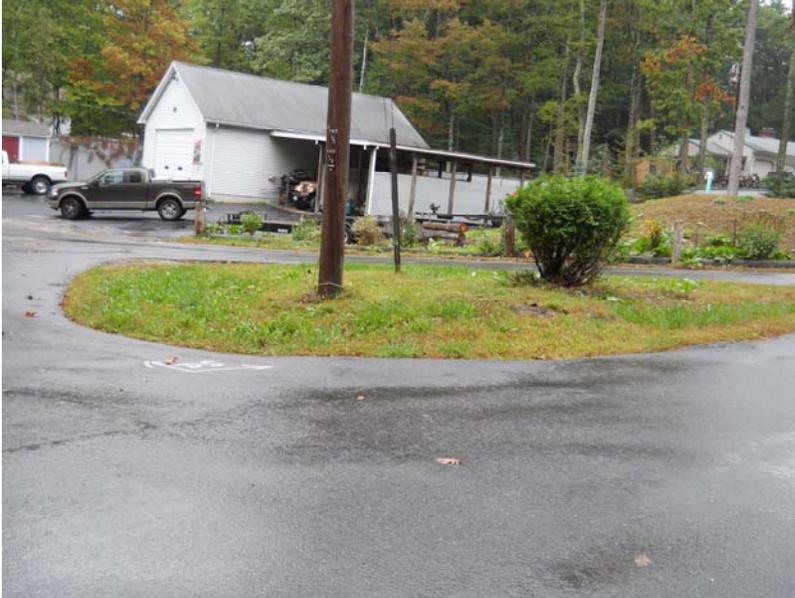
Site #10B, pre-construction:

Photo 39, site #10B prior to construction, taken by CEI

- **Install riprap lined forebay to store runoff from the paved roadway and settle out TSS prior to discharge into a raingarden.**
- **Install raingarden with subsurface crushed stone storage area to promote infiltration of stormwater**
- **Install mulch, filtering materials and plants in rain garden to remove nutrients and other pollutants prior to discharge into the lake**

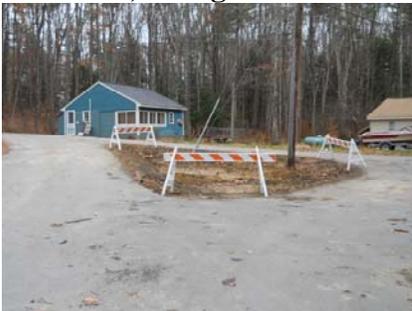
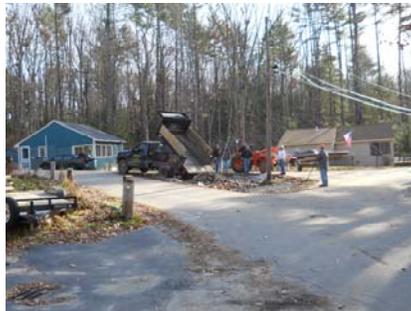
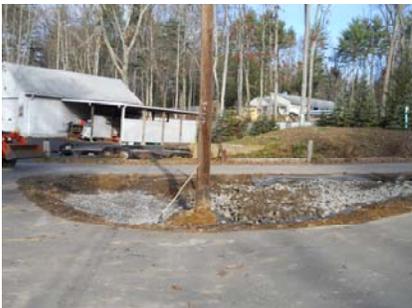
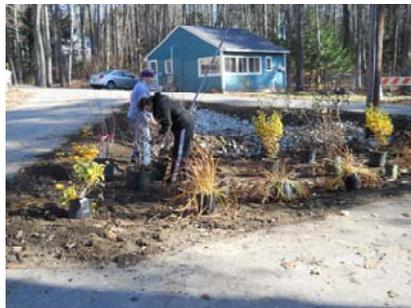
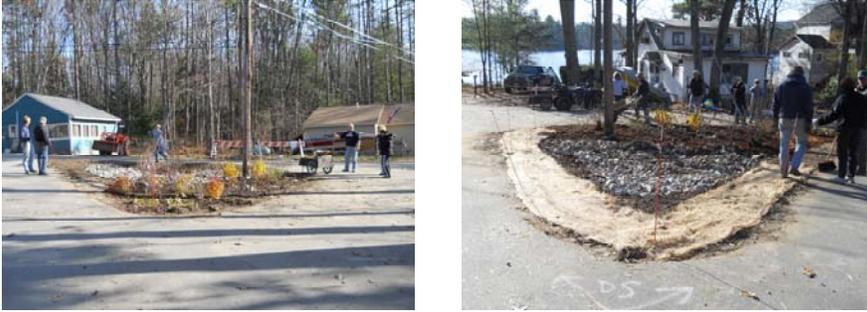
Site #10B, rain garden construction:

Photos 40-45: site #10B- rain garden during construction, taken by CEI.

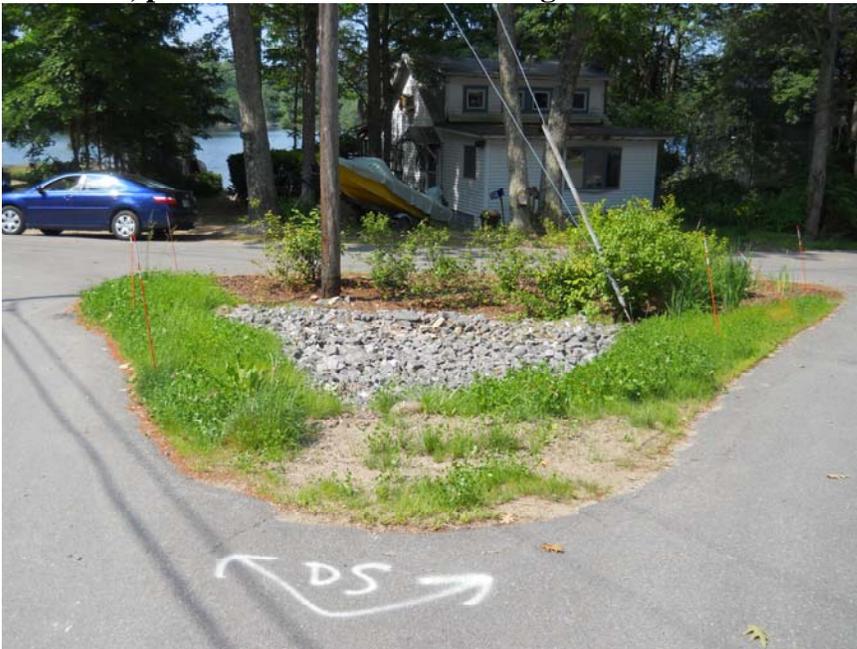
Site #10B, post-construction of the rain garden

Photo 46: site #10B, riprap forebay and raingarden post construction, taken by CEI.

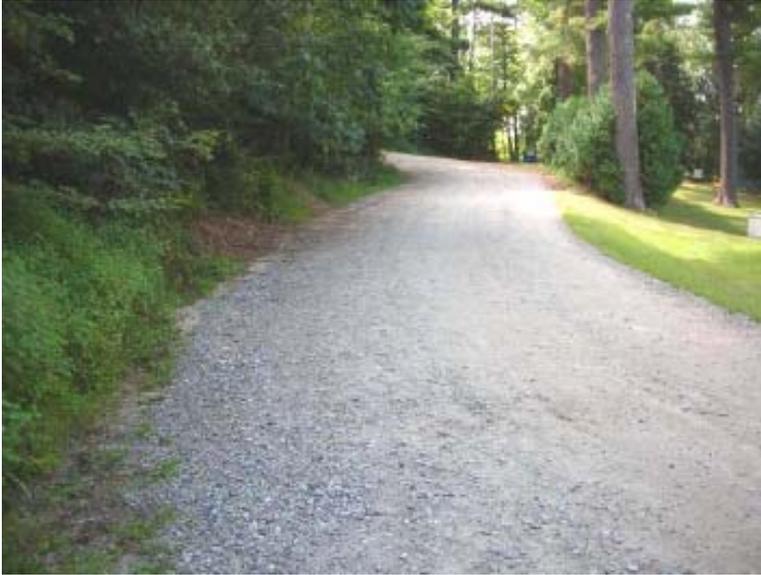
Site #12, pre-construction:

Photo 47, site #12 prior to construction, taken by CEI

- **Install riprap lined forebay to store runoff from the gravel roadway and settle out TSS prior to discharge into a vegetated swale.**
- **Install vegetated swale prior to catch basin and roadway culverts to store runoff and settle out TSS and nutrients prior to discharge into the lake.**
- **Stabilize roadway shoulder to prevent erosion**

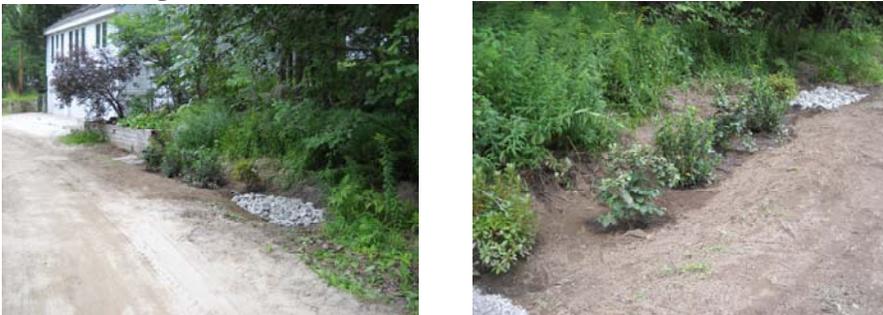
Site #12, vegetated swale construction:

Photos 48-49: site #12- vegetated swale during construction, taken by CEI.

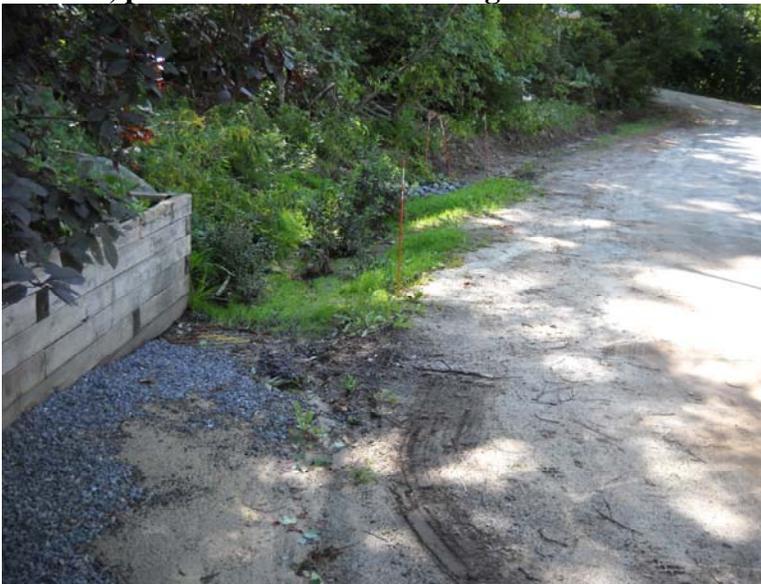
Site #12, post-construction of the vegetated swale

Photo 50: site #12 vegetated swale post construction, taken by CEI.

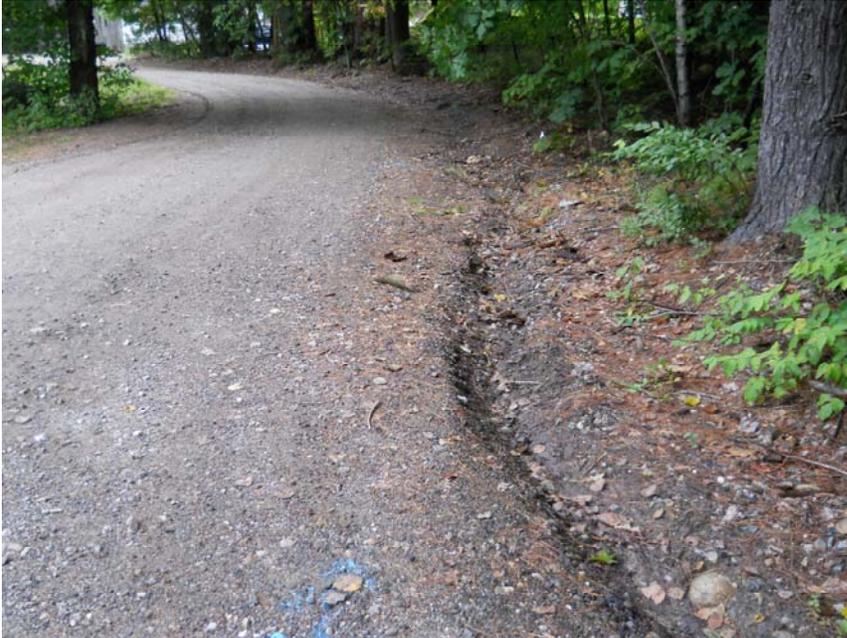
Site #14A, pre-construction:

Photo 51, site #14A prior to construction, taken by CEI

- Install riprap lined plunge pool to store runoff from the gravel roadway and settle out TSS prior to discharge into a vegetated swale.
- Install vegetated swale with stone check dams to store runoff and settle out TSS and nutrients prior to discharge into the lake.
- Stabilize roadway shoulder to prevent erosion

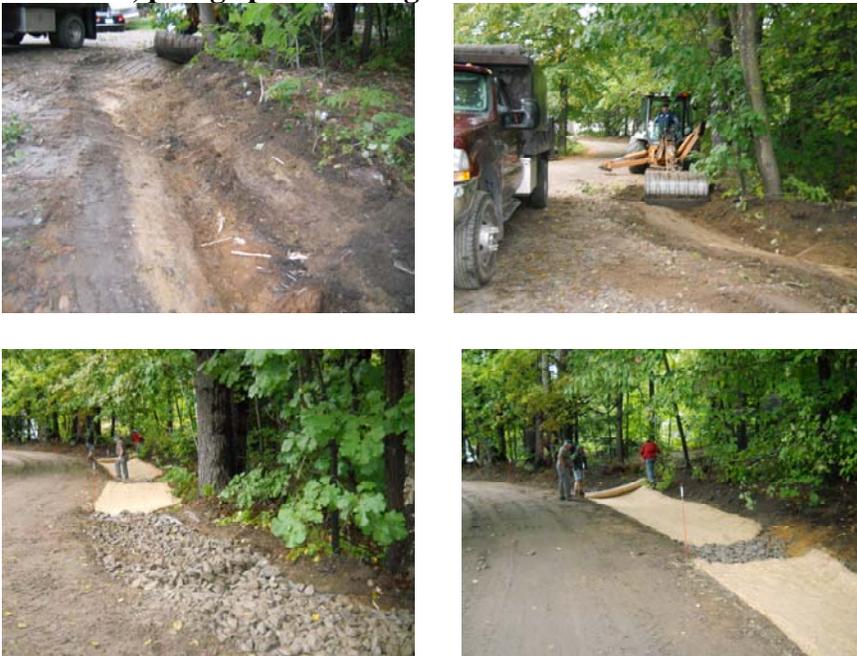
Site #14A, plunge pool and vegetated swale construction:

Photos 52-55: site #14A- vegetated swale during construction, taken by CEI.

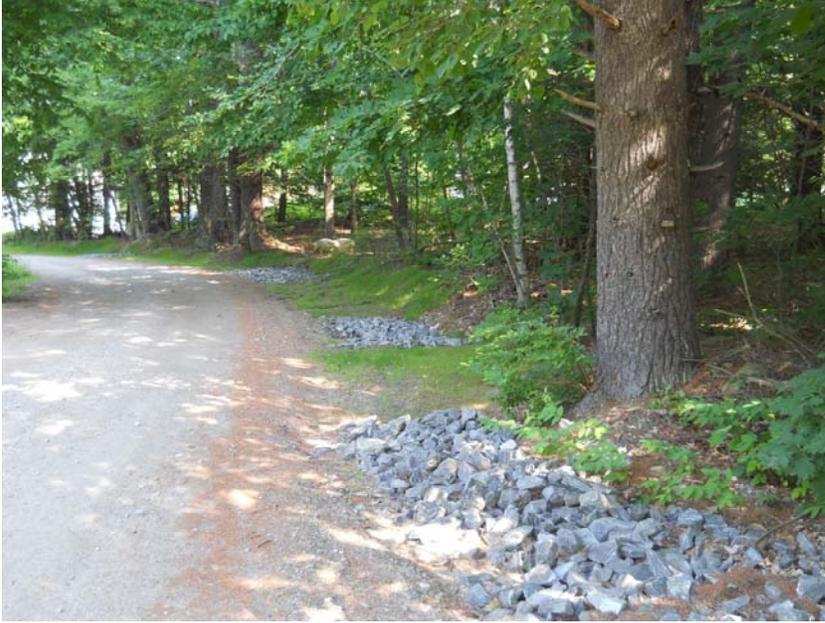
Site #14A, post-construction of the plunge pool and vegetated swale

Photo 56: site #14A vegetated swale post construction, taken by CEI.

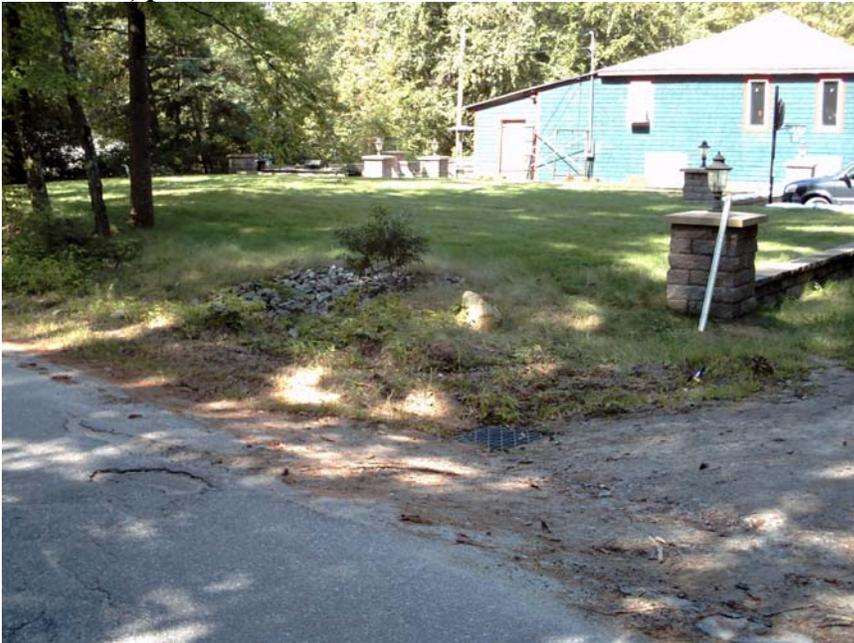
Site #14B, pre-construction:

Photo 57, site #14B prior to construction, taken by CEI

- **Install riprap lined forebay to store runoff from the paved and gravel roadways and to settle out TSS prior to discharge into a raingarden.**
- **Install raingarden with subsurface crushed stone storage area to promote infiltration of stormwater**
- **Install mulch, filtering materials and plants in rain garden to remove nutrients and other pollutants prior to discharge into the lake**

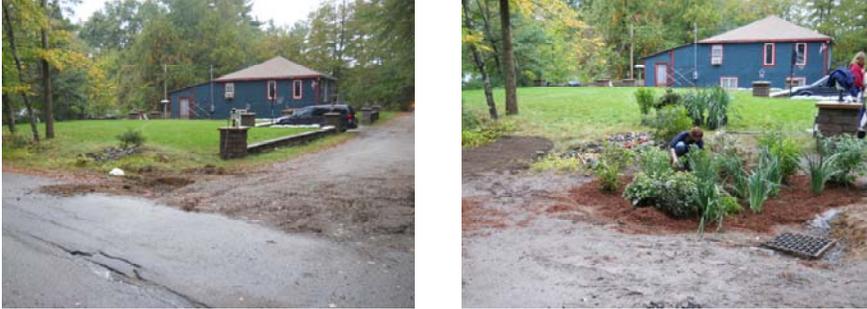
Site #14B, rain garden construction:

Photos 58-59: site #14B- rain garden during construction, taken by CEI.

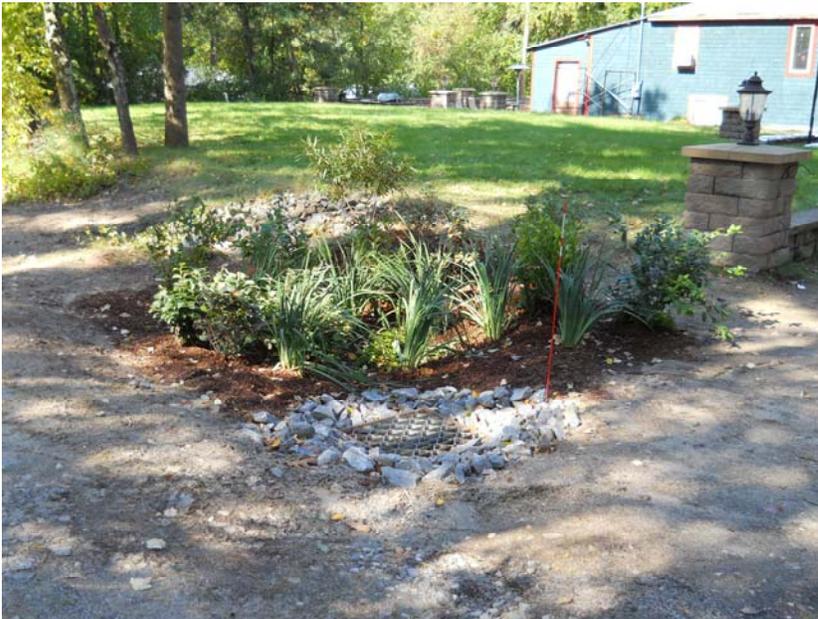
Site #14B, post-construction of the rain garden

Photo 60: site #14B, riprap forebay and raingarden post construction, taken by CEI.

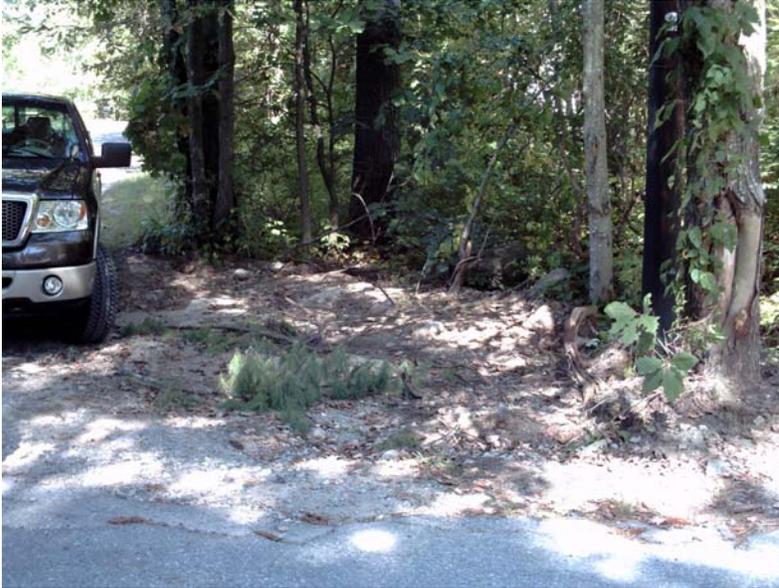
Site #14C, pre-construction:

Photo 61, site #14C prior to construction, taken by CEI

- **Install riprap lined forebay to store runoff from the paved roadway and to settle out TSS prior to discharge into a raingarden.**
- **Install raingarden with subsurface crushed stone storage area to promote infiltration of stormwater**
- **Install mulch, filtering materials and plants in rain garden to remove nutrients and other pollutants prior to discharge into the lake**

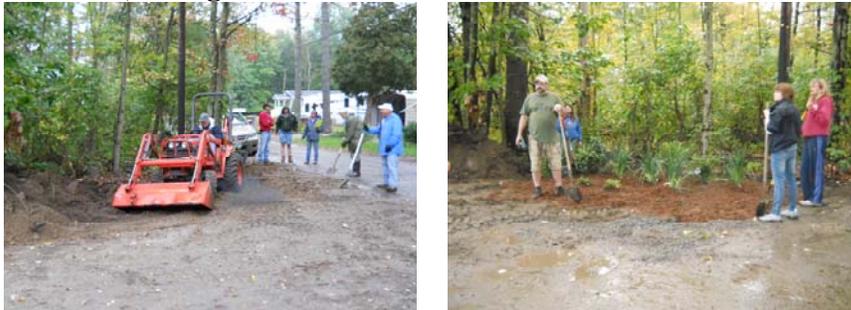
Site #14C, rain garden construction:

Photos 62-63: site #14C- rain garden during construction, taken by CEI.

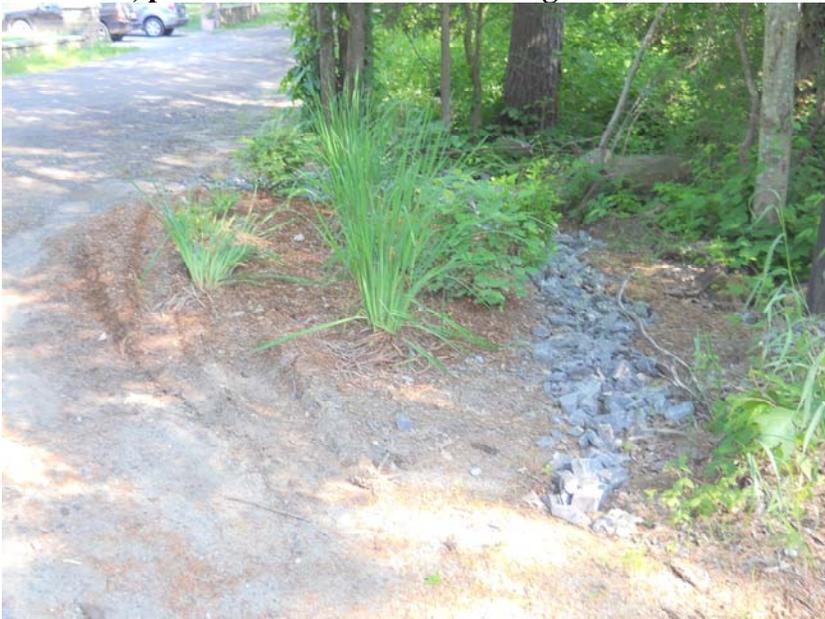
Site #14C, post-construction of the rain garden

Photo 64: site #14C, riprap forebay & raingarden post construction, taken by CEI.

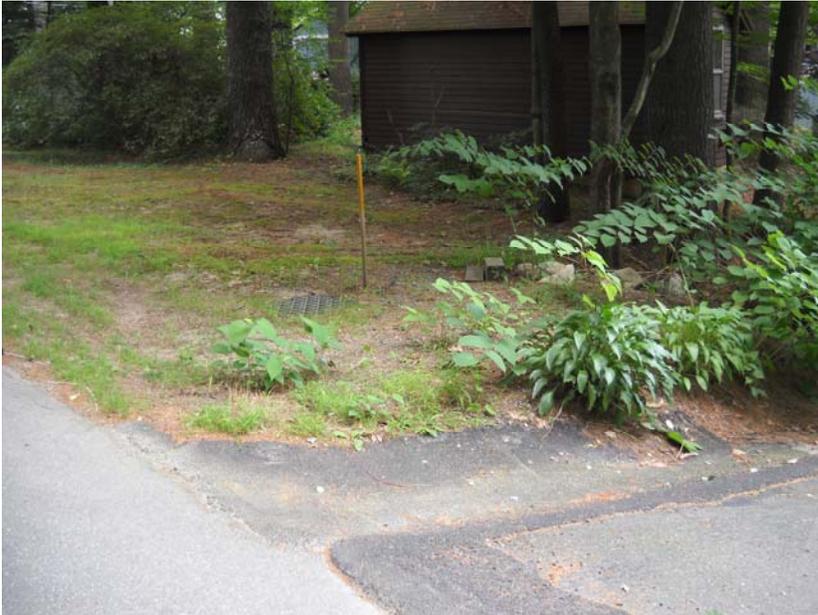
Site #16, pre-construction:

Photo 65, site #16 prior to construction, taken by CEI

- **Install riprap lined forebay to store runoff from the paved roadway and to settle out TSS prior to discharge into a raingarden.**
- **Install raingarden with subsurface crushed stone storage area to promote infiltration of stormwater**
- **Install mulch, filtering materials and plants in rain garden to remove nutrients and other pollutants prior to discharge into the lake**

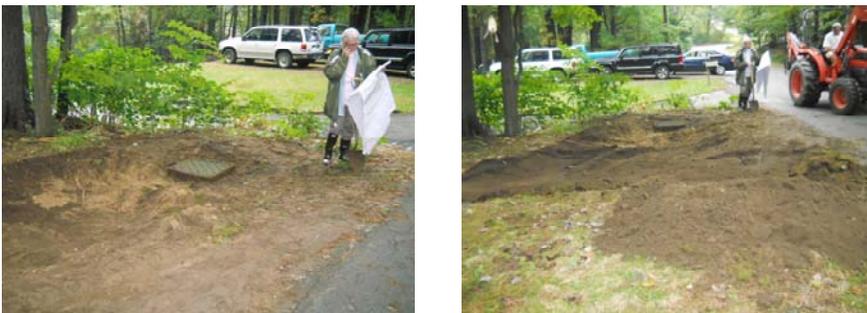
Site #16, rain garden construction:

Photos 66-67: site #16- rain garden during construction, taken by CEI.

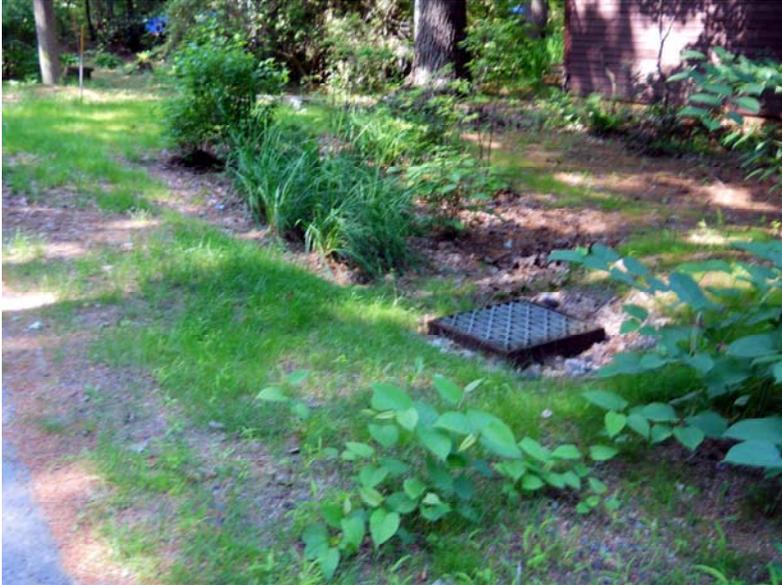
Site #16, post-construction of the rain garden

Photo 68: site #16, riprap forebay and raingarden post construction, taken by CEI.

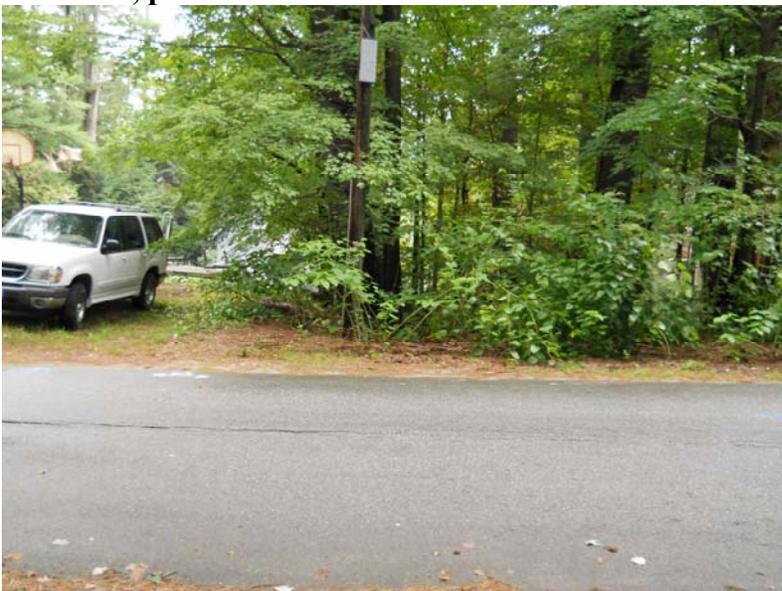
Site #16A, pre-construction:

Photo 69, site #16A prior to construction, taken by CEI

- **Install riprap lined forebay to store runoff from the paved roadway and to settle out TSS prior to discharge into a raingarden.**
- **Install raingarden with subsurface crushed stone storage area to promote infiltration of stormwater**
- **Install mulch, filtering materials and plants in rain garden to remove nutrients and other pollutants prior to discharge into the lake**

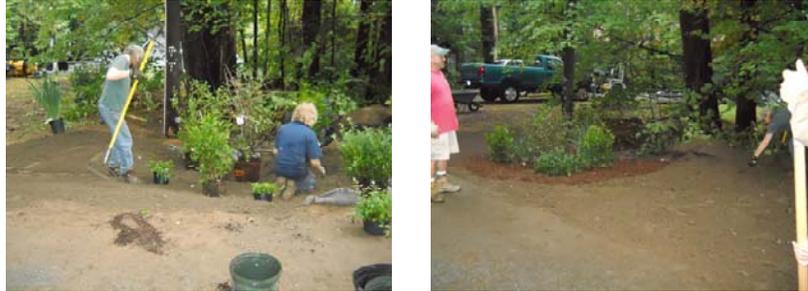
Site #16A, rain garden construction:

Photos 70-71: site #16A- rain garden during construction, taken by CEI.

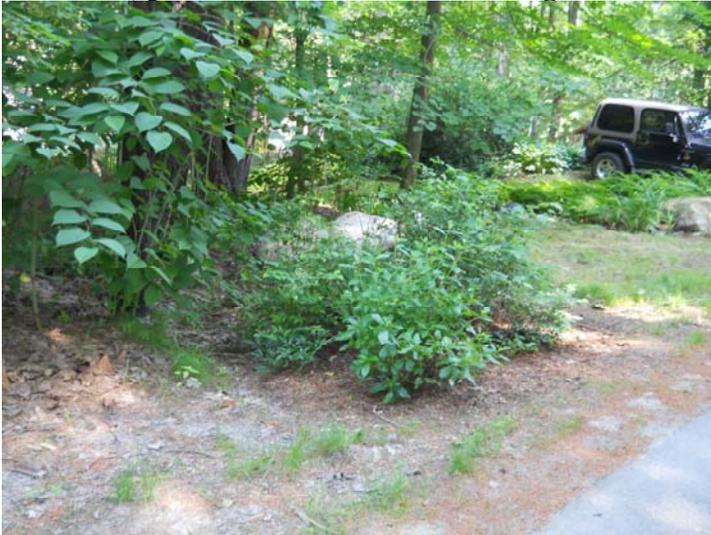
Site #16A, post-construction of the rain garden

Photo 72: site #16A, raingarden post construction, taken by CEI.

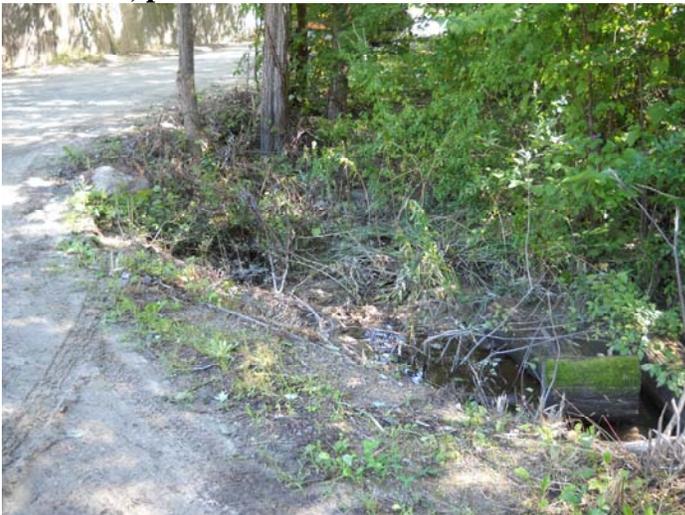
Site #16B, pre-construction:

Photo 73, site #16B prior to construction, taken by CEI

- **Install plunge pool prior to outfall pipes and roadway culverts to store runoff and settle out TSS and nutrients prior to discharge into the lake.**

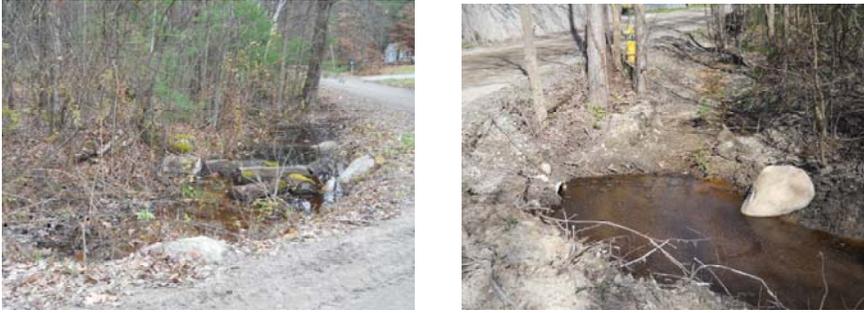
Site #16B, plunge pool construction:

Photos 74-75: site #16B - plunge pool during construction, taken by CEI.

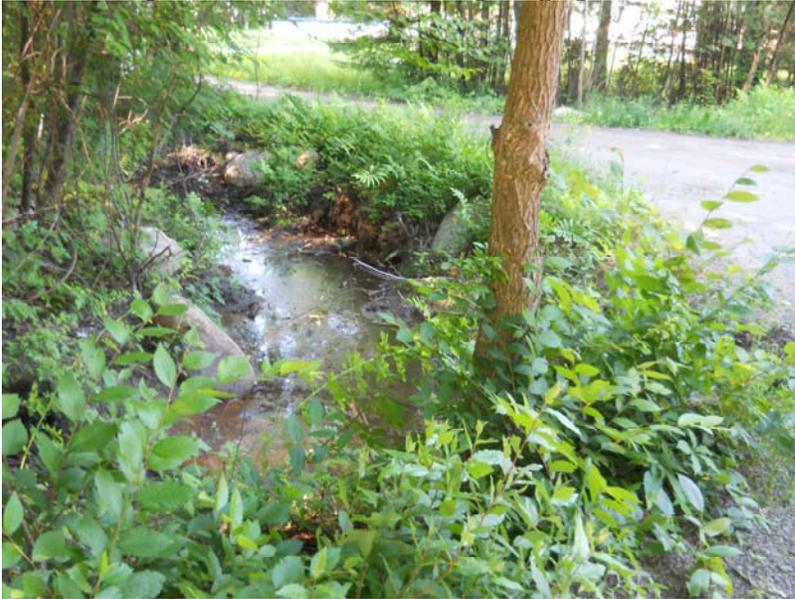
Site #16B, post-construction of the plunge pool

Photo 76: site #16B riprap plunge pool post construction, taken by CEI.
